REPORT OF INVESTIGATION

**Surface Metal Mine
(Copper)**

**Fatal Fall of Material Accident
January 9, 2010**

**Ames Construction Inc.
Contractor ID No. U82
at
Freeport McMoRan Miami Inc.
Freeport McMoRan Miami Inc.
Miami, Gila County, Arizona
Mine ID No. 02-00112**

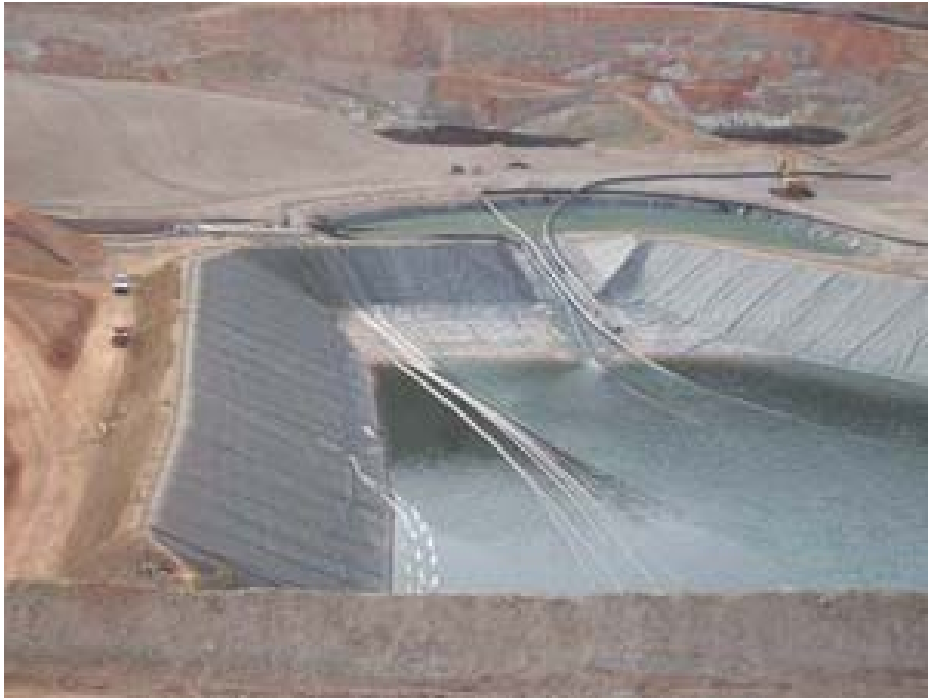
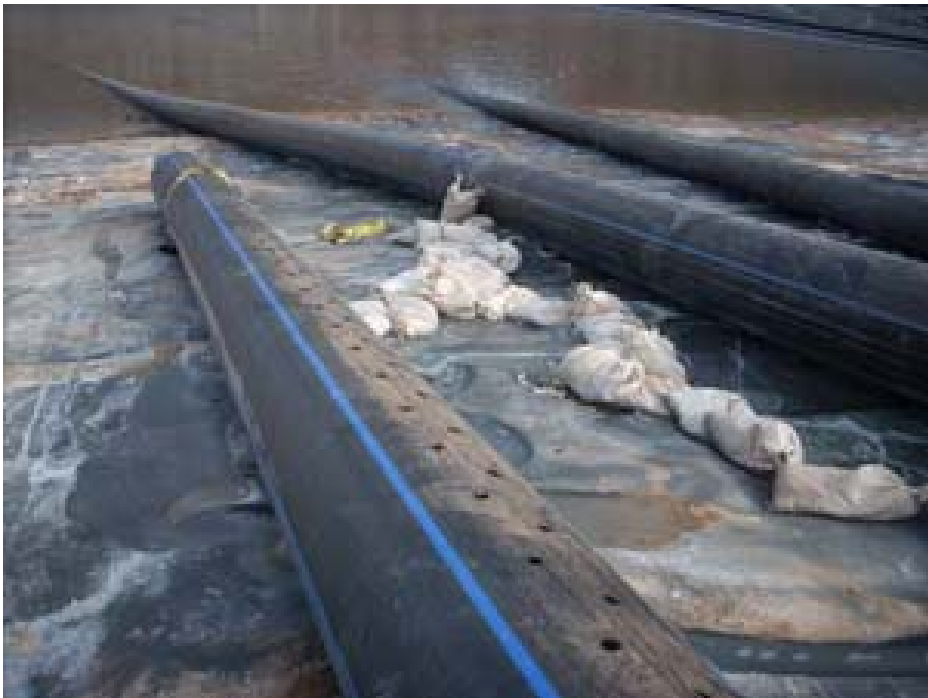
Estevan R. Benavidez, laborer, age 20, was fatally injured on January 9, 2010, when a suspended 400-foot long section of 24-inch diameter high density polyethylene pipe fell and struck him. The pipe was being installed into a new pregnant leach solution reservoir.

The accident occurred because contractor management policies and controls were inadequate. A risk assessment to discuss the task and identify possible hazards was not conducted prior to placing the pipe. The procedures failed to ensure that persons stay clear of suspended loads.
