REPORT OF INVESTIGATION

**Surface Nonmetal Mine
(Cement)**

**Fatal Powered Haulage Accident
January 26, 2010**

**Tehachapi Plant
Lehigh Southwest Cement
Tehachapi, Kern County, California
Mine I.D. No. 04-00196**

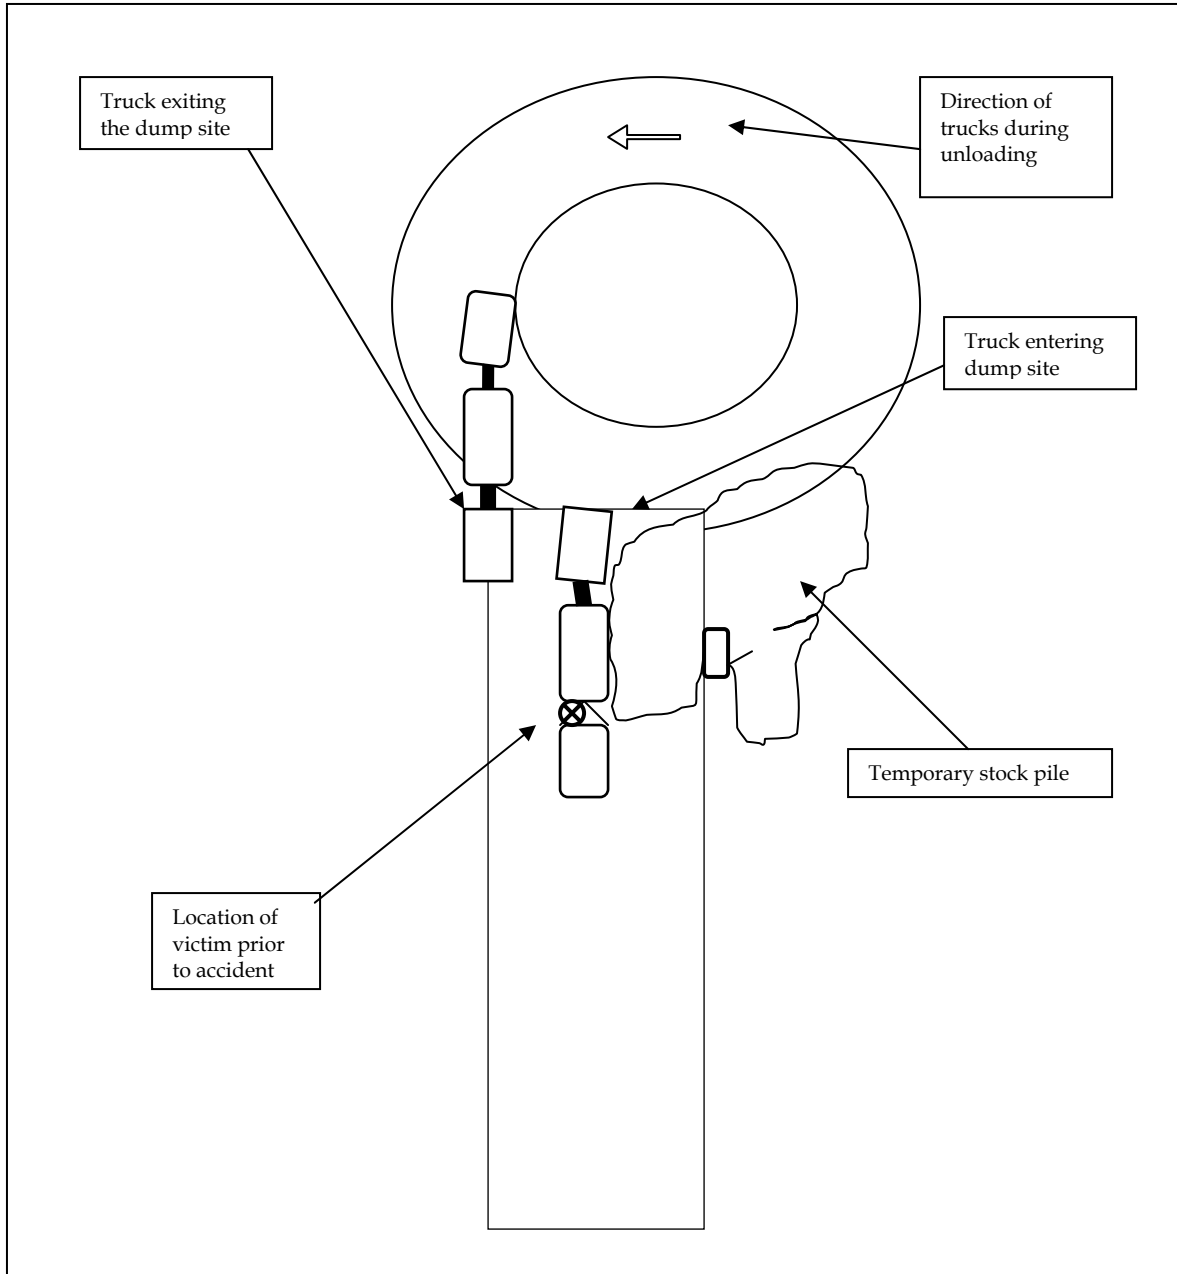
Plan View of Accident Scene

The accident occurred at the south entrance to the temporary dump site located at the intersection east of the gypsum silos. This site was created on January 21, 2010, because the primary dump site area was too wet and muddy for trucks to travel. Rain from the previous week had caused as much as two feet of mud to accumulate at the site.

The temporary dump site was approximately 84 feet in diameter. Trucks entered the dump site from the south and traveled in a counter clockwise direction as material was emptied from their trailers. Trucks waiting to unload parked on the entry road just south of the dump site. This road was originally approximately 31 feet wide; however, as gypsum material was delivered and stockpiled (approximately 50 feet in diameter and 20 feet high,) the width of the road was reduced to about 15 feet where the accident occurred.

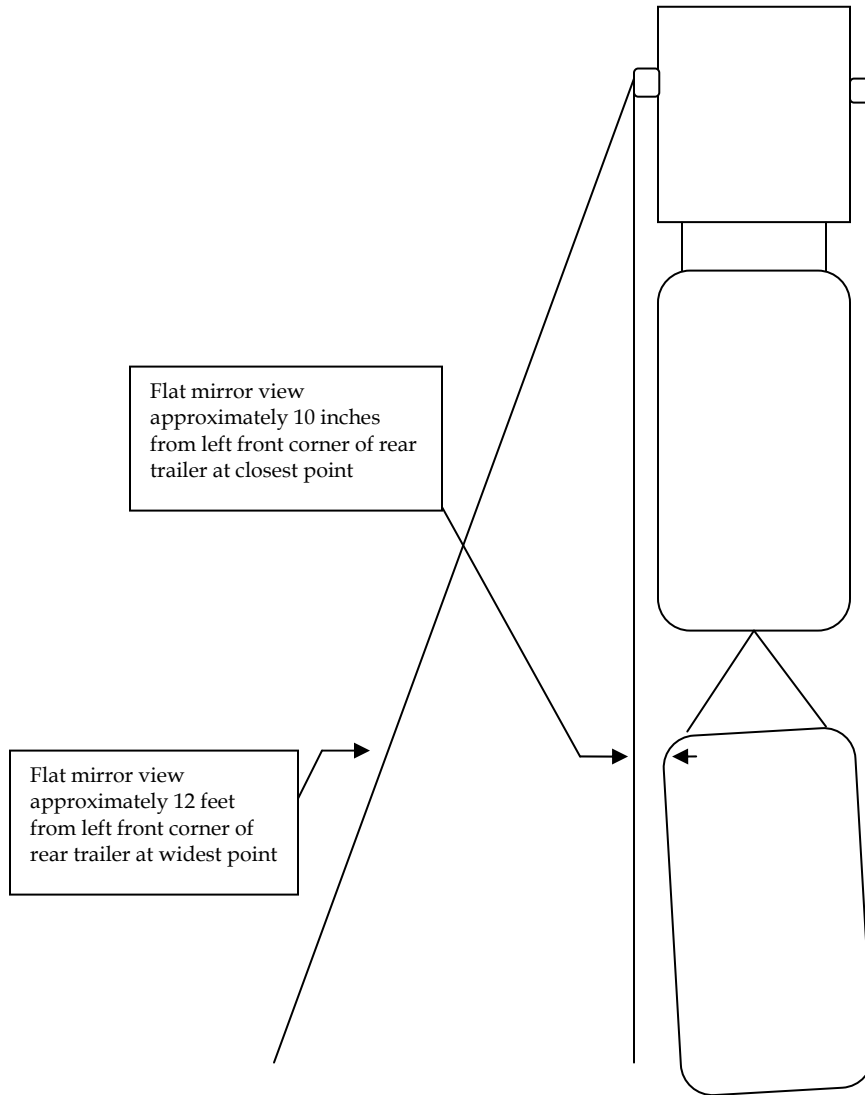
Truck Mirrors and Visibility

The approximate visibility zones for the left side and left rear trailer areas of the truck are shown in Appendix D. The investigators determined that the victim had traveled within the viewing area of the left side mirror sections while walking to the area between the front and rear trailer but was not noticed by the driver.

At the time of the accident, the position of the truck and trailers prevented an accurate view of the left rear trailer area. The truck and trailers had pulled up at about 2-3 mph for approximately 3 to 5 feet prior to striking the victim.
