REPORT OF INVESTIGATION

Fatal Falling Material Accident

March 24, 2010

Cayuga Mine
Cargill Deicing Technology
Lansing, Tompkins County, New York
Mine I.D. No. 30-00663

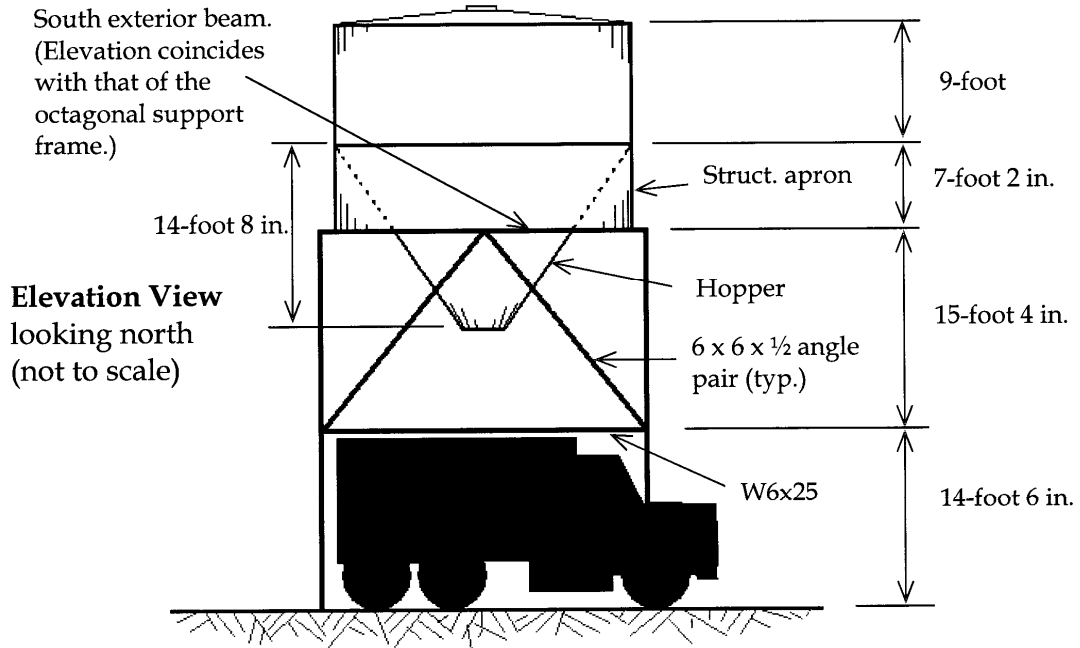
Schematic of Accident Scene

The bin structure involved in the accident was reportedly constructed in 1989. As shown in Appendix C, the bin and cone portion of the structure were supported by four 14-inch-deep (W14x99) steel columns positioned at each of the four corners of a 25-foot-4-inch by 25-foot-4-inch square frame. Each column extended vertically 29 feet 4 inches above its base, and was supported by a reinforced concrete foundation and anchor bolts. The columns were braced at mid-height by horizontal (W6x25) and diagonal (6 x 4 x ½ back-to-back angles) steel members. The square frame located at the tops of the columns consisted of 24-inch-deep (W24x68) perimeter beams. These perimeter beams were bolted to the support columns.

While relatively minor corrosion was observed at locations throughout the structure, severe corrosion damage was apparent in several of the shear tab connections between the octagon frame beams and the exterior perimeter beams. The shear tabs closest to the southeast support column were in the worst condition. Measurements were taken on all tabs to obtain the effective connective length and average thickness of each failed cross-section. The tab plate at the south end of the east exterior perimeter beam had only 10 percent of its initial cross-sectional area remaining. The shear tab connection at the east side of the south exterior perimeter beam had a similar degree of section loss. The bin weight, including its roof and accessories, was as 28,000 pounds as listed on the design drawings. By direct measurement, management determined the weight of salt in the bin at the time of the accident to be 233,000 pounds. Calculations of the stress on the shear tabs adjacent to the southeast column demonstrated that, at the time of the accident, they were loaded well beyond their capacity.

Failure of the tabs in the southeast corner of the structure led to a redistribution of the bin load, causing higher stresses on the remaining tabs. The redistribution of the load, as well as the introduction of dynamic effects, led to failure of less corroded tabs and the catastrophic collapse of the entire bin. This sequence was further supported by other observations made at the site. The west beam experienced significant torsional deformation during the bin collapse. The octagonal support frame exerted a large torsional force on the west beam as the bin moved and the shear tab connections were strong enough to deform the beam before failing. The scrape marks on the east face of the bin wall and the deformations of the roof on the east side of the bin indicated impact with the east-side exterior beam and possibly the beam in the lower east bay. This was consistent with a failure that initiated at the shear tabs nearest the southeast column. The cause of the collapse was the overloading of the severely corroded shear tab connections between the diagonal beams in the octagon framework and the main exterior perimeter beams adjacent to the southeast column.

"X" indicates the victim's location when the accident occurred.
