REPORT OF INVESTIGATION

**Surface Nonmetal Mine
(Limestone)**

**Fatal Machinery Accident
May 24, 2010**

**US Lime Company - St. Clair
US Lime Company - St. Clair
Marble City, Sequoyah County, Oklahoma
Mine ID No. 34-00282**

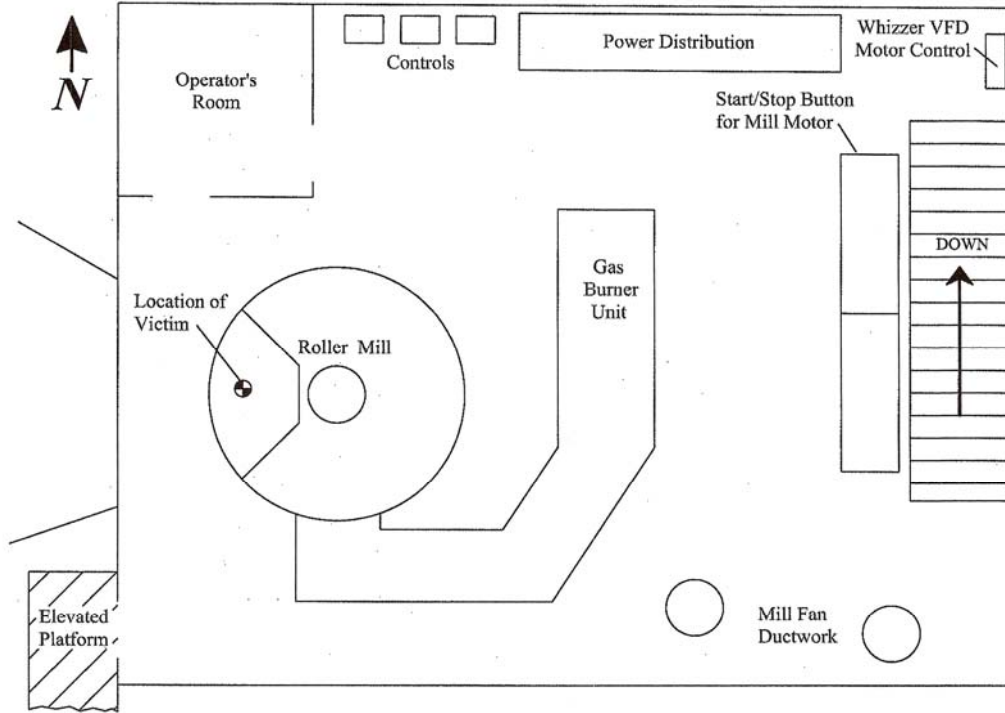
FLOOR PLAN – FINES BUILDING SECOND LEVEL

The accident occurred indoors on the second level of the Fines Building at the surface plant. The weather consisted of clear skies and 80-degree temperatures and was not considered a factor in the accident.

The Fines Building was a 2-story 30-foot by 39-foot steel structure that housed the roller mill. The second floor was accessible by one set of stairs inside the building and one set of stairs outside the building. Finished product from the roller mill was stored in two loading bins located just outside the Fines Building.
