REPORT OF INVESTIGATION

Underground Metal Mine  
(Silver)

Fatal Fall of Ground Accident  
June 18, 2010

Galena Mine  
U.S. Silver - Idaho, Inc.  
Wallace, Shoshone County, Idaho  
Mine I.D. No. 10-00082

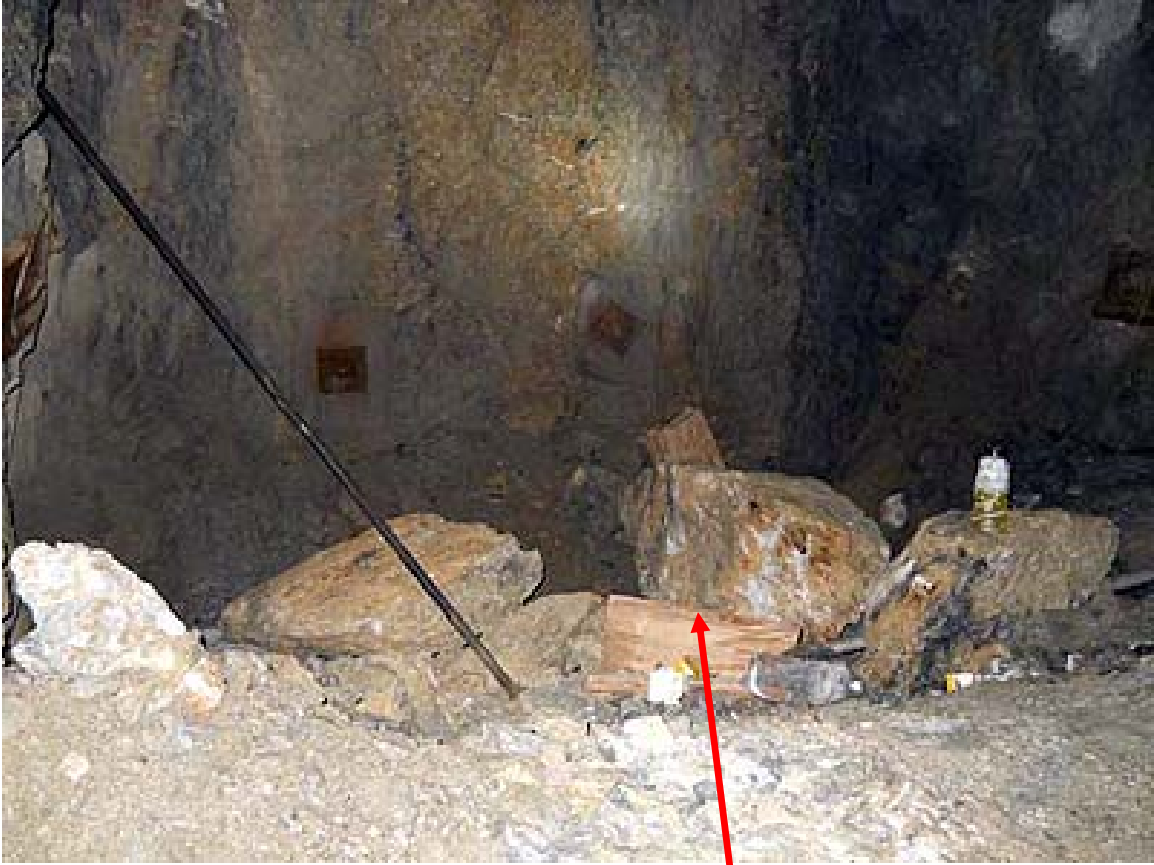
**3400-287 Raise**

**Location of victim**

Prior to the accident, about 1/3 of the back/face area had been bolted. About 2/3 of the back/face area and all of the ribs remained to be bolted.

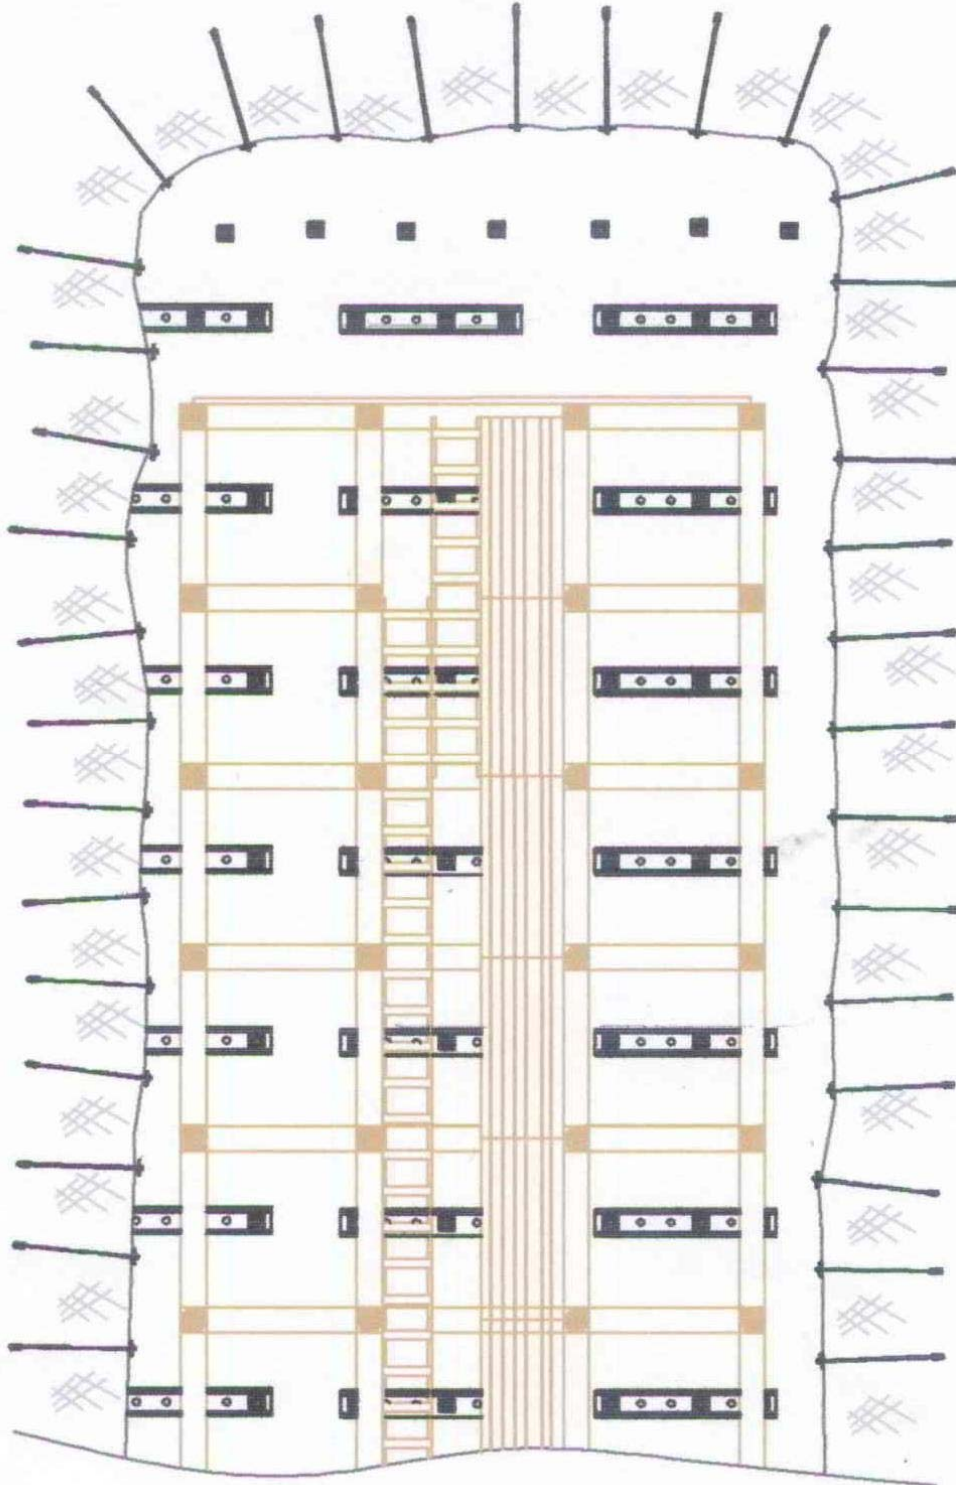
## 4 Cap Raise Diagram

After the near vertical Raise is secured by rock fixtures, timber supports are installed. Each 4-cap timber set consists of eight – 62 inch posts, with 4 caps, six girts, heading and lacing. This method provides for a three-compartment raise. The middle compartment was the manway and timber slide and the compartments to the west and east were used for muck.
