REPORT OF INVESTIGATION

Surface Metal Mine  
(Copper)

Powered Haulage Accident  
June 20, 2010

Ray  
Asarco LLC  
Mine I.D. No. 02-00150  
Ray, Pinal County, Arizona

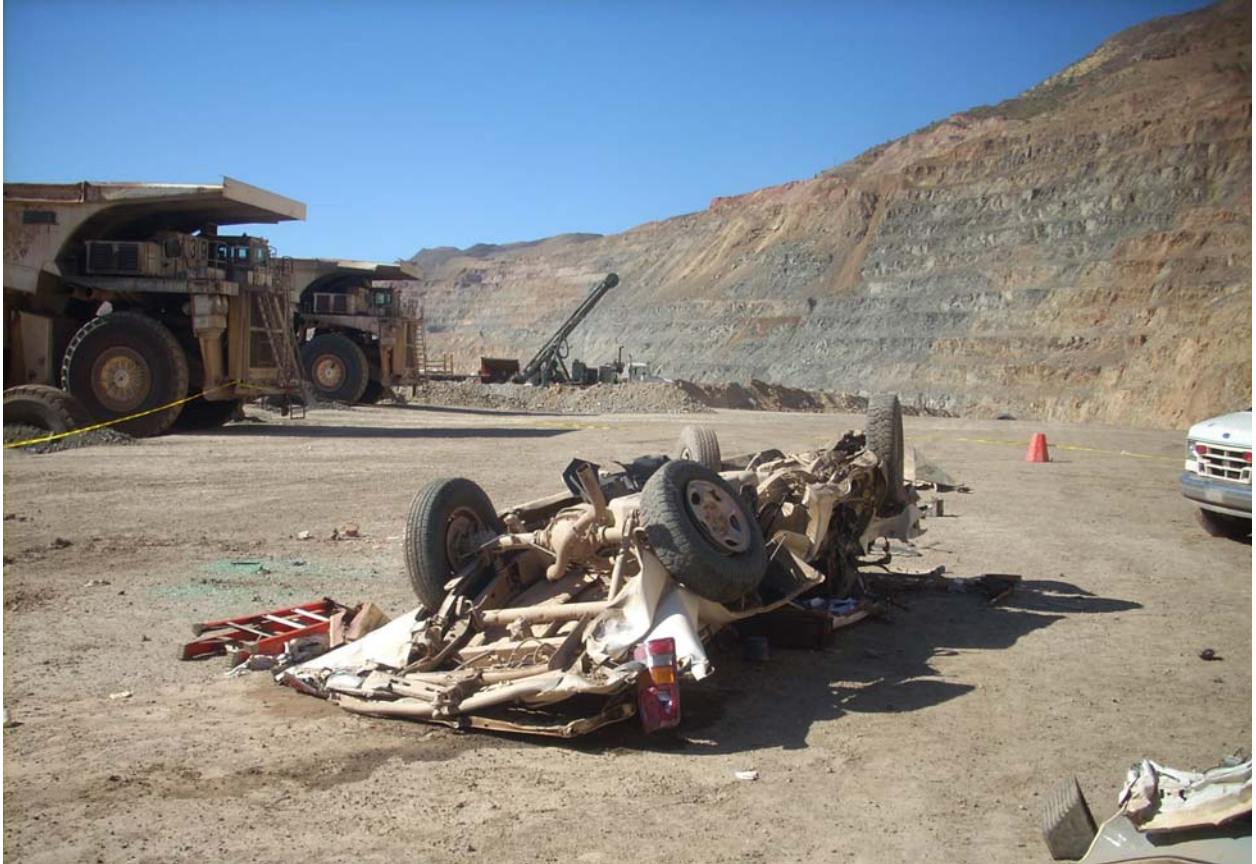
Thomas E. Benavidez, mechanic, age 52, died on June 20, 2010, when the 1/2-ton pickup truck he was operating was struck by a 240-ton haul truck. The pickup truck had parked in front of the haul truck just prior to the accident. William Hyde, mechanic, a passenger in the pickup truck, was seriously injured in the accident.

The accident occurred in the tie down parking area of the south dike haul road. Four days prior to the accident, large haul truck tires were placed in the parking area to demarcate parking spaces for mobile equipment that would then be parked between the large tires.

For testing purpose, a pickup truck similar to the truck involved in the accident was parked approximately 7 feet in front of the haul truck. At this location, the haul truck operator's view of the 8-foot buggy whip was almost completely blocked by the hand rails and framework of the haul truck.

*Corrective Action:* Management established new procedures in the mine's "Self-Propelled Mobile Equipment Field Service & Repair Approach and Departure" policy designating specific non-blind areas for service and maintenance vehicles to park. Procedures were established requiring service and maintenance vehicles to be parked next to the driver's side of a haul truck.
