REPORT OF INVESTIGATION

Surface Nonmetal Mine  
(Limestone)

Fatal Powered Haulage Accident  
October 16, 2010

Plant # 80013  
N.R. Hamm Quarry Inc.  
Perry, Jefferson County, Kansas  
Mine I.D. No. 14-01609

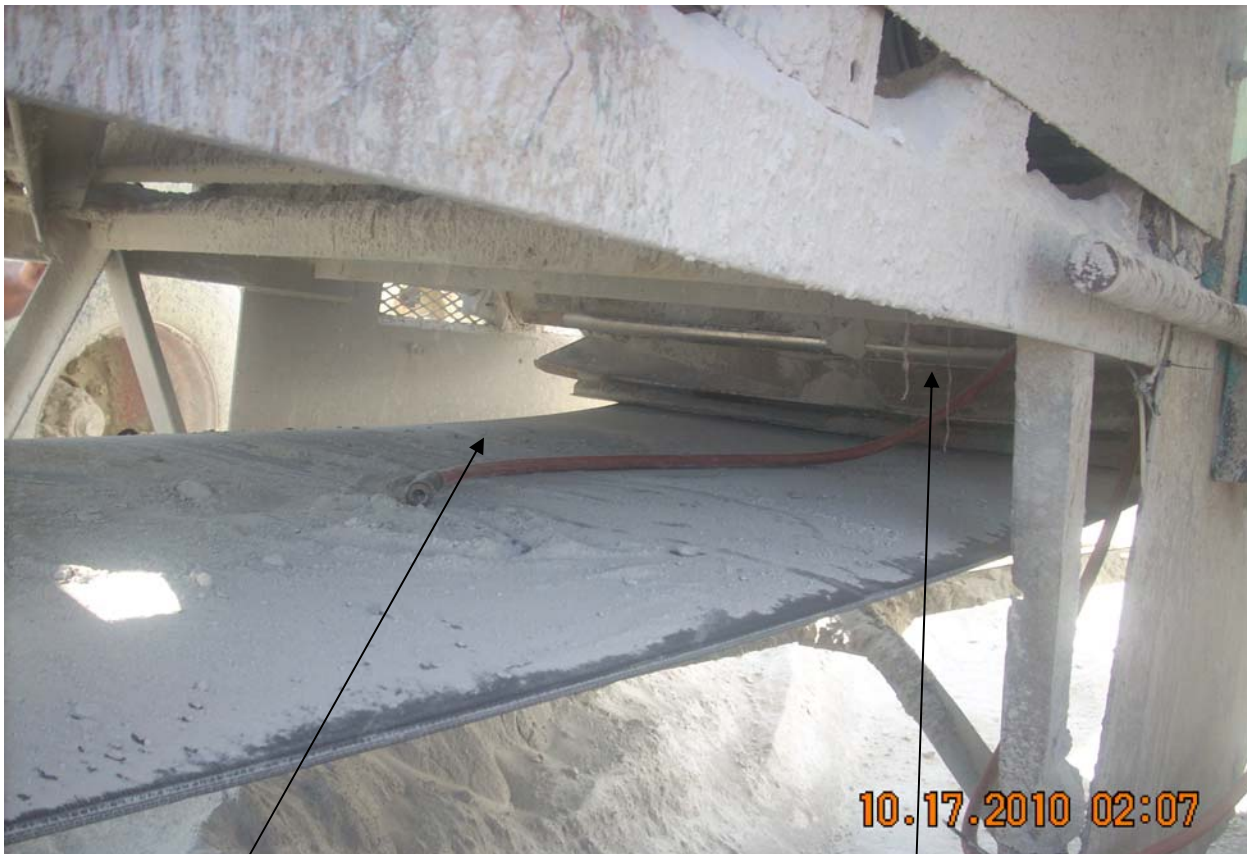
PHOTOGRAPH OF ACCIDENT SCENE  
BELT CONVEYOR TAIL PULLEY

AIR HOSE FOR CHIPPING HAMMER

VICTIM WAS CLEANING HERE

On October 16, 2010, William W. Oaks, haul truck driver, age 52, died while he was cleaning out hardened material on a belt conveyor tail pulley. Oaks was positioned on top of the return side of the belt conveyor when the belt conveyor was energized, entangling him in the tail pulley.

The accident occurred because management failed to ensure that safe work procedures were followed while persons performed work on the belt conveyor tail pulley. The belt conveyor was not deenergized and blocked against motion before persons removed spillage. Additionally, the procedures for starting the belt conveyor did not ensure that persons were protected.

**Corrective Action:** The procedures to deenergize and block equipment from hazardous motion have been revised. All miners have been trained regarding the new procedures.

**Corrective Action:** Safe operating procedures for starting belt conveyors have been established and all miners have been trained regarding the new procedures.
