REPORT OF INVESTIGATION

**Surface Nonmetal Mine
(Sand and Gravel)**

**Fatal Powered Haulage Accident
November 13, 2010**

**Hutchins Sand & Gravel
Hutchins Sand & Gravel
Ferris, Dallas County, Texas
Mine ID No. 41-04611**

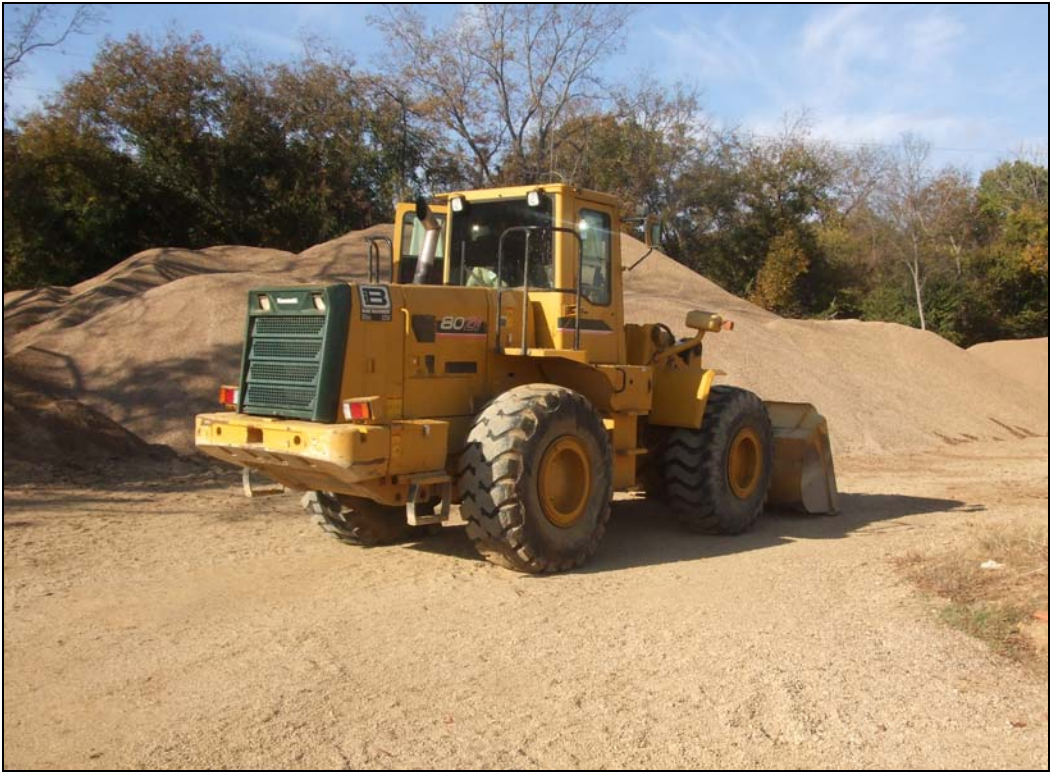
The accident occurred because management policies and procedures did not ensure that persons could safely perform maintenance tasks on a front-end loader. The power was not off and the front-end loader was not blocked against hazardous motion. The machine was parked on a slight grade, the bucket was raised off the ground, and the wheels were not chocked.

The accident occurred at a refueling area just north of the mine office. The front-end loader was parked on a 3 percent grade. The weather at the time of the accident consisted of clear skies and a temperature of 60 degrees Fahrenheit. The weather was not considered to be a contributing factor.
