REPORT OF INVESTIGATION

Fatal Falling Material Accident  
November 30, 2010

Portable Plant  
Shawnee Rock Inc.  
Pullman, Whitman County, Washington  
Mine ID No. 45-03112

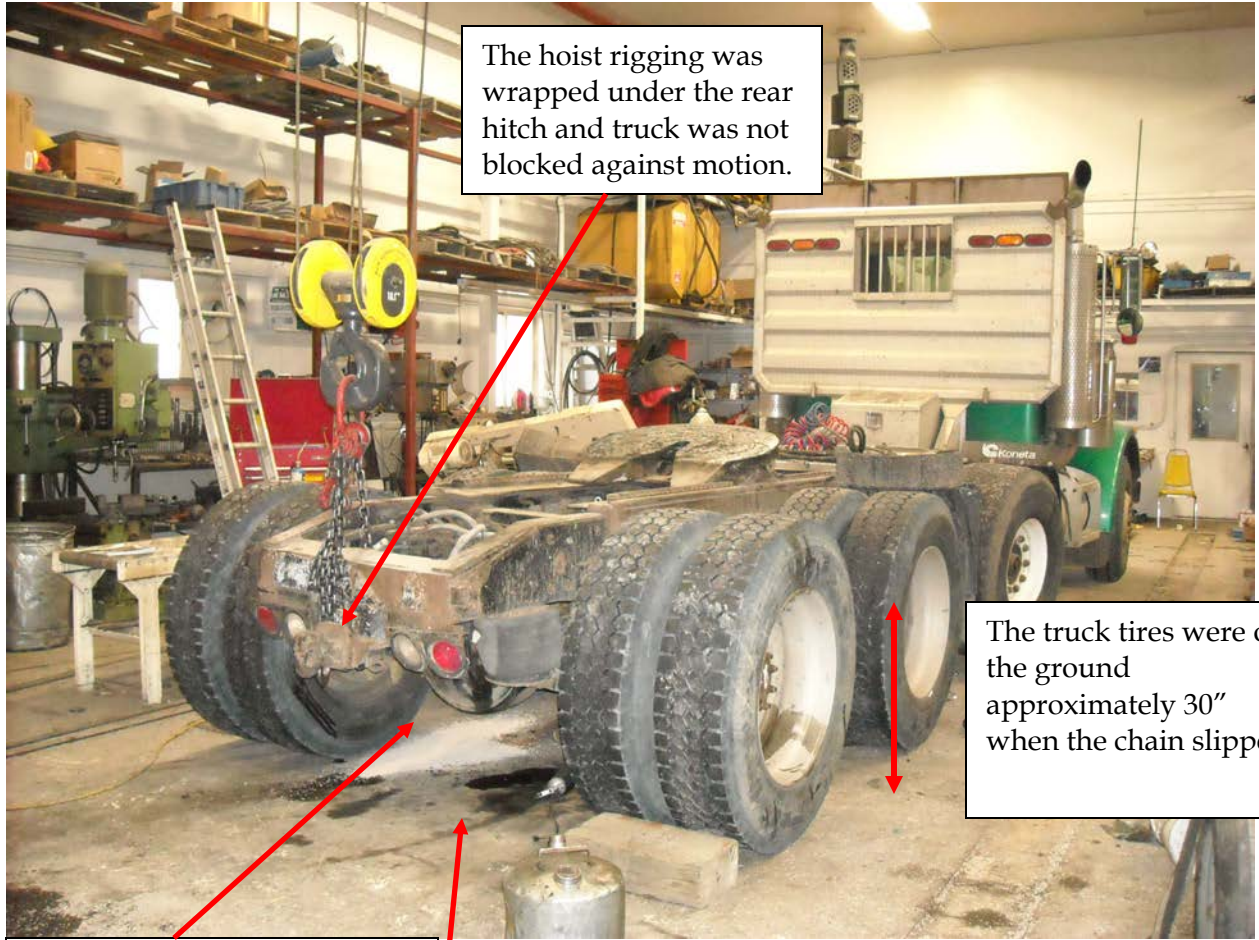
The hoist rigging was wrapped under the rear hitch and truck was not blocked against motion.

The truck tires were off the ground approximately 30" when the chain slipped.

The victim was under the truck when the chain slipped. The injured miner was kneeling under the rear-end of the truck near the lights assembly.

The accident occurred because management had not developed policies and procedures to provide safe practices when persons worked around or under equipment in a raised position. The truck was not blocked to prevent it from accidentally falling. Additionally, a safety latch was not provided for the hook of the chain rigging.

*Corrective Action:* Management implemented policies, procedures, and controls to ensure that when mobile equipment is raised, it is properly blocked while persons perform maintenance in the shop. All persons were trained regarding the new procedures and will be monitored to ensure that these safe procedures are being followed.
