**REPORT OF INVESTIGATION**

**Surface Nonmetal Mine  
(Limestone)**

**Fatal Falling Material Accident  
December 23, 2010**

**Mid-Coast Aggregates LLC- Mazak Mine  
Mid-Coast Aggregates LLC  
Webster, Sumter County, Florida  
Mine I.D. No. 08-01282**

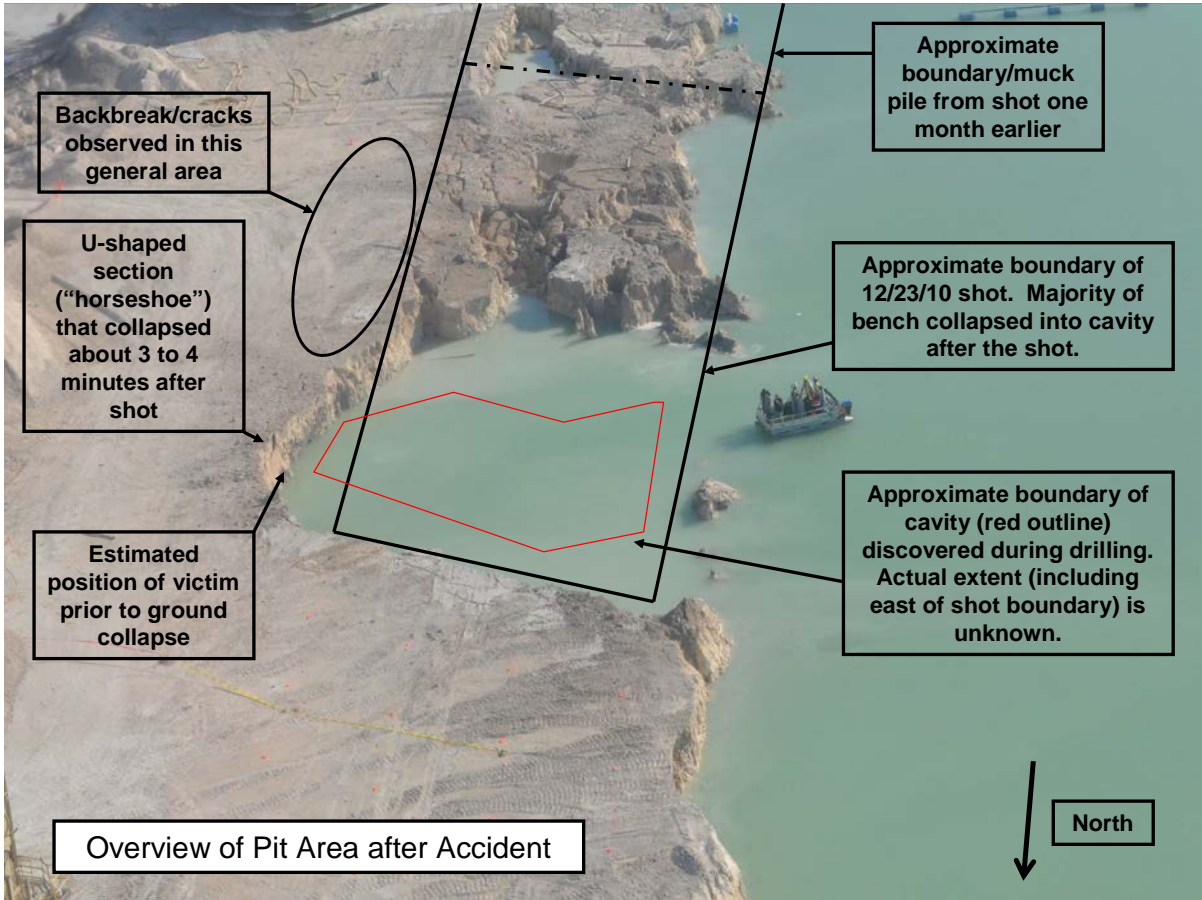
## APPENDIX B

Investigators determined that the blast immediately brought down a majority of the limestone bench directly above the cavity and as a result, it was completely submerged below the water level. This corresponded to a rectangular-shaped, approximately 80-foot wide by 140-foot long, section of the bench within the north end of the blast area. A 250-foot long section of the muck pile was observed still partially standing above the water. This section of the muck pile contained the remaining south end section of the blast area in addition to material from a blast approximately one month earlier.

There was evidence of backbreak (cracks) running parallel to the face due south immediately adjacent to the collapsed area. These cracks were approximately 20 to 40 feet from the edge of the standing portion of the muck pile.

The section of ground that collapsed east of the blast area (engulfing the victim) had formed a general U-shape and was referred to as the “horseshoe”. The collapsed section formed a vertical scarp approximately 120 feet wide (north-south direction) that extended up to 20 feet to the east beyond the last row of holes drilled. Investigators could not determine how deep the scarp extended below the water level.
