**UNITED STATES
DEPARTMENT OF LABOR
MINE SAFETY AND HEALTH ADMINISTRATION
Metal and Nonmetal Mine Safety and Health**

REPORT OF INVESTIGATION

**Surface Nonmetal Mine
(Dimension Sandstone)**

**Fatal Falling Material Accident
December 29, 2010**

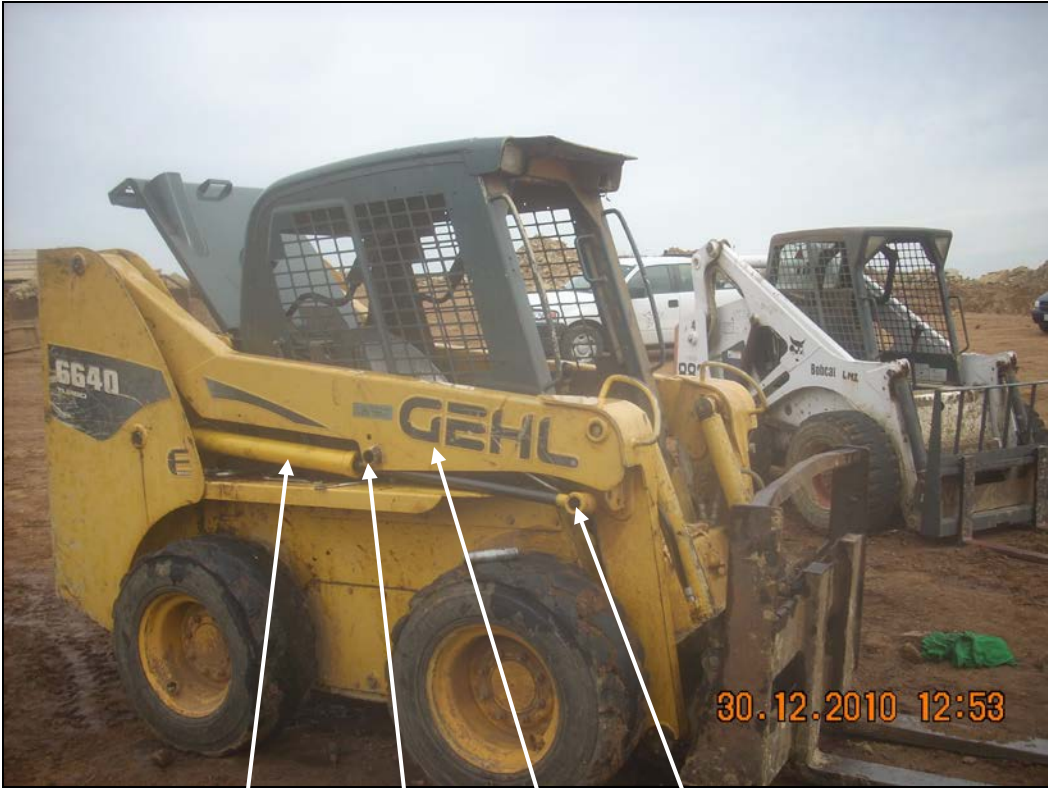
hydraulic lift
arm cylinder

clevis

lift arm

rod eye

Jesus Martinez removed the defective hydraulic lift arm cylinder and began installing a new hydraulic cylinder. He installed a pin in the eye at the base of the cylinder and attempted to line up the eye at the rod end of the cylinder with the clevis located about mid-length on the right lift arm of the loader.

Jesus Martinez extended the right hydraulic lift arm cylinder rod and placed a 5/8-inch diameter by 21-inch long steel bar through the rod eye and clevis. He then stowed the lift arm support device and shut off the loader using the key switch.

Investigators found that two flexible hydraulic hoses had separated from where they connected to two rigid hydraulic lines attached to the right lift arm cylinder. The ends of the threads on both male portions of the connections were damaged, indicating that these connections had not been tightened adequately and then failed under pressure. One of the failed hose connections was located between the interlock valve for the lift arm circuit and the right lift arm cylinder.

The engine of the skid-steer loader was not running when the accident occurred and the ignition key was in the OFF position. However, the interlock valve for the lift arm hydraulic circuit was ineffective since lift pressure had been lost between the valve and the right lift arm. With no pressure to the lift arms and the lift arm support device stowed, the lift arms lowered accidentally.

Corrective Action: Management trained all persons regarding safe work procedures when performing maintenance, including proper blocking of equipment components to prevent them from accidentally lowering.
