MNMF Fatal 2011-04

- Fall of Roof Accident
- April 15, 2011 (Idaho)
- Underground Silver Operation
- Miner
- 53 years old
- 26 years of experience

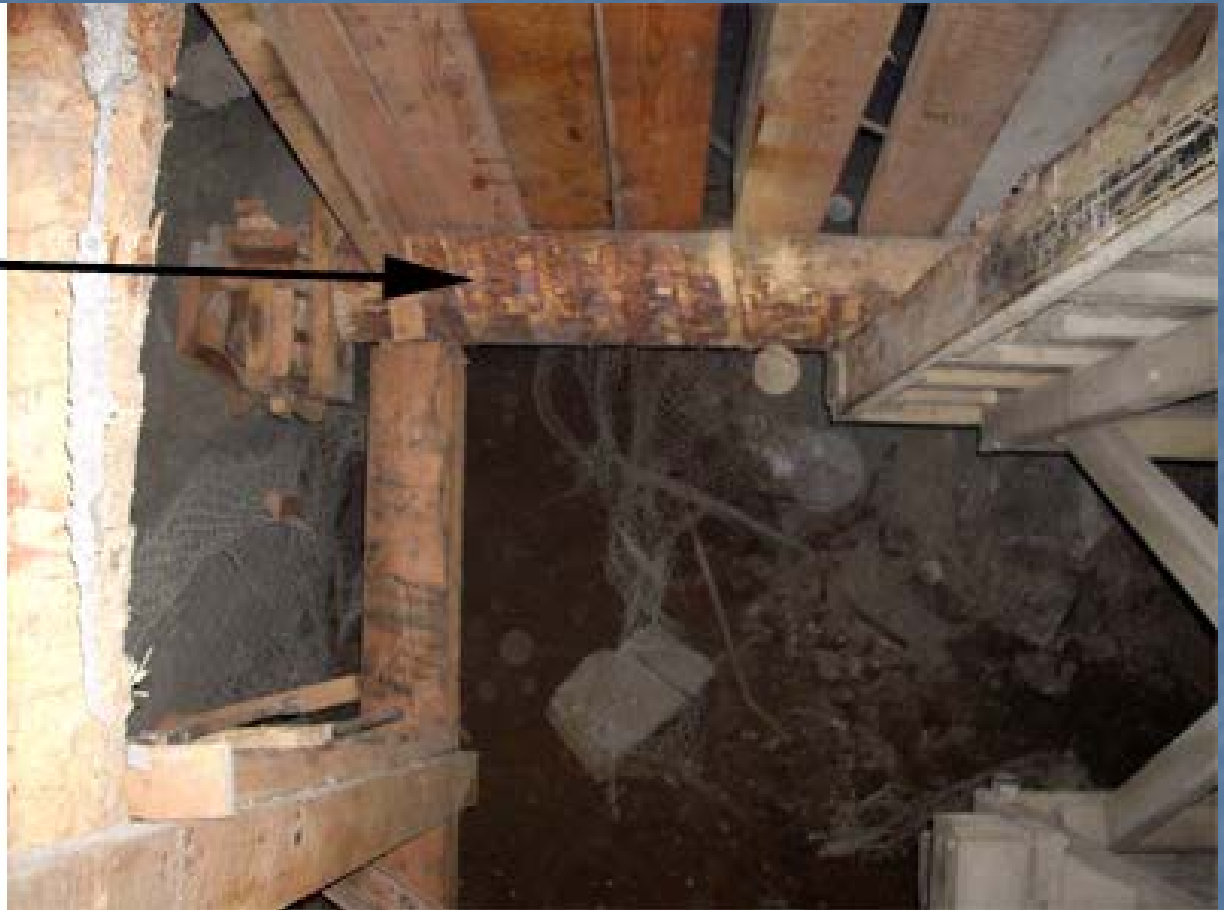
The victim was killed while watering down a muck pile in a stope. A rock fall approximately 90 feet long, 20 feet wide, and 30 feet high struck him.

The accident occurred because management did not have policies and procedures that provided for the safe mining of split stopes in a multi-vein deposit. Management failed to design, install, and maintain a support system to control the ground in places where miners worked and traveled. Additionally, management failed to ensure that appropriate supervisors or other designated persons examined or tested the ground conditions where the fall occurred.

Note:
Roof supports were
installed during the
recovery effort.

Root Cause: Management did not conduct an evaluation, engineering analysis, or risk assessment to determine the structural integrity of the stope back. The back that struck the victim was comprised of a combination of paste fill and waste pillar. As shown on projection maps, geologic structure in the form of joints, faults, and fractures intersected the waste pillar at various angles. These intersecting discontinuities cut the pillar rock mass into angular blocks and wedges which facilitated gravity failure. The large blocks and wedges observed in the fall rubble were not sufficiently supported by the 6-foot long rock bolts installed in the undercut surface of the waste pillar.

Root Cause: Management policies, procedures, and controls failed to ensure appropriate supervisors or other designated persons examined and tested ground conditions to determine if additional ground control measures needed to be taken to ensure the safety of miners prior to commencing work in the stope.

Corrective Action: Management developed and implemented new ground control standards that prohibit mining under intervening waste pillars and also established a maximum stope width. Management trained miners regarding these new standards.

Corrective Action: Management developed and implemented new ground control standards that include guidance on who is responsible for examining and testing the ground conditions. Management trained miners regarding these new standards.
