# MNM Fatal 2011-08

- Explosives Accident
- September 7, 2011 (Alaska)
- Gold Mine
- Miner
- 30 years old
- 1 year and 8 weeks of experience

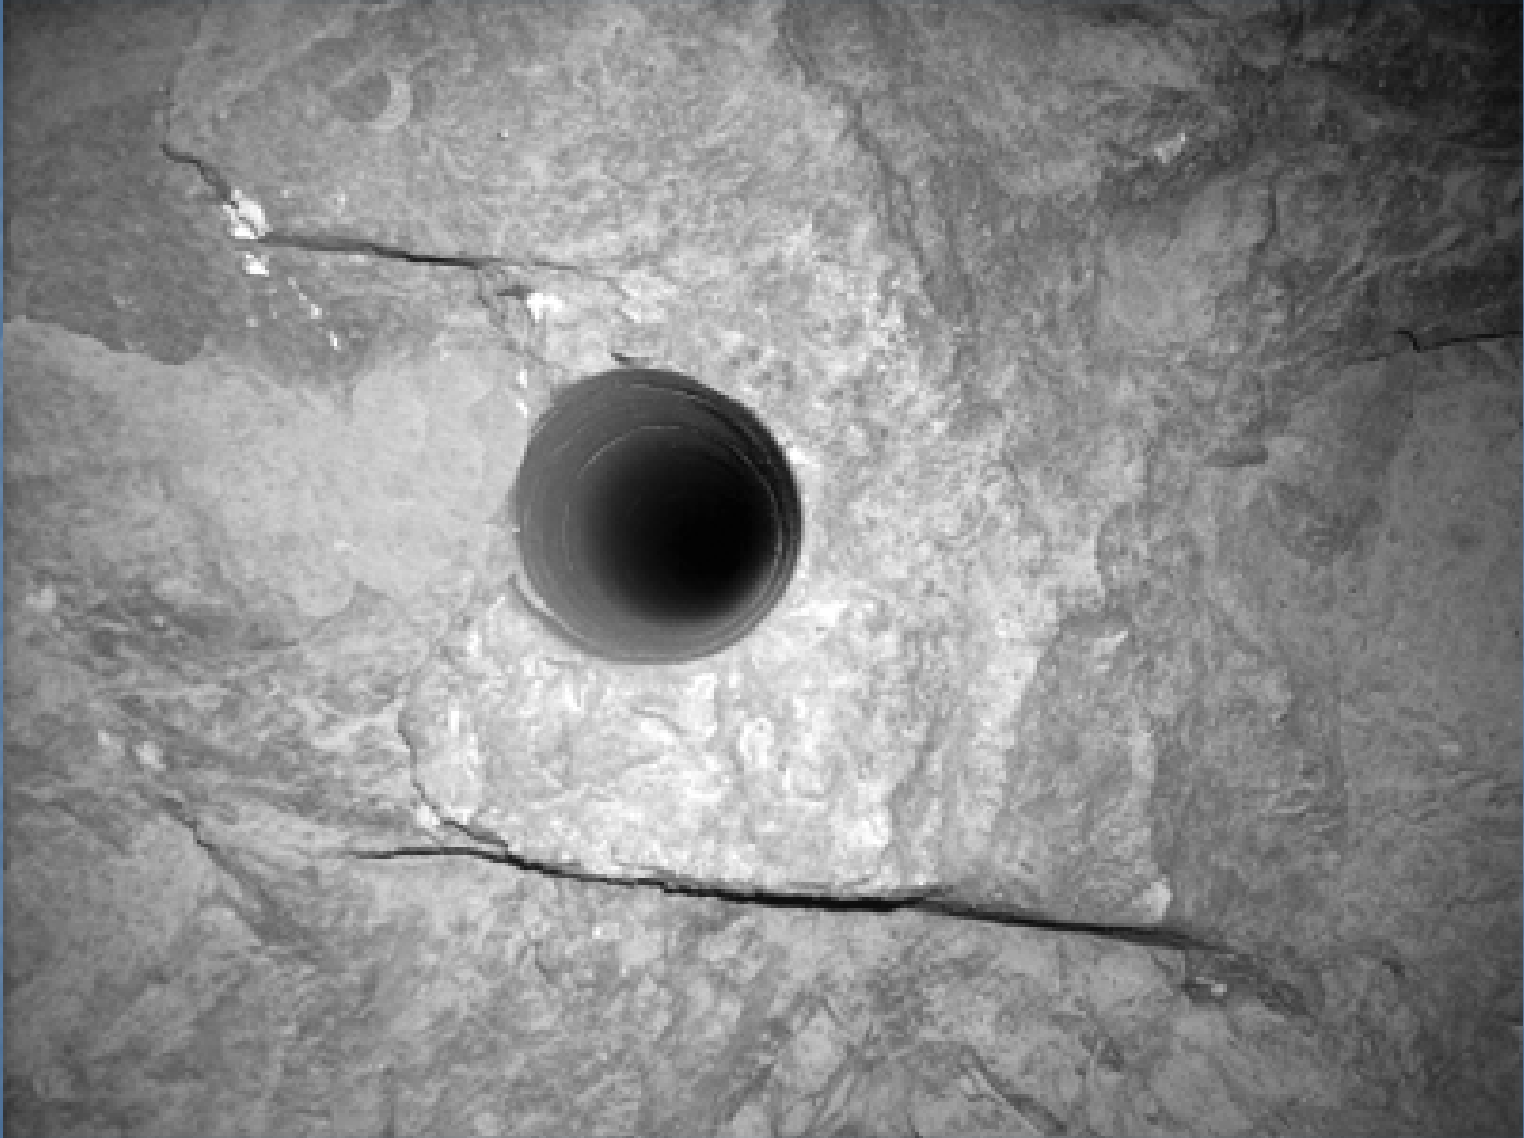
The victim was killed when he was struck by rock and debris after a production blast was initiated. The rock and debris passed through a 3-inch diameter diamond drill hole that intersected the blast site. He was standing next to a tractor positioned on the uphill side of a haulage ramp near the 1290 crosscut. He was approximately 200 feet from the blast site and in line with the drill hole when the blast was initiated.

The accident occurred because management policies, procedures, and controls were inadequate and did not protect persons from flying materials near the blast area. An old diamond drill hole, that intersected the blast pattern, had not been identified prior to initiating the blast. An adequate examination to check the area for hazards or to identify the diamond drill hole was not conducted prior to initiating the blast. Persons were not trained to be out of the blast area or in a location that would protect them from concussion, flying material, or gases. The blaster and blaster's helper were not provided with a blasting shelter or removed from the blast area to protect them from concussion and flying material.

**Corrective Action:** Management implemented new policies and procedures for blasting that removes all persons from the blast area. Management has designated a safe zone in an area where there are not any diamond drill core holes and a significant distance away from any active blast areas. A centralized blasting initiation system has been installed to allow the initiation of blasts from the designated safe zone.

**Corrective Action:** Management provided additional training regarding workplace examinations to all miners. The training included conducting adequate examinations to check for hazards or to identify diamond drill holes prior to initiating a blast, ventilation, and ground control.
