Fatality #11 – October 28, 2011
Other – Gold Ore
Newmont USA Limited - South Area

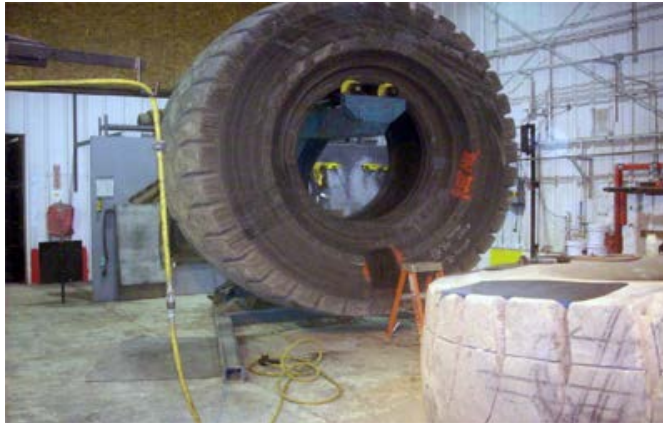
METAL/NONMETAL MINE FATALITY - On October 28, 2011, a 21 year-old contract tire repair technician with 37 weeks of experience was killed at a surface gold operation. The victim was working in a shop repairing a haul truck tire. He was applying adhesive inside the tire and was completely out of view. He was not wearing respiratory protection.

- Develop, implement, and maintain a written Hazard Communication (HazCom) program.
- Ensure that a Material Safety Data Sheet (MSDS) is accessible to persons for each hazardous chemical to which they may be exposed.
- Review and discuss MSDS control section recommendations. Establish and discuss safe work procedures before starting any work and identify and control all hazards.
- Train all persons to recognize and understand safe job procedures, including the physical and health hazards of chemicals that are being used and the proper use of respiratory protection.
- Ensure that adequate exhaust ventilation is provided to all work areas.
- Ensure that persons are not required to perform work alone in any area where hazardous conditions exist that would endanger their safety.
