REPORT OF INVESTIGATION

Surface Nonmetal Mine
(Phosphate Rock)

Fatal Sliding Material Accident
March 2, 2011

Lee Creek Mine
PCS Phosphate Company Inc.
Aurora, Beaufort County, North Carolina
Mine ID No. 31-00212

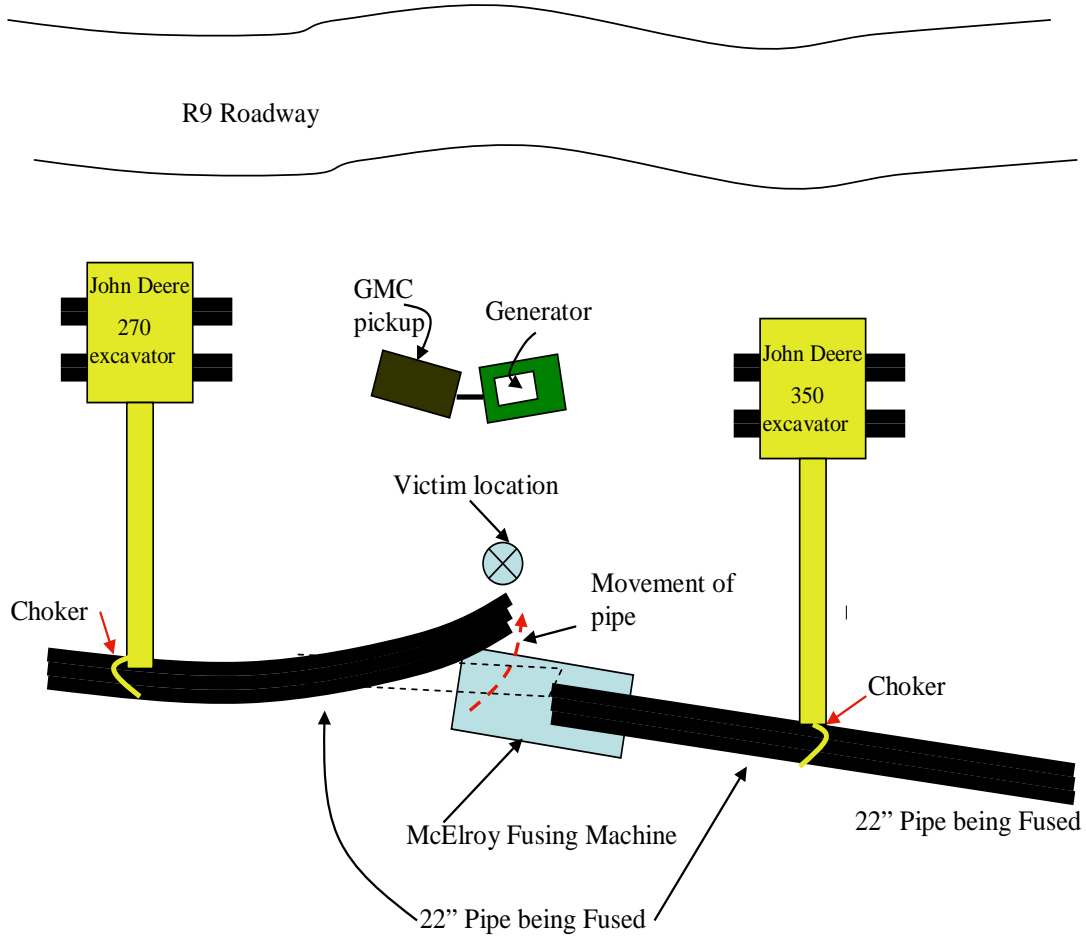
Sketch Showing Location of Accident

Clark had been on the operator's side of the machine. He traveled west along the pipe, crossed over it, and walked behind the excavator that Joyner was operating to the other side of the machine. Clark helped align the pipe in the cradle while Strickland had Joyner pull up the pipe. As they were attempting to align the west end of the pipe, it slipped from the cradle and sprung towards Clark, striking him.

The accident occurred on the south side of R9 roadway, between R9 roadway and a long narrow incised pond, 652 feet inside the gate along State Route 306. The area is level and comprised of sandy soil. Since roadways are located on both sides, mine management had the pipe placed at this location to protect it from mobile equipment.

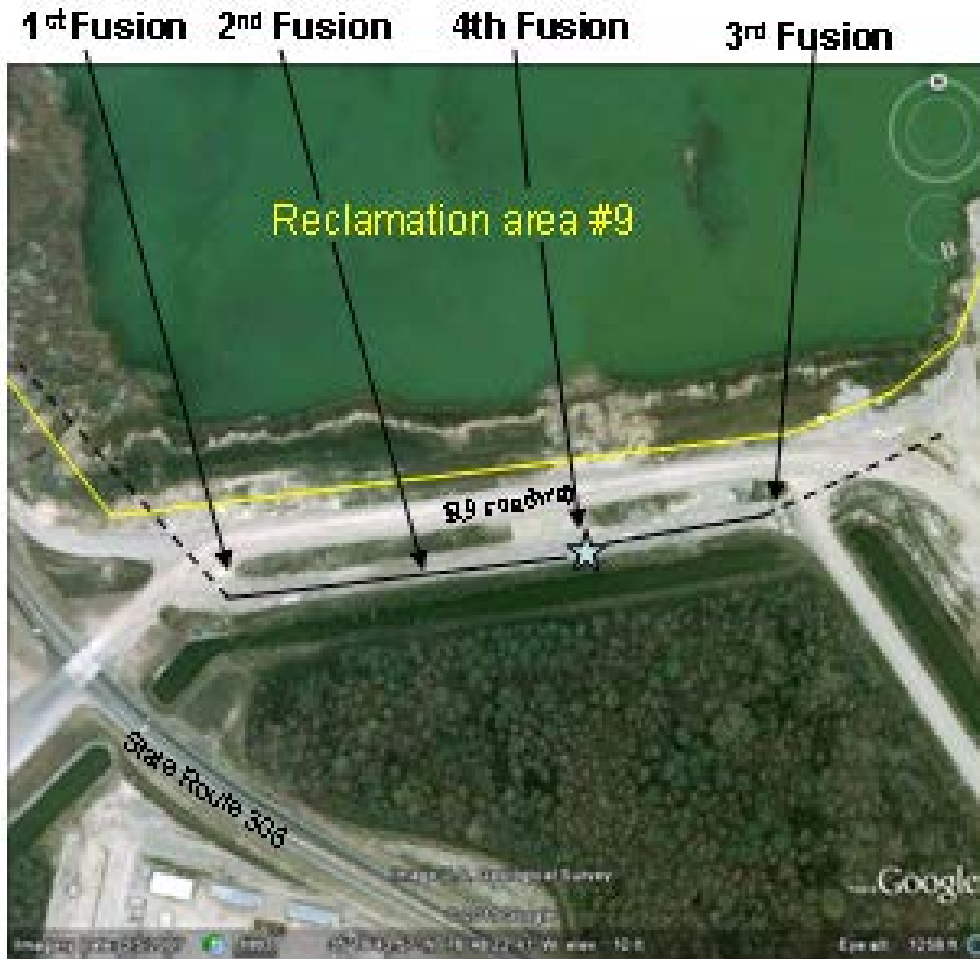
Aerial view of accident scene

After lunch, the crew prepared equipment to begin fusing pipe on the south side of R9 roadway. The first fusion (connection) was made on the west end of the pipe where it surfaced under R9 roadway (see Appendix C). The crew moved east, made the second fusion without incident, and moved further east to make another fusion.

★ Accident scene
