REPORT OF INVESTIGATION

Surface Nonmetal Mine
(Crushed & Broken Quartzite)

Fatal Powered Haulage Accident
February 24, 2011

Crushing and Sampling Unit
Bolinder Resources LLC
Tooele, Tooele County, Utah
Mine I.D. No. 42-01247

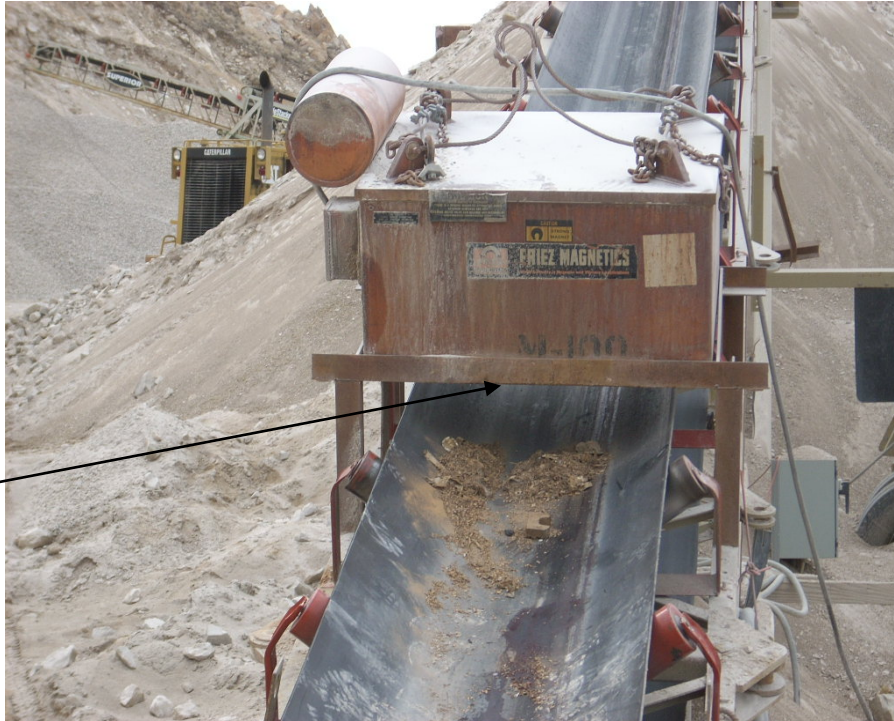
Photograph of Accident Scene

VICTIM
WORKING
HERE

The accident took place at the tramp steel magnet on a belt conveyor at the jaw crusher unit.

The tramp metal magnet involved in the accident is an Eriez Magnetics electromagnet, serial #560. It can be started and operated independently of the belt conveyor. There was 9 inches of clearance between the top of the belt conveyor and the bottom of the tramp steel magnet.
