**REPORT OF INVESTIGATION**

**Fatal Fall of Roof Accident  
April 15, 2011**

**Lucky Friday Mine  
Hecla Limited  
Mullan, Shoshone County, Idaho  
Mine I.D. No. 10-00088**

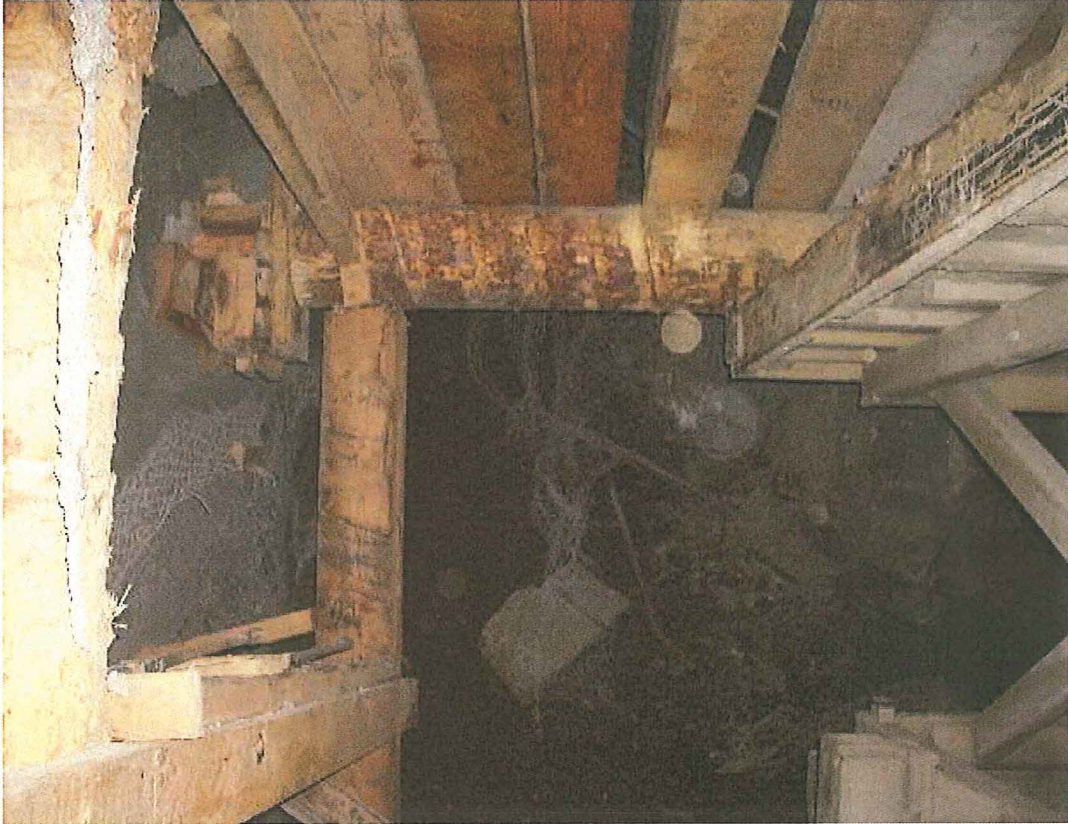
**Note: Timbers installed after ground fall.**

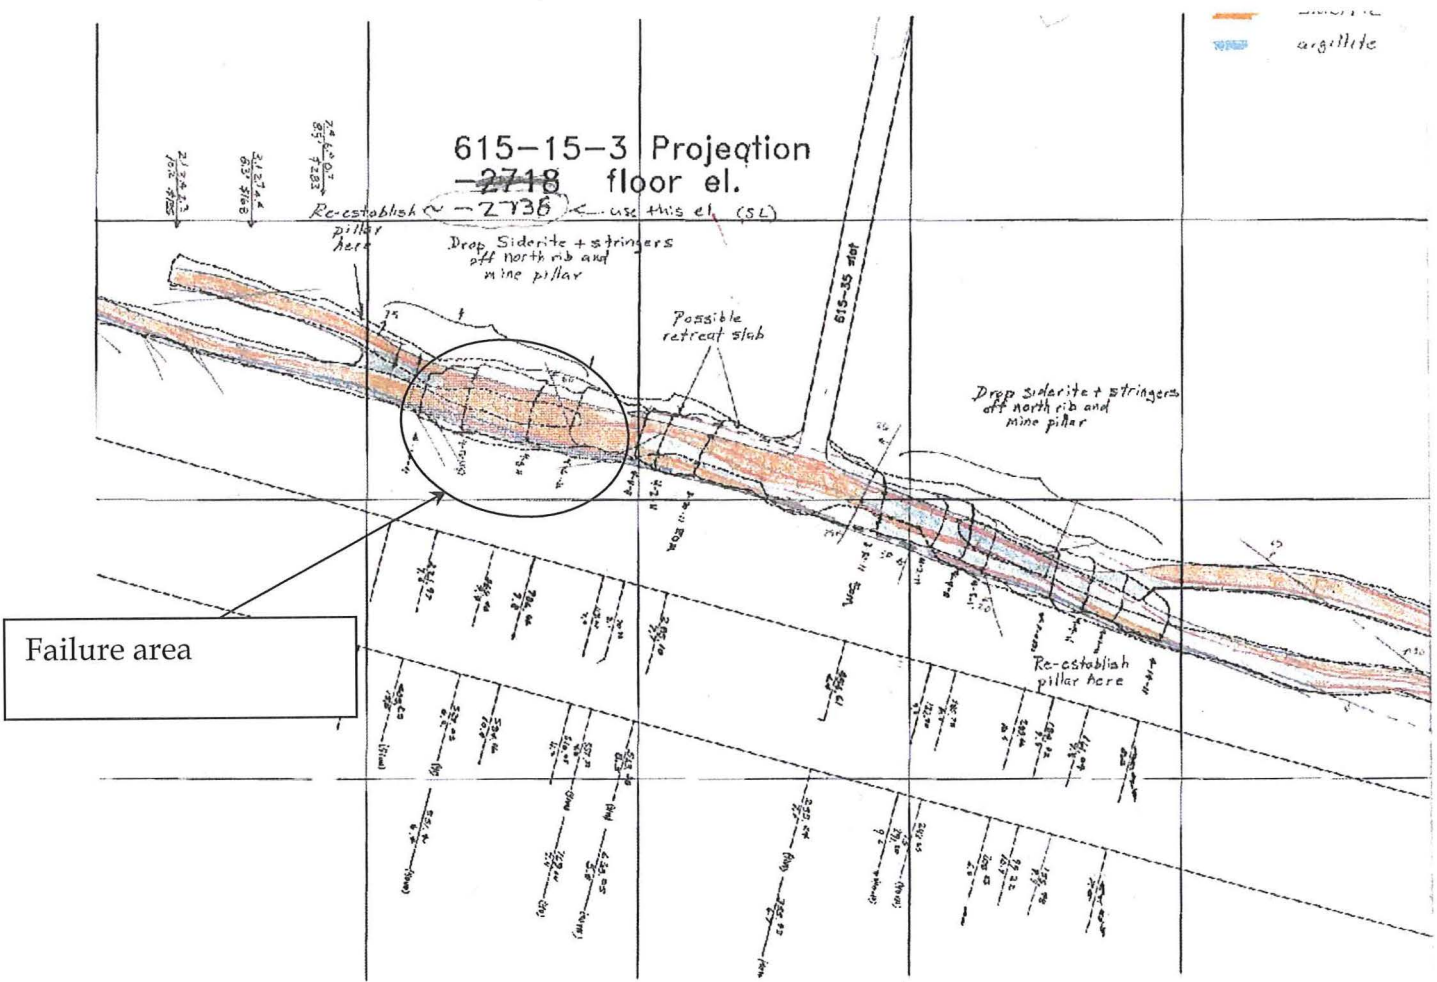
## 6150-15 cut 3 Stope Map

The mining method in the 6150-15-3 west stope represented a departure from typical mining methods. In the stopes immediately above 6150-15-3 (6150-15-2, 6150-15-1), a minor ore vein (41) splayed off the main 30 vein on the north side. The barren rock between the 30 and 41 veins was left intact as a waste pillar. The 30 and 41 veins converged within the 6150-3 cut and both were extracted in the same production face.

Consequently, the waste pillar in the overlying stopes was undercut. At the time of the accident, the exposed surface of the undercut waste pillar in the 6150-15-3 west cut extended 72 feet from the face and was 3 to 9 feet wide. The 3 cut stope was 18 to 24 feet wide. In the overlying 6150-15-2 and 6150-15-1 cuts (backfilled), the waste pillar width ranged from approximately 3 to 20 feet.

- Prior to the accident, the 6150-15-3 west cut had been advanced approximately 154 feet from the 35 slot.
- The failure zone was 74 feet long.
- The failure zone, as measured from the west rib line of the 6150-35 slot, extended from a point 58 feet inby to 132 feet inby.
- The failure zone extended to a point approximately 22 feet from the face.

Corrective Action: Management developed and implemented new ground control standards that prohibit mining under intervening waste pillars and also established a maximum stope width. Management trained miners regarding these new standards.
