REPORT OF INVESTIGATION

**Fatal Fall of Roof Accident
April 25, 2011**

**Subtropolis Mine
Subtropolis Mining Co.
Petersburg, Mahoning County, Ohio
MSHA I.D. No. 33-04547**

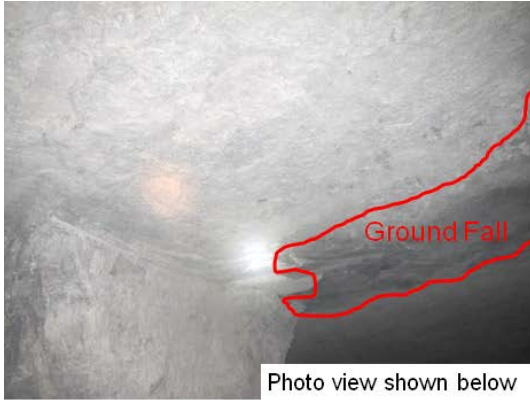
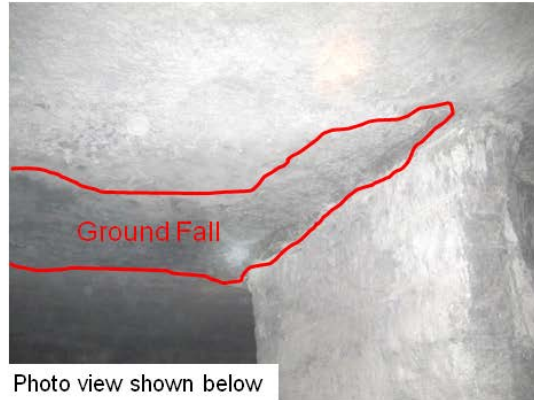
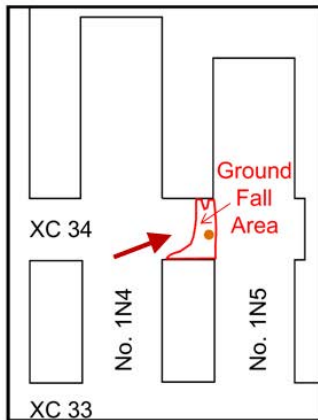
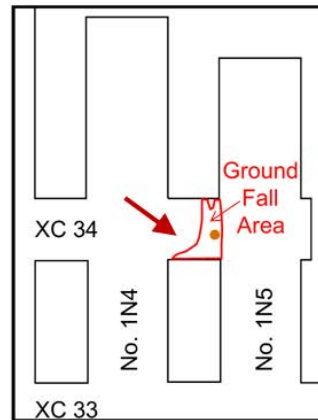
Appendix C-Map and Photo of Accident Area

The accident occurred in crosscut 34 between the No. 1N4 and No. 1N5 entries. This area is located approximately 3,600 feet northwest (linearly) from the mine portal and is accessed via approximately one mile of travel way.

Investigators determined that within the crosscut, prior to the roof fall, the transition zone limestone bed remained against the base of the “Cap Rock” between entries. The transition zone limestone remaining in the roof varied from a few inches to 12 inches thick. The thickest portion was along the No. 1N5 entry in the area above the third blast round. Roof scaling marks were evident along the No. 1N4 side of the transition zone limestone. The accident occurred when the transition zone limestone fell from the “Cap Rock”. The roof fall extended from rib-to-rib across the crosscut (see Appendix C). The portion of roof removed from the victim measured 8 to 12 inches thick, 50 to 70 inches wide, and 74 inches long with an estimated weight of 4,200 pounds.

On April 25, 2011, a fatal accident occurred at this operation. An employee was struck by a slab of rock that measured approximately 8 inches to 12 inches thick by 50 to 70 inches wide by 74 inches long. The roof fall occurred at the 34 Main, between Xcut 1North4 & Xcut 1North5.
