REPORT OF INVESTIGATION

**Fatal Fall of Person Accident
June 4, 2011**

**Fairbanks Gold Mining Inc.
Fort Knox Mine
Fairbanks, North Star County, Alaska
Mine ID No. 50-01616**

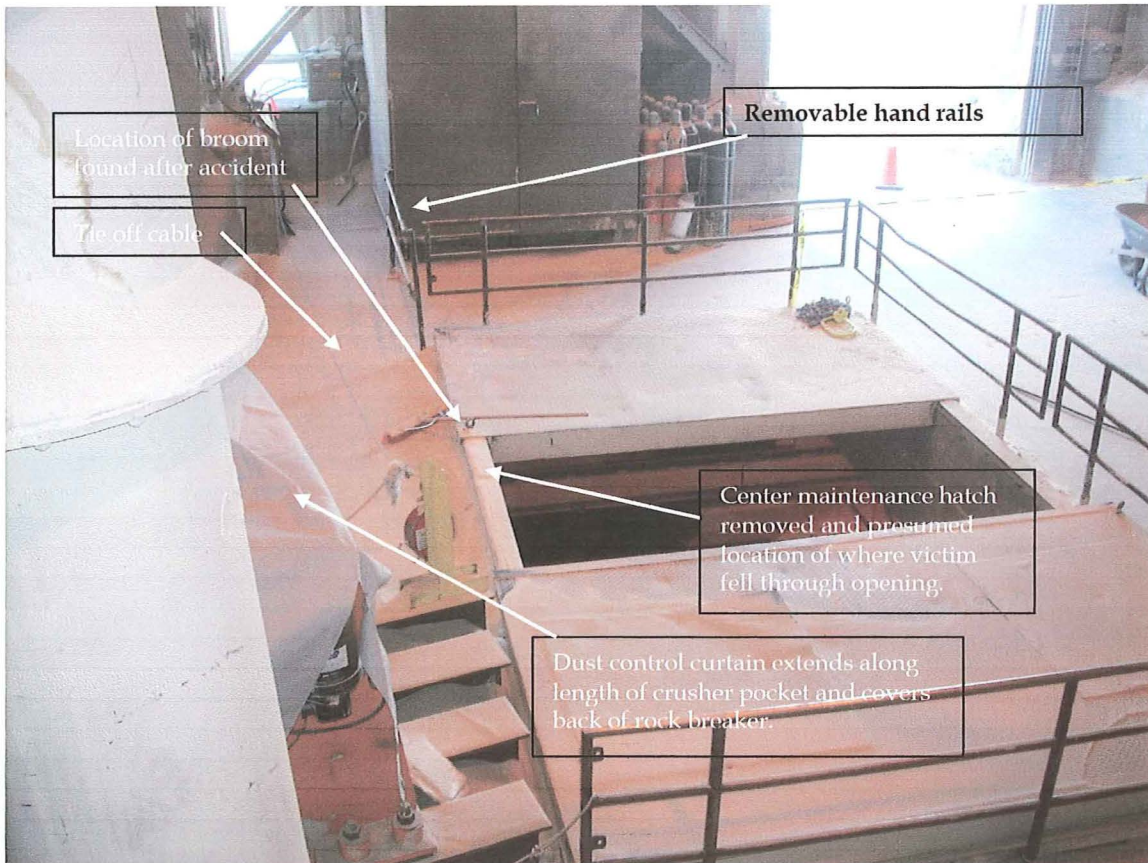
Figure 1 - Overview of accident scene

The accident occurred in the gyratory crusher building that contained five floors. The top three floors consisted of the dump floor, the drive floor, and the lube floor. A mill maintenance hatch had been removed on the dump floor eight days prior to the accident. (Figure 1, Appendix B). The hatch was removed to ventilate excess heat build up in the lube floor located two floors below.

Six maintenance hatches are located on the primary crusher dump floor. Three of these hatches are on the east side and three on the west side near the primary crusher hopper. The hatch covers rest on a 6-inch wide by 6-inch high curb placed around each opening. The center hatch on the west side, that the victim fell through, was removed on May 27, 2011. Removing this hatch created an opening 6 feet 9 inches wide by 11 feet long.

On the west side of the dump floor, the railings are located on the north, east, and south side of the maintenance hatches. The hatches on the west side closest to the crusher pocket did not have any handrails. A removable double handrail is located on the northwest corner of the west side maintenance hatches. This handrail extended to a storage cabinet allowing persons to enter the area for cleanup and maintenance work.

Root Cause: Management failed to ensure that it had policies and procedures so persons could safely clean the crusher dump floor between the west maintenance hatches and crusher dump pocket where there was a danger of falling.

Corrective Action: Railings were fabricated and installed around the maintenance hatches and along the crusher dump pocket to prevent entry into those areas. Signage was posted on all railings requiring the use of fall protection when the railings are removed. Management established policies for persons working around maintenance hatches and made persons aware of these new policies and procedures.

This citation was terminated on September 26, 2011. Railings were installed around all sides of the maintenance hatch and along the gyro crusher dump hopper on the primary crusher dump floor area.
