REPORT OF INVESTIGATION

**Underground Metal Mine
(Gold Ore)**

**Fatal Explosives Accident
September 7, 2011**

**Kensington Mine
Coeur Alaska, Inc.
Juneau, Juneau County, Alaska
Mine ID No. 50-01544**

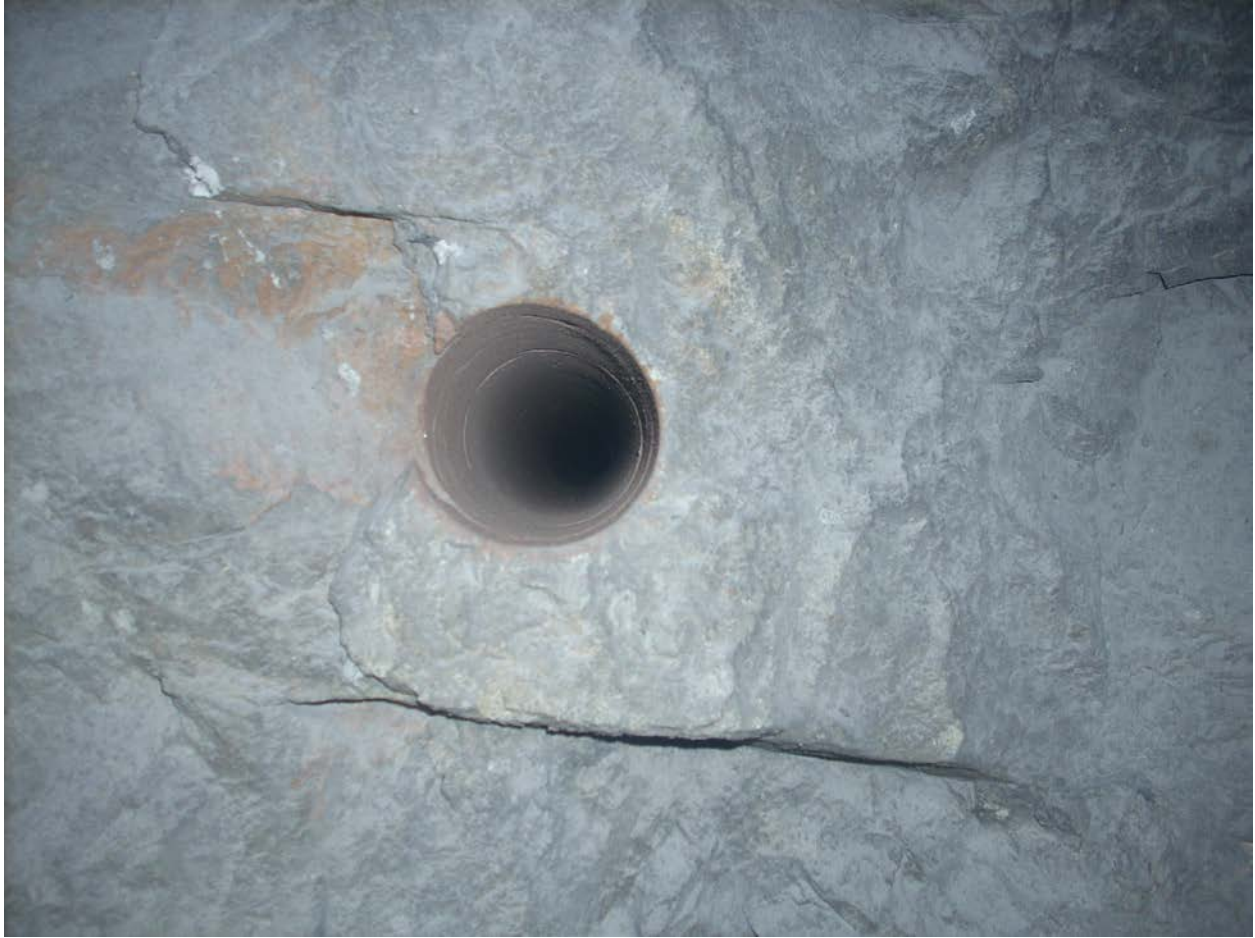
DIAMOND DRILL HOLE

On September 7, 2011, Joseph L. Tagaban, blaster's helper, age 30, was killed when he was struck by rock and debris after a production blast was initiated. The rock and debris passed through a 3-inch diameter diamond drill hole that intersected the blast site. Tagaban was standing next to a tractor positioned on the uphill side of a haulage ramp near the 1290 crosscut. He was approximately 200 feet from the blast site and in line with the drill hole when the blast was initiated.
