**REPORT OF INVESTIGATION**

**Surface Nonmetal Mine  
(Sand and Gravel)**

**Fatal Electrical Accident  
September 13, 2011**

**Plant #1  
DeAtley Crushing Co.  
Oakesdale, Whitman County, Washington  
Mine ID No. 10-01658**

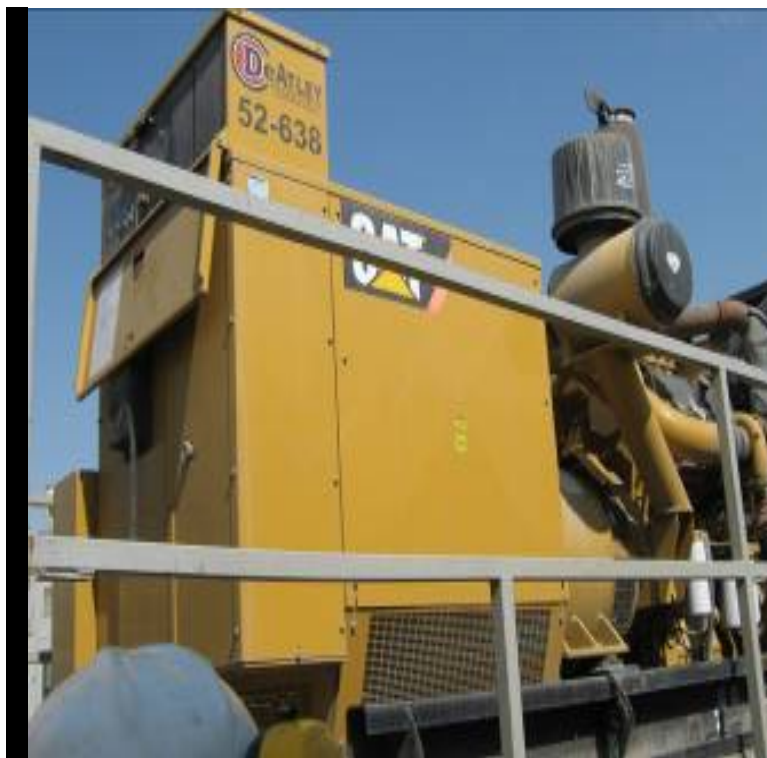
Two generators of the same type were involved in the accident, gen 1 and gen 2. They were three phase wye configured Caterpillar SR4B generators with 480 volt line to line rating at 60 Hertz with a supply capacity of 1091 amps. Gen 1 and gen 2 were located on top of a single generator trailer. Each generator had one 1200 amp breaker.

Trailer mounted Generator

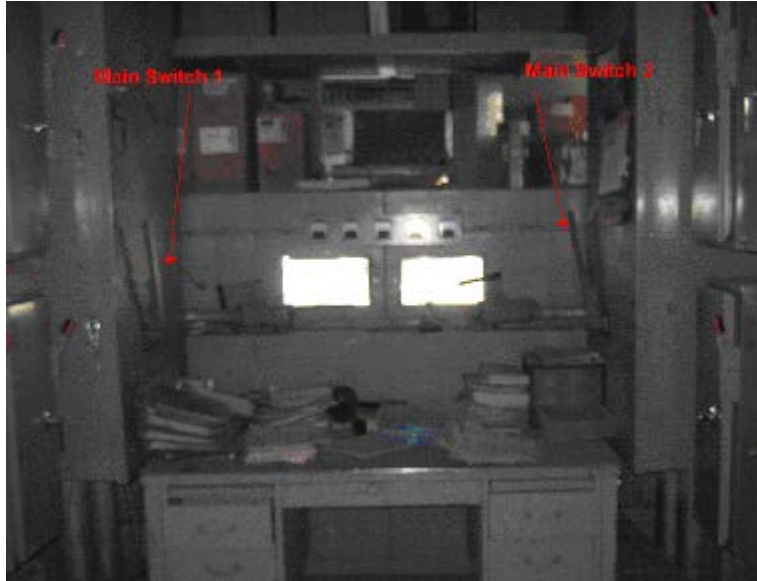
The generators, gen 1 and gen 2 ran independently. Gen 1 and gen 2 exclusively fed a separate main fused switch at the MCC, main switch 1 and main switch 2 respectively.

Main Switches Located Inside MCC

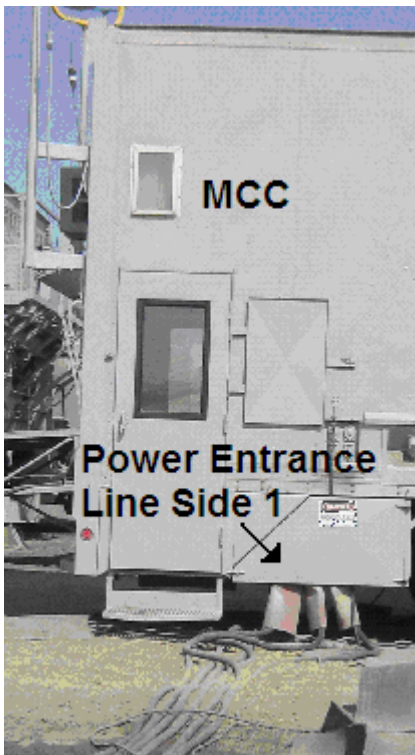
The terminations which fed the line side of the two main switches, line side 1 and line side 2, were located at opposite sides of the MCC.

Power Entrance Line Side 1

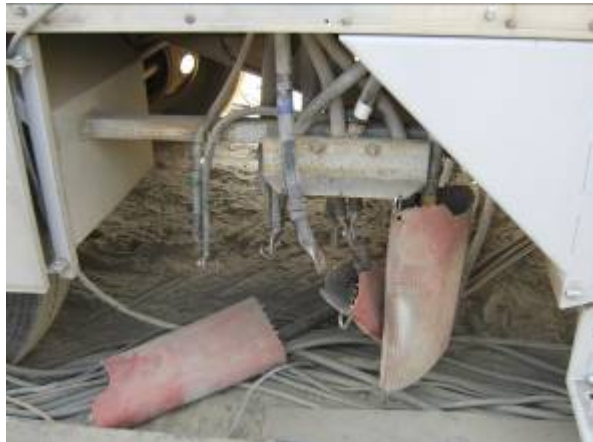
Power Entrance Line Side 2

At the time of the accident, James Hussey was wiring the two Caterpillar SR4B generators, gen 1 and gen 2, to the two independent main switches, main switch 1 and main switch 2, at the MCC power entrance line side 1 and line side 2. During motor rotation testing, it was discovered that two of the phases were reversed on load side 2. One of the generators was de-energized, gen 1. Gen 2 was not de-energized. Hussey started to swap phase conductors fed from gen 2 at the power entrance line side 2 to the MCC. Unaware, Hussey started working on the energized line, line side 2, and received a fatal electrical shock.

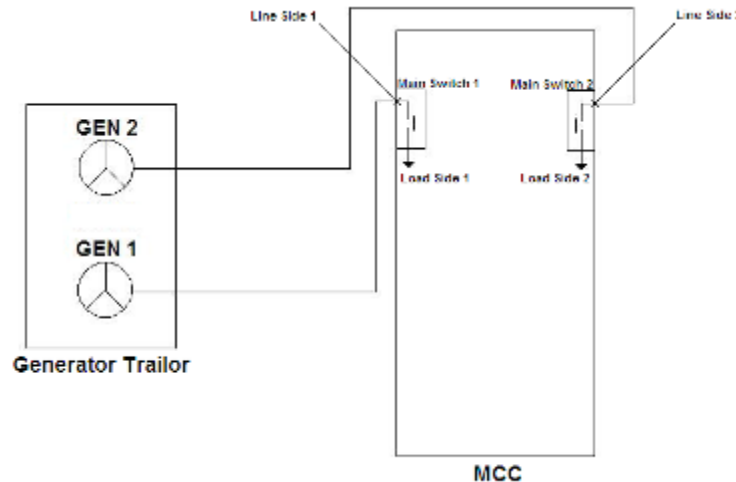
Referring to the Physical Layout figure below, line side 1 was facing the generator trailer with the generator trailer in view. Line side 2 was on the opposite side; therefore, the MCC was blocking the view of the generator trailer.
