REPORT OF INVESTIGATION

**Surface Nonmetal Mine
(Sand and Gravel)**

**Fatal Slip/ Fall of Person Accident
September 23, 2011**

**Freedom Pit
Lafarge North America, Inc.
Delevan, Cattaraugus County, New York
MSHA I.D. No. 30-01582**

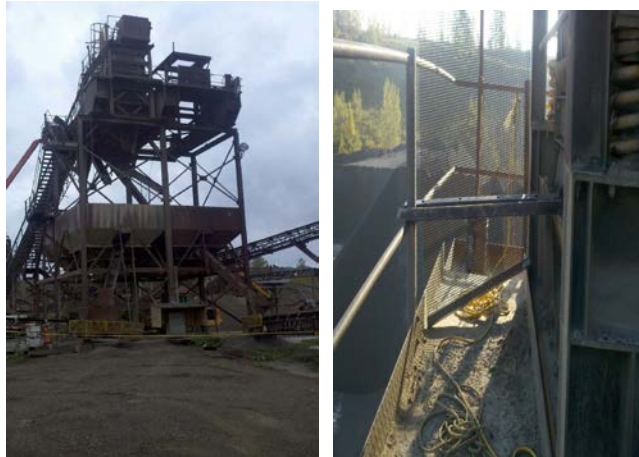
On September 23, 2011, John P. Collingwood, plant operator, age 32, was killed when he fell from a screen deck work platform 56 feet to the ground below. He was standing on two steel clamping bars that had been placed between the midrail of the protective rail surrounding the screen deck work platform and the screen structure to create a step. Collingwood stood on the step to reposition a screen. He was positioned above the confines of the protective railing when he slipped and fell.

The accident occurred because management policies, procedures, and controls did not ensure that persons could safely perform maintenance on the secondary screen tower. Routine maintenance required that the screens be replaced periodically. The height of the opening for the screen being replaced was 64 inches from the work platform, making it difficult for persons to gain the leverage necessary to safely remove the screen. No procedures had been established to ensure that persons could safely reach the elevated screen from the provided work platform. To gain the needed leverage on the screen, the victim had to be positioned above the protective railing on the screen deck work platform. He was not wearing a safety belt and line where there was a danger of falling. The victim's fall protection was attached to a man lift that had been used earlier to lift the screens to the elevated platform.

Corrective Action: Management established a written Job Safety Analysis (JSA) for the task of changing screens and trained all persons regarding these safe procedures. The mine operator also trained all persons in the use of fall protection where there is a danger of falling.
