UNITED STATES  
DEPARTMENT OF LABOR  
MINE SAFETY AND HEALTH ADMINISTRATION  
METAL AND NONMETAL MINE SAFETY AND HEALTH  
REPORT OF INVESTIGATION

Surface Metal Mine  
(Gold Ore)

Fatal Other Accident  
October 28, 2011

Purcell Tire & Rubber Co.  
Contractor ID No. (LMD)

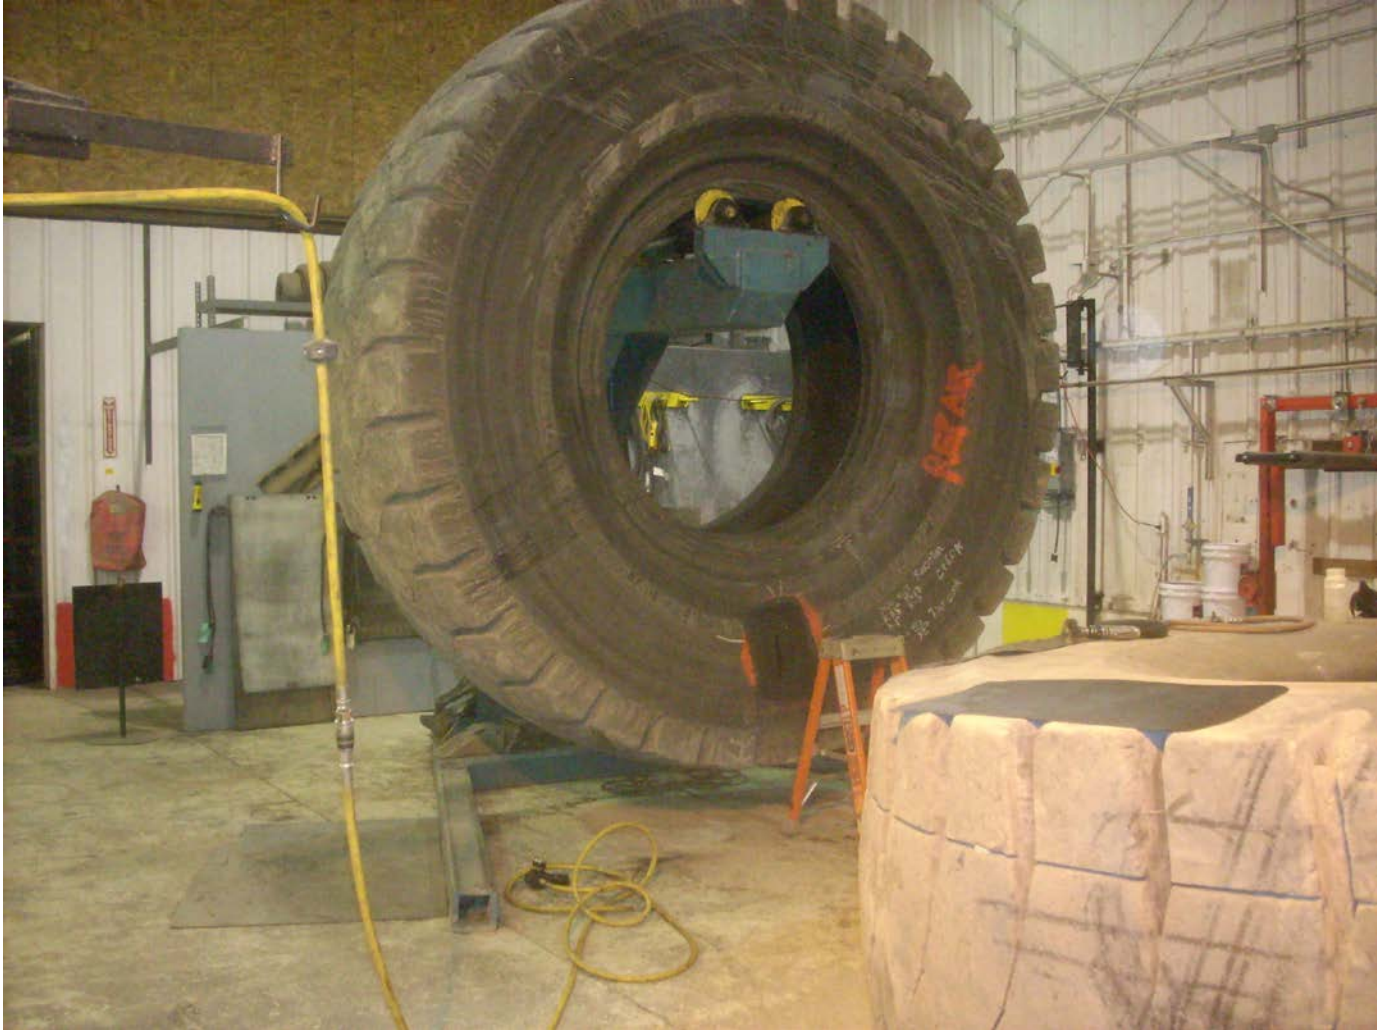
On October, 28, 2011, Joe M. Ashdown, contract Tire Repair Technician, age 21, was killed while repairing a haul truck tire in a tire repair shop. He was inside the large tire, completely out of view, repairing a damaged section in the tire's side wall. While applying glue to the interior area of the tire, he was overcome by trichloroethylene vapors.
