Report of Investigation

Underground Metal Mine
(Platinum)

Fatal Powered Haulage Accident
October 31, 2011

Stillwater Mine
Stillwater Mining Company
Nye, Stillwater County, Montana
ID No. 24-01490

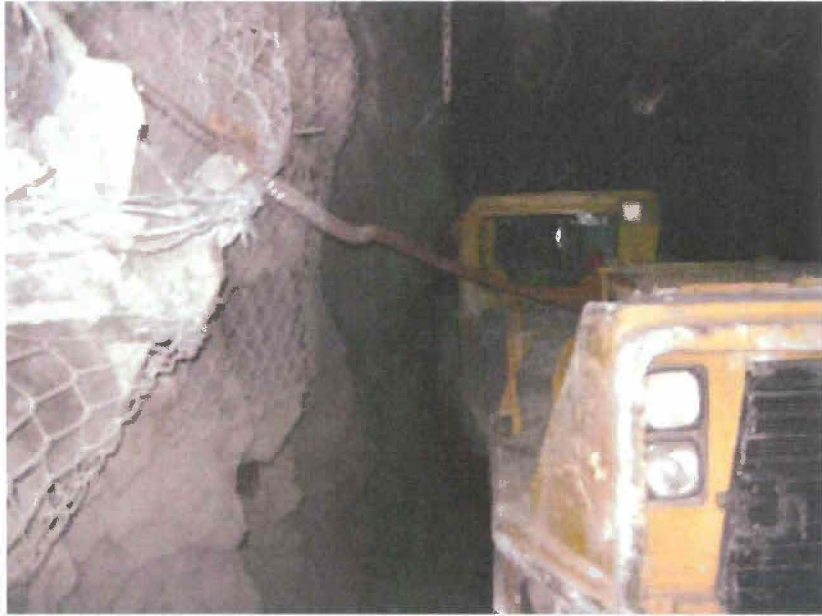
Dale A. Madson, muck haul leadman, age 42, was killed on October 31, 2011. Madson was operating a 4-yard Load-Haul-Dump (LHD) on an underground haul road when he lost control of the LHD on an "S" curve. The right rear corner of the LHD struck the right rib of the 38W heading between 4500 and 5500 Foot Wall Lateral (FWL). The LHD traveled across the haul road to the left side for approximately 49 feet, striking the rib several times with the left side of the cab. At that time, a spiling (rebar anchored in the rib for ground control), penetrated the top left corner window, entered the cab, and struck the victim.

The spiling entered the cab through the top left corner window located behind the operator on his left side. After it entered the cab, the forward motion of the LHD bent the spiling, causing it to sweep through the cab as the LHD went by. Opposite the corner of the cab from where the spiling entered, two brake pressure gages were broken away from the fiberglass dashboard panel they were mounted in. Additionally, the fiberglass door panel on the inside of the door was broken off. The steering and transmission lock lever on this inside door panel was bent and the interlock linkage that it operated was damaged; including the roller on the top of the transmission interlock switch. As a result, the STIC steering joystick did not freely return to center upon release.

Corrective Action: Management established policies and procedures to ensure that equipment operators operate mobile equipment safely. The new policies and procedures require in part that:
