REPORT OF INVESTIGATION

Surface Nonmetal Mine
Limestone (Crushed and Broken)

Fatal Machinery Accident
November 7, 2011

Anderson Sand and Gravel
Anderson Sand and Gravel
Dewitt, Clinton County, Iowa
Mine ID No. 13-02166

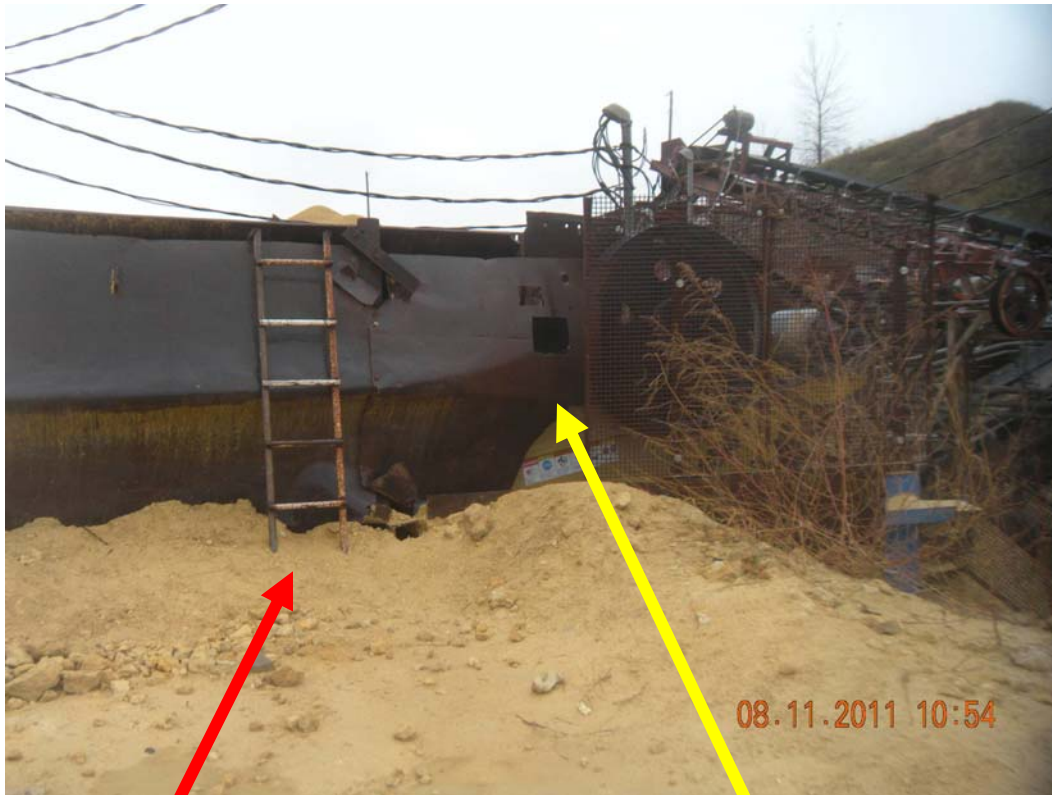
Ladder was brought into position during the rescue.

Victim was last seen standing with both feet in the lower observation hole.

Two holes, located adjacent to the crusher, had been cut in a protective steel plate for persons to observe the crusher to determine if it is plugged. The lower

hole is approximately 9 inches high by 10 inches wide and 35 inches above the ground. This hole had been cut when the previous crusher was operating. The second hole is approximately 5 inches high by 7 inches wide and 47 inches above the ground. This hole was cut when the current crusher was placed in operation.

Root Cause: Bruce Anderson was not effectively protected when working from the operating primary crushing plant. He was working on the equipment and the power was not de-energized and the equipment was not blocked against hazardous motion. A suitable walkway was not provided along the feed hopper.

Corrective Action: After the accident, policies and procedures were established to ensure persons are effectively protected when working from the operating primary crushing plant. The newly established policies and procedures prohibit persons from climbing on the operating equipment. The feed hopper will be accessed by using a ladder. Additionally, all power will be de-energized and locked out. A safety meeting was conducted with all miners to discuss these new policies and procedures. The mine operator is exploring the purchase of a rock breaker to eliminate manually unplugging of material in the jaw crusher.

This citation was terminated on January 24, 2012. The mine operator covered the observation holes so they can no longer be used as a means of access on the feed hopper skirting. The mine operator established policies and procedures prohibiting persons from climbing on the operating equipment. The feed hopper will be accessed by using a ladder. Additionally, all power will be de-energized and locked out. A safety meeting was conducted with all miners to discuss these new policies and procedures. The mine operator is exploring the purchase of a rock breaker to eliminate manually unplugging of material in the jaw crusher.
