**UNITED STATES
DEPARTMENT OF LABOR
MINE SAFETY AND HEALTH ADMINISTRATION
METAL AND NONMETAL MINE SAFETY AND HEALTH**

REPORT OF INVESTIGATION

**Fatal Slip or Fall of Person Accident
November 17, 2011**

**Lucky Friday
Hecla Limited
Mullan, Shoshone County, Idaho
ID No. 10-00088**

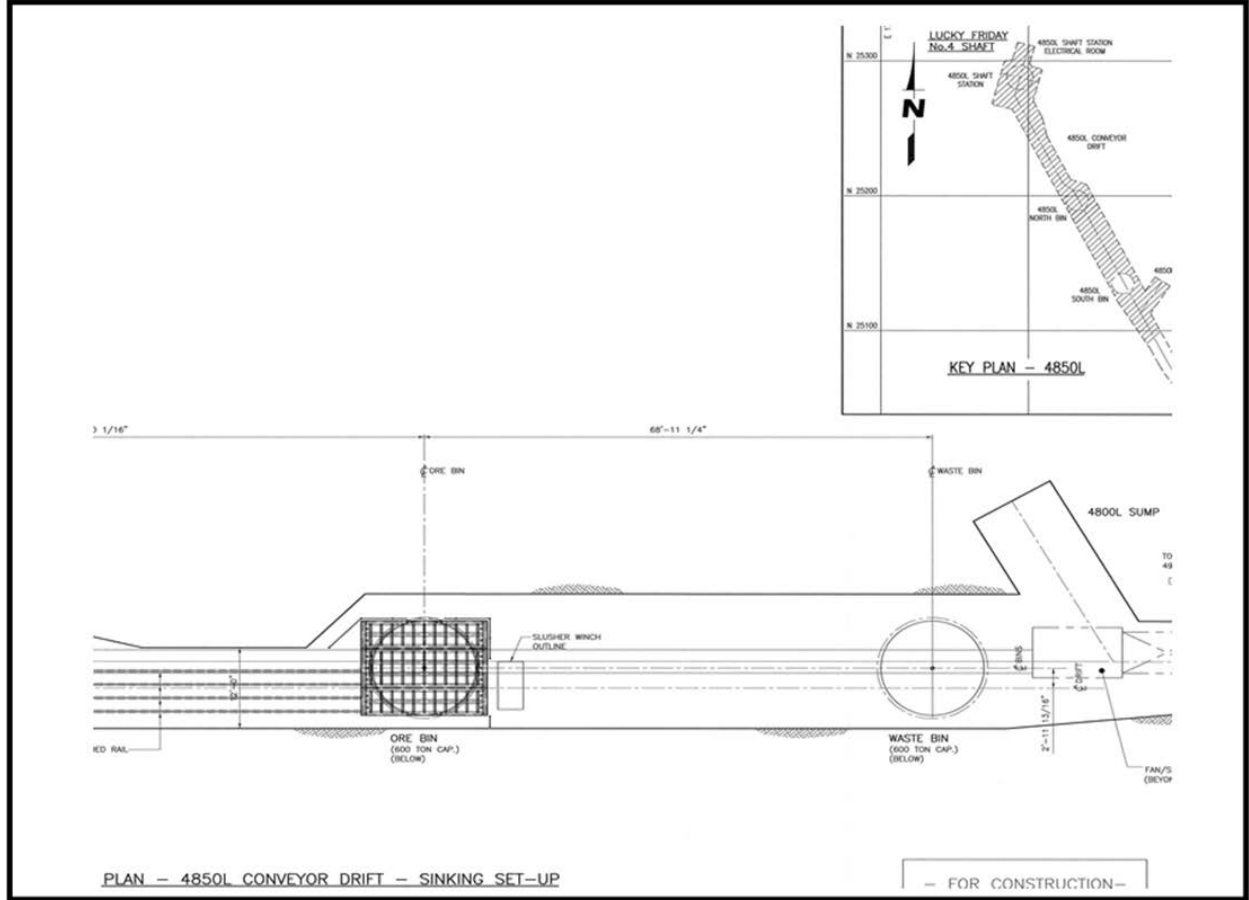
Figure 1 - Plan View of North (Ore) and South (Waste) Bins on 4850 Level

The accident occurred in the south bin that is being excavated vertically between the 4850 level and the 4940 level and located adjacent to the Number 4 Shaft construction project. The location of the south bin in relation to the north bin on the 4850 and 4940 levels is shown in Appendix B, Figures 1 and 2, respectively, in which it is identified as the "waste bin." The shaft to the north-northwest of the bins is the Number 4 shaft. When the Number 4 Shaft project is completed and operational, ore and waste will be hoisted to the 4850 level where the materials will be transported via belt conveyor to either the south (waste) or north (ore) bin. Both materials will be taken from the bottom of the bins at the 4940 level and transported via truck to the Silver Shaft. The material will be dumped into skips and hoisted to the surface for final transportation to the processing plant (ore) or disposal (waste.)

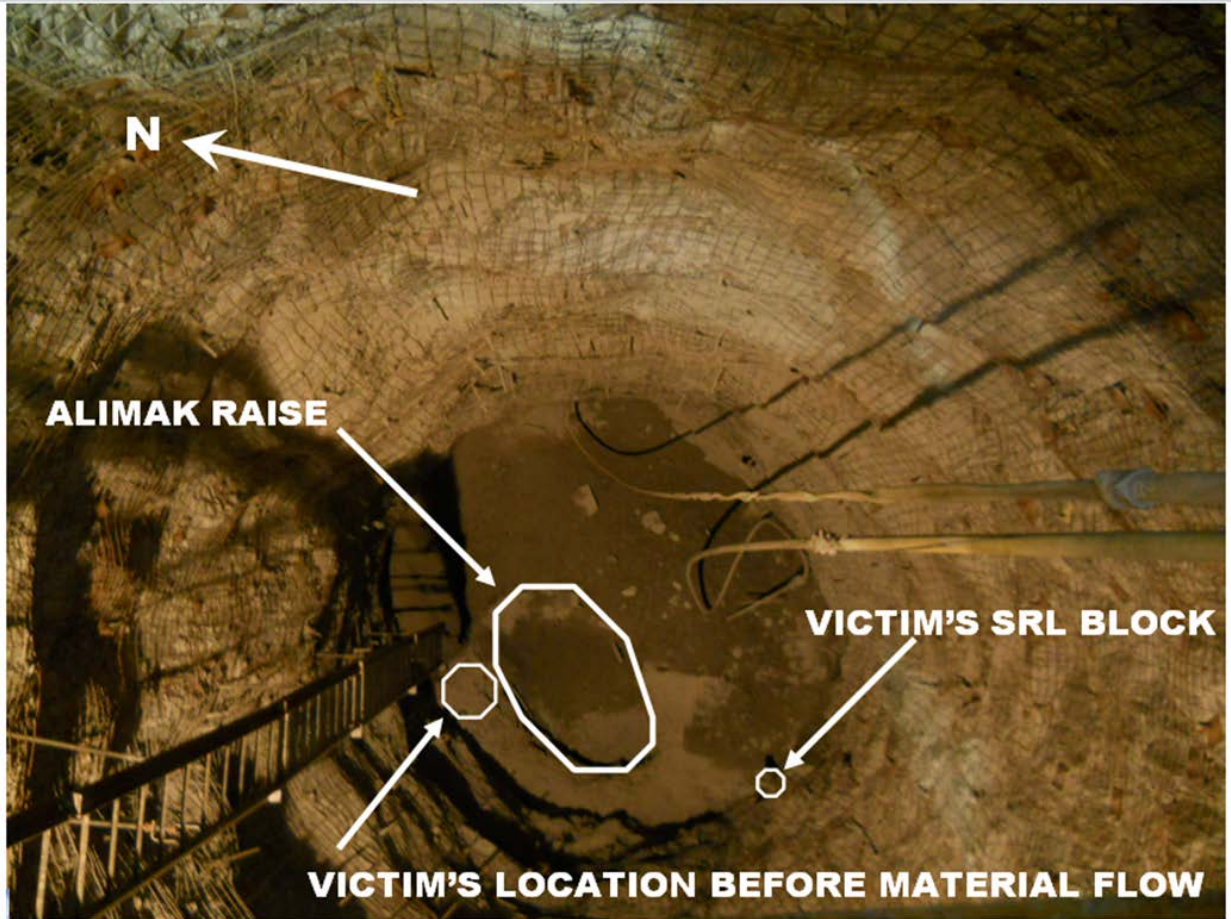
Figure 4 -View of South (Waste) Bin Looking Down from 4850 Level

Investigators learned that the muck began to hang up recently and was pulling mainly from one side. Figure 4 shows the hole in the bottom of the bin is toward its west-northwest side, corresponding to the side of the bin from where the raise was constructed and where the LHD would remove muck.

Investigators discovered that at the time of the hang-up, the muck pile just below the roof brow at the 4940 level was standing more vertically than in the remainder of the muck pile. Considering the relatively narrow opening through which muck would typically flow, the investigators determined that one or more pieces of plywood, possibly together with the boulder that was observed near the muck pile and perhaps obstructed by the bolt protruding from the wall, could have caused the hang-up. The removal of the muck at the top of the pile may have left barely enough muck at the obstruction's edges to keep it in place. The blow piping performed in the bin, just preceding the material giving way, may have brought it to the edge of instability.
