REPORT OF INVESTIGATION

Surface Nonmetal Mine
(Stone)

Fatal Powered Haulage Accident
December 8, 2011

Knife River North Central
43491
Milaca, Mille Lacs County, Minnesota
Mine I.D. No. 21-00462

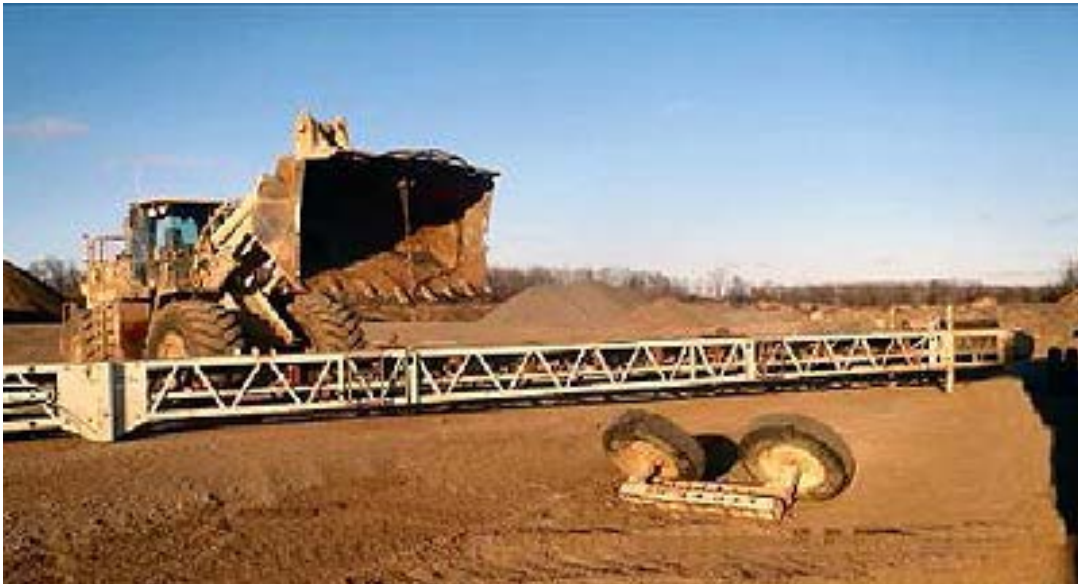
Scott A. Armstrong, Crusher Operator, age 41, was killed on December 8, 2011, when a wheel strut axle assembly struck him. The wheel assembly was to be installed on a conveyor to transport it from the mine site. A front-end loader was used to lift the conveyor. The loader bucket suddenly dropped, allowing the frame of the conveyor to strike the wheel assembly. The wheel assembly shifted, striking Armstrong.
