# MNM Fatal 2012-10

- Powered Haulage Accident
- July 26, 2012 (Montana)
- Crushed Stone Operation
- Equipment Operator
- 49 years old
- 18 weeks of experience

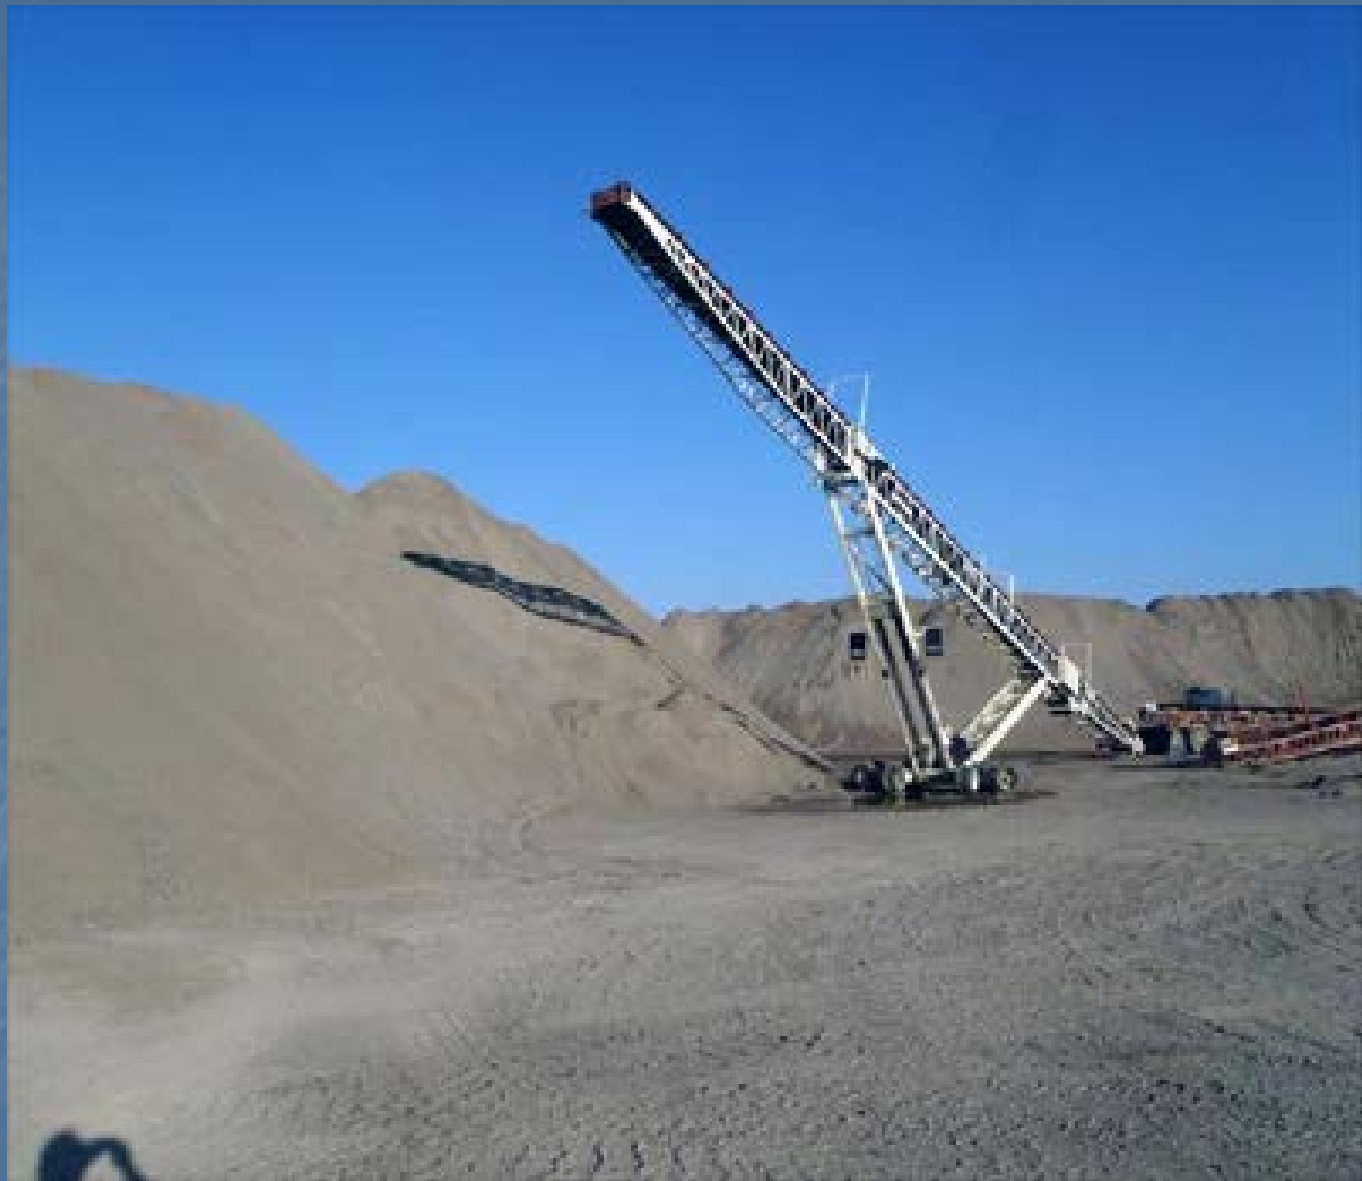
The accident occurred because management previously directed the electrical panel for the conveyor to be modified, allowing the stacker conveyor's start/stop switches to be bypassed. The wiring was changed to bypass the start/stop switches on the stacker conveyor's electrical panel provided by the manufacturer.

At the end of each day and in preparation for the next day, the disconnect switch on the electrical panel located on the side of the stacker was placed in the "on" position so a person could remotely control the stacker conveyor from inside a control van, located approximately 230 feet away. This condition contributed to the stacker conveyor starting by a means other than recommended by the manufacturer.

Additionally, the victim was greasing the head pulley on the stacker conveyor and it was not deenergized, locked and tagged out, and blocked against motion. The audible warning device was not sounded, as required, to warn the victim who was working on the stacker conveyor that the conveyor was going to start.

*Corrective Action:* The wiring was returned to a manufacturer approved design.

*Corrective Action:* Management established policies, procedures, and controls to ensure that belt conveyors are deenergized, locked and tagged out, and blocked against hazardous motion before persons work on them. Management also installed grease lines that can be reached from the ground. A man lift has also been provided to provide safe access. All miners have been trained regarding these new procedures.

*Corrective Action:* A standard operating procedure for sounding the horn before starting the equipment was implemented and all miners were trained accordingly.
