MNM Fatal 2012-12

- Falling Material Accident
- August 17, 2012 (Florida)
- Victim Recovered September 4, 2012
- Cement Operation
- Cement Equipment Operator
- 58 years old
- 19 years of experience

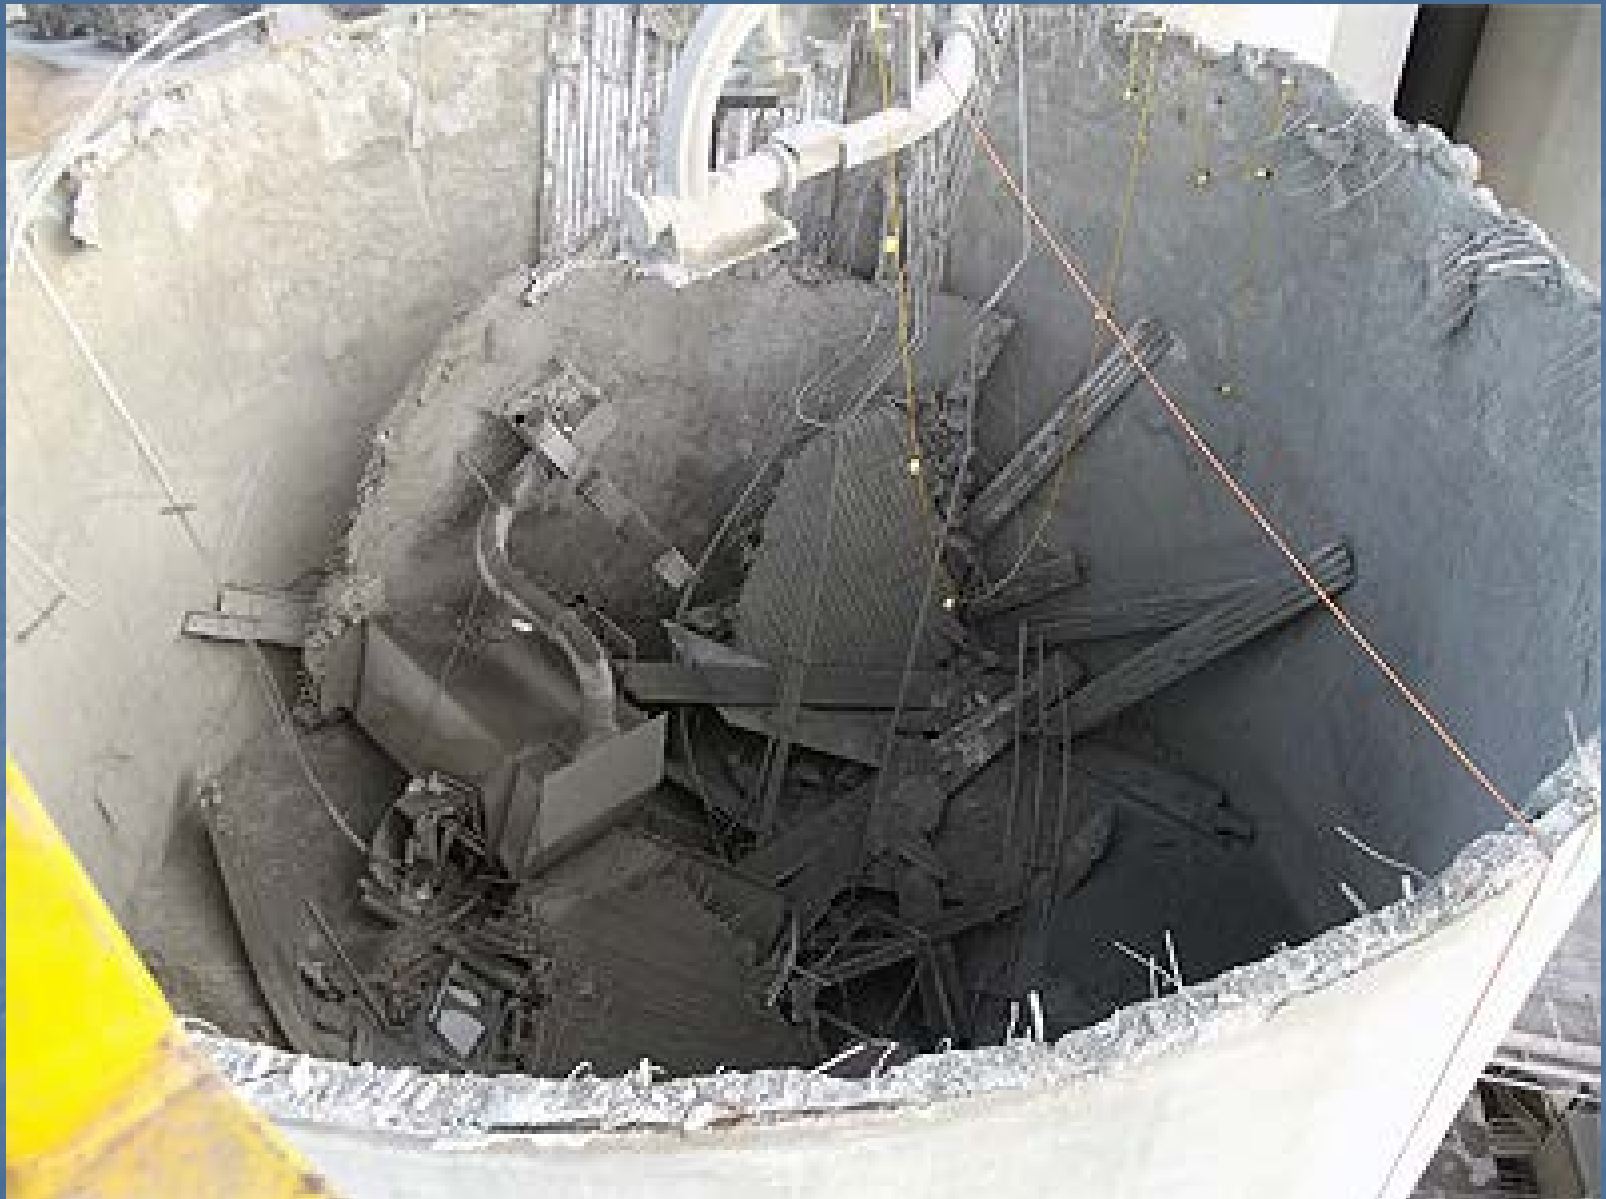
The victim was killed when the silo roof he was working on collapsed. The cement roof slab, beams, and the grout in the beam pockets failed causing the roof and the equipment on the roof to fall into the 3/4 full silo. Rescuers responded and the victim was recovered from the silo on September 4, 2013.

The accident occurred due to management's failure to correct defects on the silo where the victim was working. The roof decking on Silo 12 was inadequately attached to the roof beams, causing the beams to become unstable and buckle; the grout under the beam ends was too thick and some of the grout in the beam pockets had cracked and delaminated; and the shear stirrups were placed too far below the beam ends to prevent the grout in the beam pockets from failing in shear. Also, in 2004 a roof beam was cut when a penetration was made into the roof to install an automatic level detecting device. This cut significantly reduced the load carrying capacity of the beam. These defects led to the collapse of the silo roof slab that was supporting the victim. In addition, adjacent Silo 11 had experienced a partial roof failure in 2011 that caused the roof to bulge and caused significant cracking in the reinforced concrete. Management did not adequately investigate the causes and conditions surrounding the Silo 11 partial roof failure and therefore did not identify similar conditions existing under the roof of Silo 12.

Management also allowed the silos to operate with defective aeration systems and the presence of a large rathole (partly caused by those defective systems). When the cement would bridge over the rathole and then collapse during discharge, this would create significant suction loading and detrimental vibrations on the roof slab, beams, grout in the beam pockets, and welds. In addition, other equipment including high level indicators and an automatic level detection device were inoperable, making manual measurement necessary and the over pressure events more likely. The over pressurization in the silo resulted in upward pressures on the silo roof slab and its support system (puddle welds and beams), and damage to those components.

When combined, these equipment-related defects and structural deficiencies contributed to the collapse of the roof slab.

Root Cause: Management failed to correct defects on Silo 12 where the victim was working. Specifically, the operator failed to determine the cause of a partial roof failure the previous year on an adjacent silo. Silos 10, 11, and 12 had not been built to specifications; maintained appropriately; and the operator added additional strain on the silo by allowing the silo to operate with an internal rathole and by subjecting the silo to overpressures during its life of operation. In addition, a modification had been made to Silo #12 that significantly weakened the roof.

Corrective Action: Silos 10, 11 and 12 at this mine have been under a Section 103(k) order since August 18, 2012, and have been the subject of an ongoing investigation. The operator must take the actions necessary to repair these three silos, and with the knowledge learned from this investigation prevent future unsafe conditions in the remaining silos at the mine. MSHA will require the operator to take appropriate actions to address the root cause of this accident to ensure that miners can safely work on or near Silos 10, 11, and 12.
