REPORT OF INVESTIGATION

**Fatal Powered Haulage Accident
January 27, 2012**

**Security Quarry
Holcim (US) Inc.
Hagerstown, Washington County, Maryland
Mine I.D. No. 18-00019**

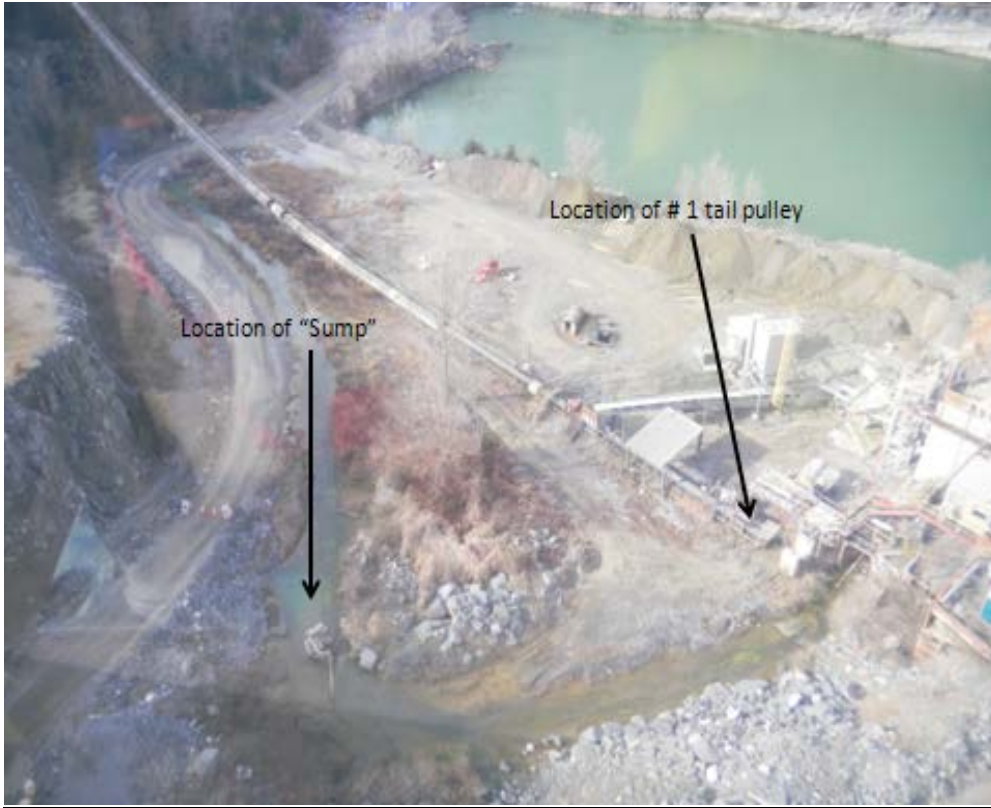
Appendix C- Photo of Accident Area

Weaver's coworkers thought he would attempt to drive the skid steer out of the water at this location however, he began to travel in reverse once again. Hurd began yelling at Weaver to stop but apparently he did not hear Hurd's calls. The loader traveled an additional 54 feet in reverse and into an approximately 5-foot deep water hole previously dug in April 2011. The loader overturned onto its side and completely submerged into the water.

The accident occurred at a 5-foot deep water hole in a stream bed located on the east side of the #1 belt conveyor. The water hole, excavated for a sump, measured approximately 11 feet wide by 13 feet long. The stream bed is used to drain water from the quarry area of the mine.

Corrective Action: Management installed a berm to the mid-axle height of the largest equipment traveling the road and posted signs at the water hole.
