REPORT OF INVESTIGATION

Surface Nonmetal Mine
(Common Shale)

Fatal Fall of Highwall Accident
February 14, 2012

Rare Red Rock
Rare Red Rock
Graysville, Jefferson County, Alabama
Mine I.D. No. 01-03273

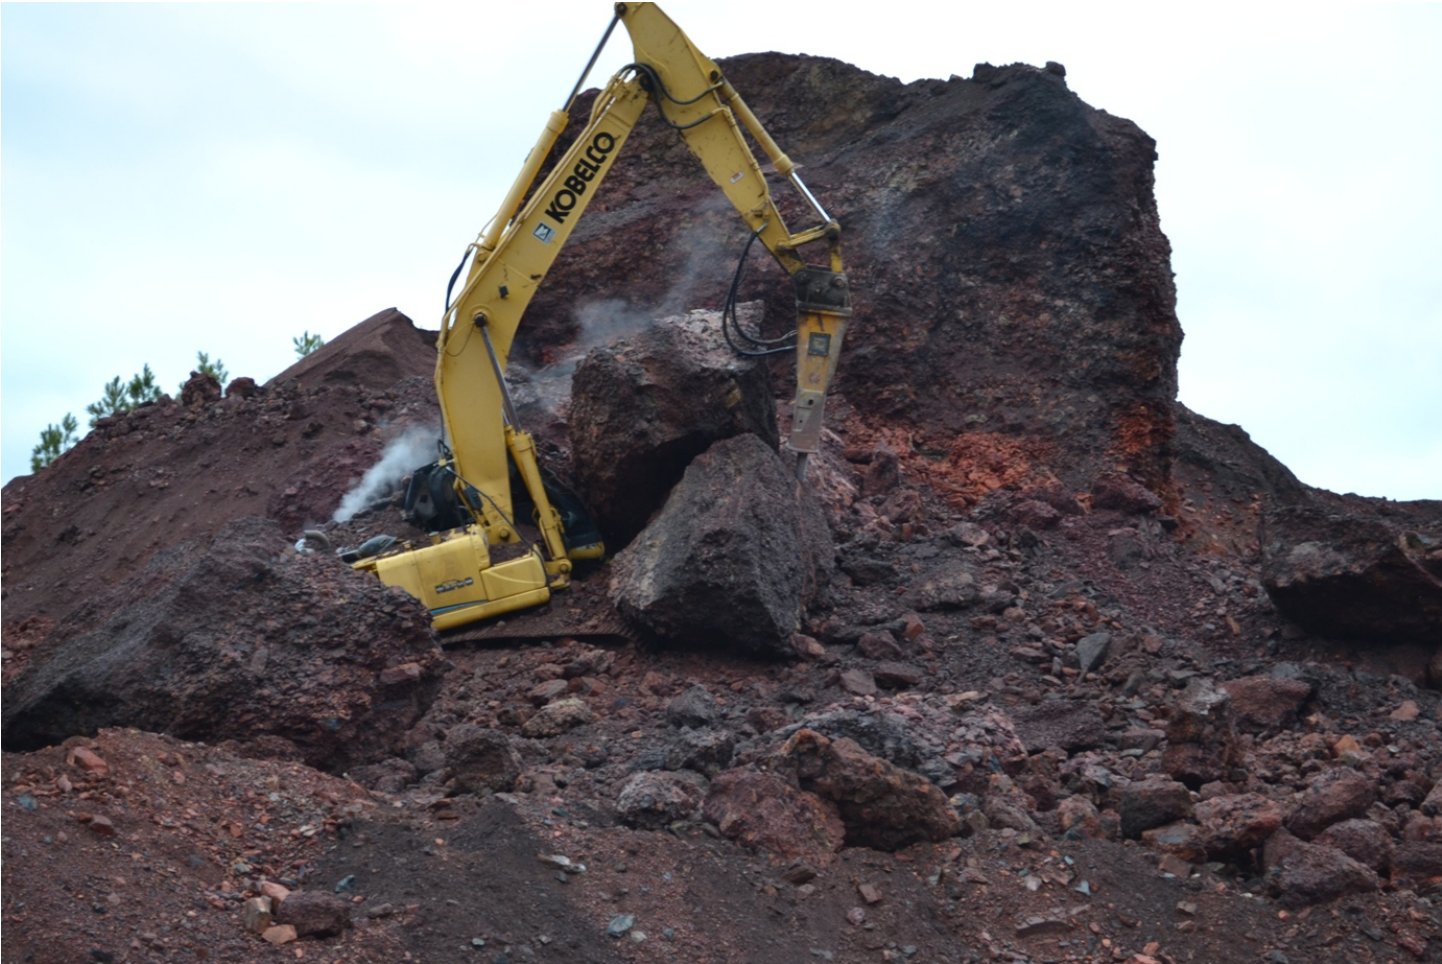
William N. Fuller, Mine Owner, age 40, was killed on February 14, 2012, when the excavator he was operating was covered by falling material from a highwall. Fuller was using a rock breaker, attached to the excavator, to break and mine material from a near vertical wall when the face fell onto the cab of the excavator, crushing him.

During interviews, the investigators learned the highwall that failed had near vertical cracks on the eastern and western sides about 10 to 15 feet from the north-facing wall. Accounts of the width of the cracks vary, but mine personnel stated that the conditions had worsened and the highwall was unstable. One equipment operator stated that he expected the highwall to fall at any time. The highwall was near vertical and the top of the highwall higher than the excavator could reach when fully extended. At the time of the accident, loose material, sloped at approximately 30 degrees from horizontal, covered the toe of the highwall. The upper portion of the wall was near vertical or averaged about 78 degrees from horizontal.

Corrective Action: Management established Standard Operating Procedures (SOP) for mining loose unconsolidated material at a safe slope angle. Before mining resumed, a blasting contractor was employed to drill and shoot the mounds of harder material to reduce the near vertical walls to a slope angle that was safe to mine. Safe mining methods were established for future mining. These methods include having a person conduct required examinations, and conducting required training for all persons working near the highwalls.
