**MAI-2012-03**

**REPORT OF INVESTIGATION**

**Fatal Fall of Person Accident  
February 22, 2012**

**White Rock Quarries  
White Rock Quarries  
Hialeah, Dade County, Florida  
Mine ID No. 08-01058**

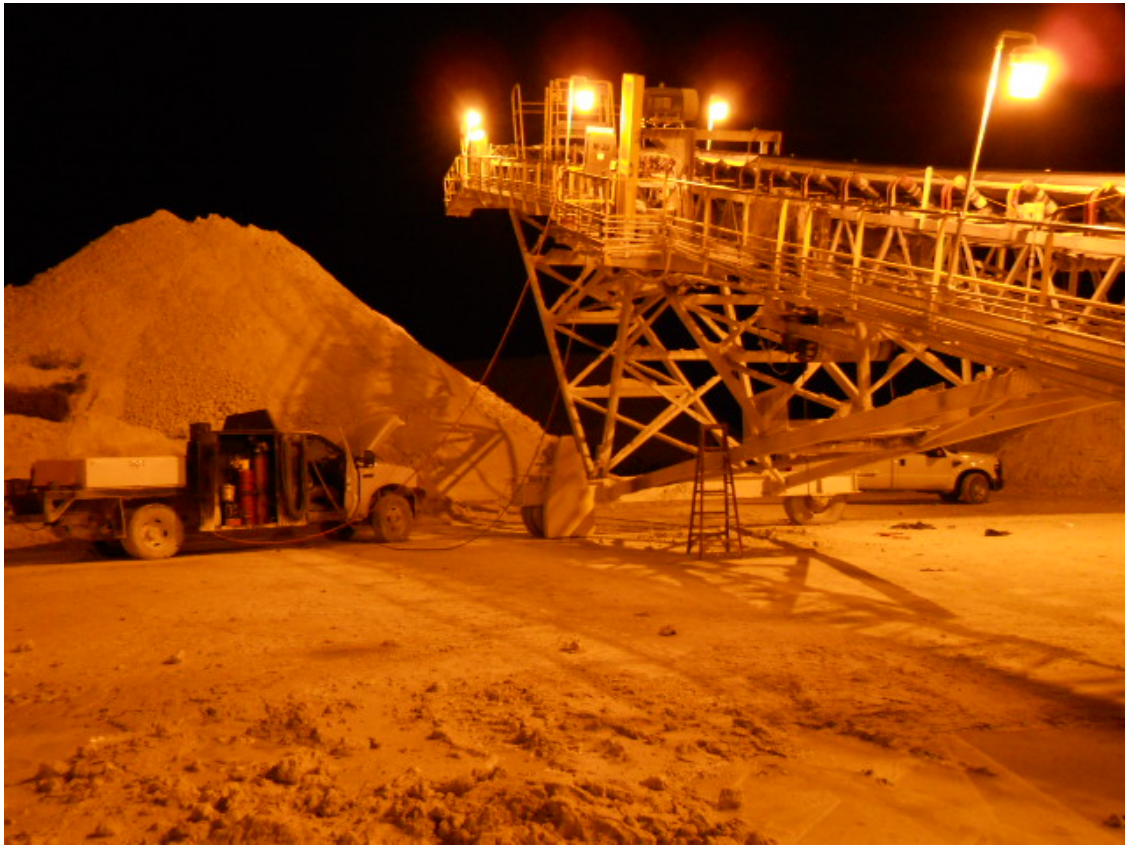
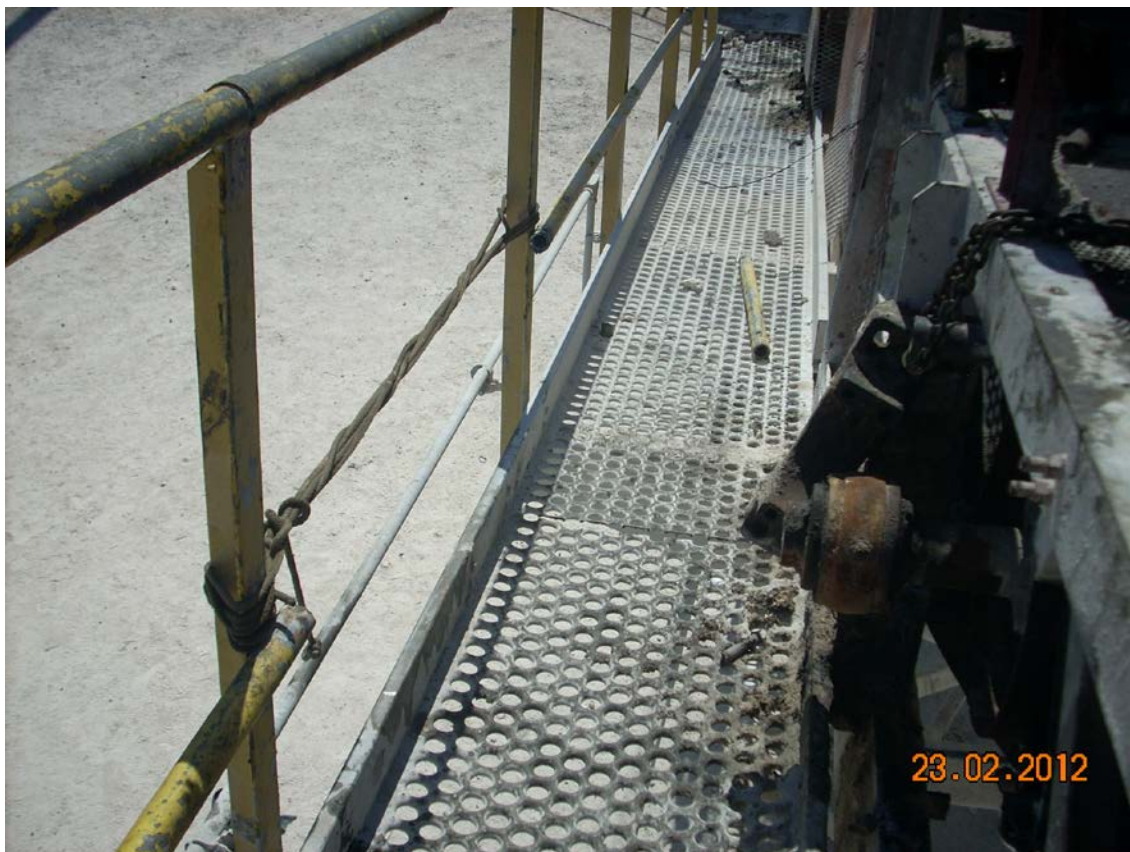
Humberto Guerra Sr., Maintenance Mechanic, age 46, suffered injuries on February 22, 2012, from a fall of 16 feet from an elevated walkway of a conveyor to the ground below. Guerra and a coworker, positioned on the other side of the belt, were bolting a snubber pulley in place. Guerra was hospitalized and died on February 26, 2012, as a result of injuries sustained from the fall.

The accident occurred due to management's failure to ensure persons wear fall protection where there is a danger of falling. The victim was not wearing fall protection.
