REPORT OF INVESTIGATION

**Surface Nonmetal Mine
(Construction Sand and Gravel)**

**Fatal Falling Material Accident
April 11, 2012**

**GS Materials Inc.
Lemon Springs
Lemon Springs, Harnett County, North Carolina
Mine I.D. No. 31-01990**

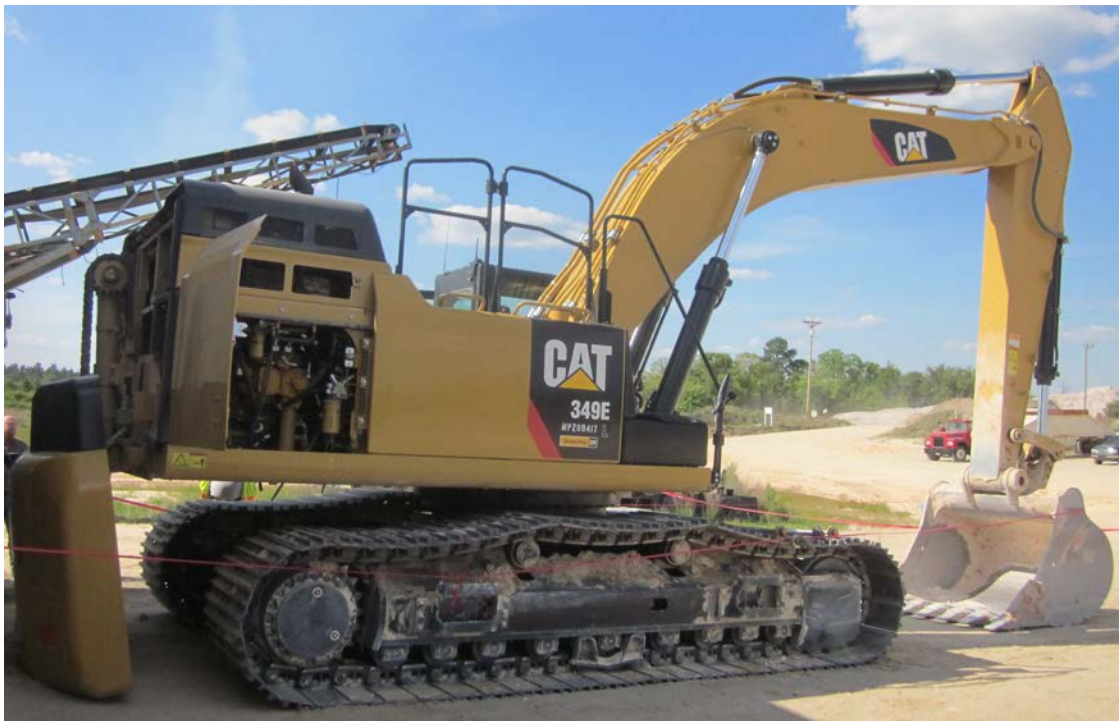
Illustration 1: Side View of Excavator showing dropped counterweight

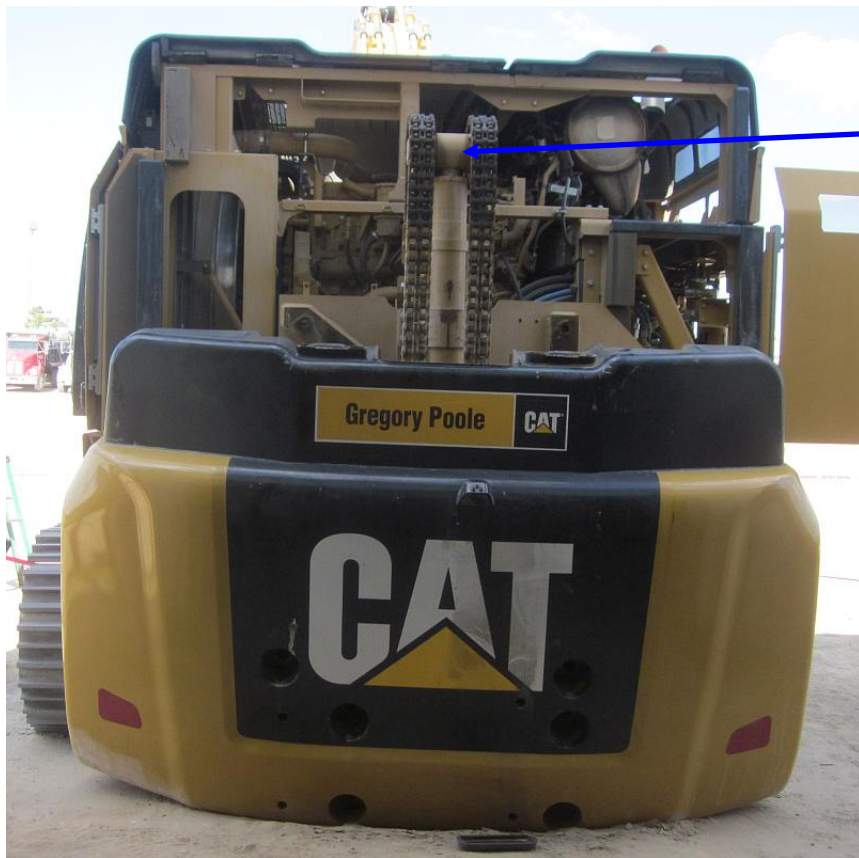
Removal system
cylinder and lift
chains

Illustration 2: Rear View of Excavator showing dropped counterweight

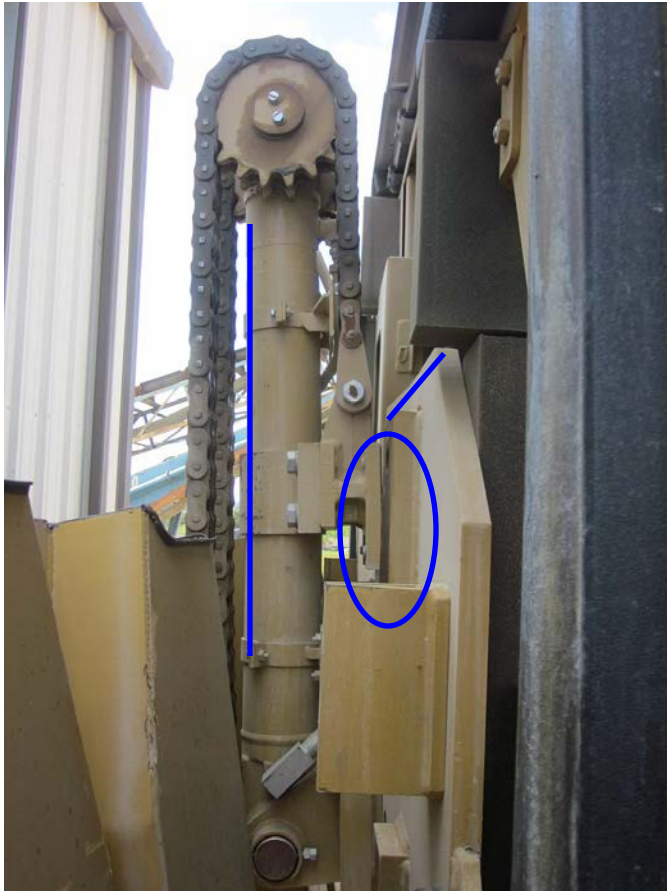
At the time of the inspection, the excavator and the counterweight were in the same position and place as when the accident occurred. Examination of the rear frame of the excavator showed structural damage where the lift mechanism for removal of the counterweight is attached. This structural damage included bending of the excavator frame plate, cracking of paint over joints, and spaces between the counterweight lift mechanism mounting brackets and excavator frame. Further inspection revealed the hydraulic cylinder on the counterweight lift mechanism was bent. Illustrations 3 and 4 show the damage.

Illustration 3: Bent cylinder, frame plate, and one of the spaces between the counterweight lift mechanism mount and excavator frame.

The structural damage present indicated the counterweight fell directly to the ground without being restrained by the counterweight removal system.

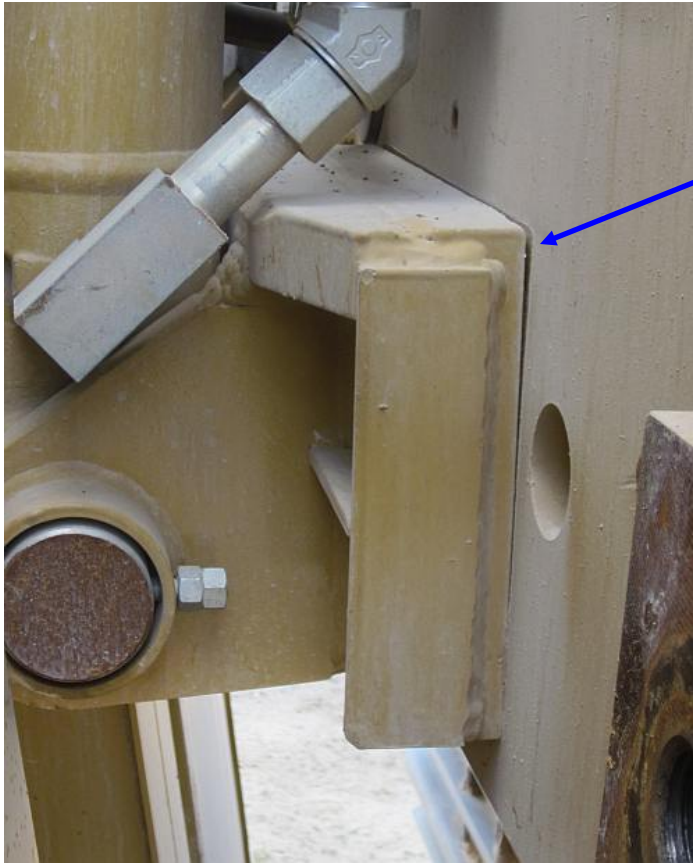
Illustration 4: Close up of one of the spaces between the counterweight lift mechanism mount and excavator frame.

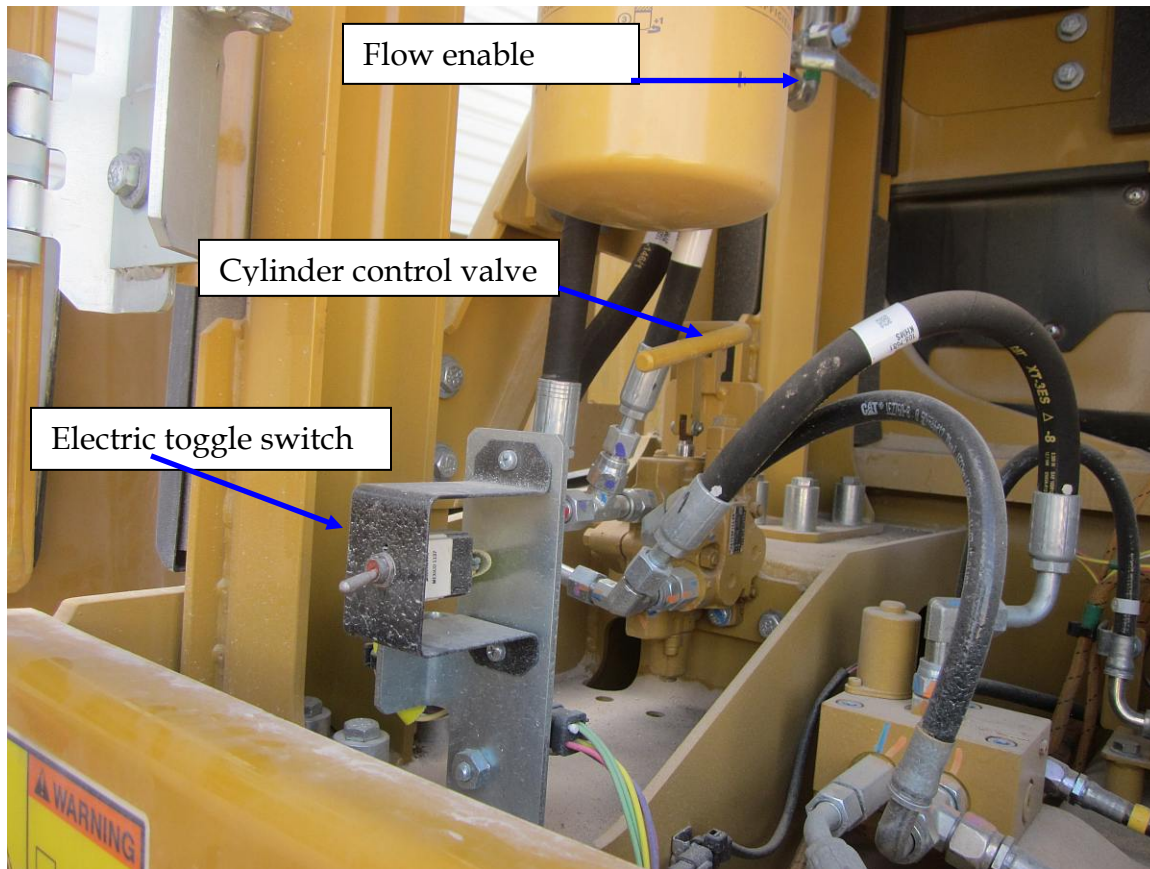
The “System for the Removal of the Counterweight” has dedicated controls in a side compartment of the excavator. These include two valves that enable flow to the optional hydraulic cylinder, a valve for control of cylinder movement, and an electric toggle switch to enable hydraulic operations when machine hydraulics are disabled in the operator’s compartment. See Illustration 5 for the layout of these controls. Note that these controls are not labeled.

Illustration 5: Controls for the “System for the Removal of the Counterweight”

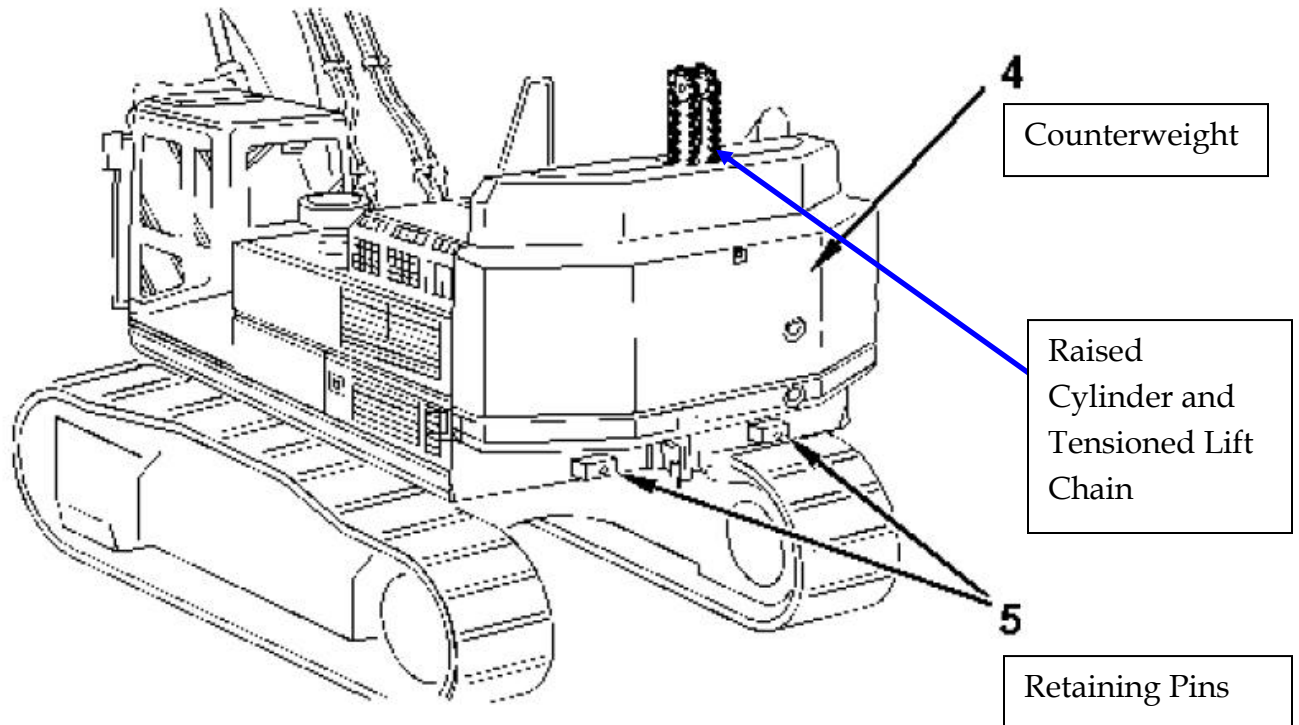
Illustration 6: Drawing of proper operation of the counterweight removal system showing the counterweight raised by tensioned lift chain to expose retaining pins. (From Caterpillar manual SEBP 5613)
