**REPORT OF INVESTIGATION**

**Surface Nonmetal Mine  
(Construction Sand and Gravel)**

**Fatal Machinery Accident  
May 23, 2012**

**Meridian Aggregates Company, A Limited Partnership  
Broken Bow Sand and Gravel  
Eagletown, McCurtain County, Oklahoma  
Mine ID No. 34-00460**

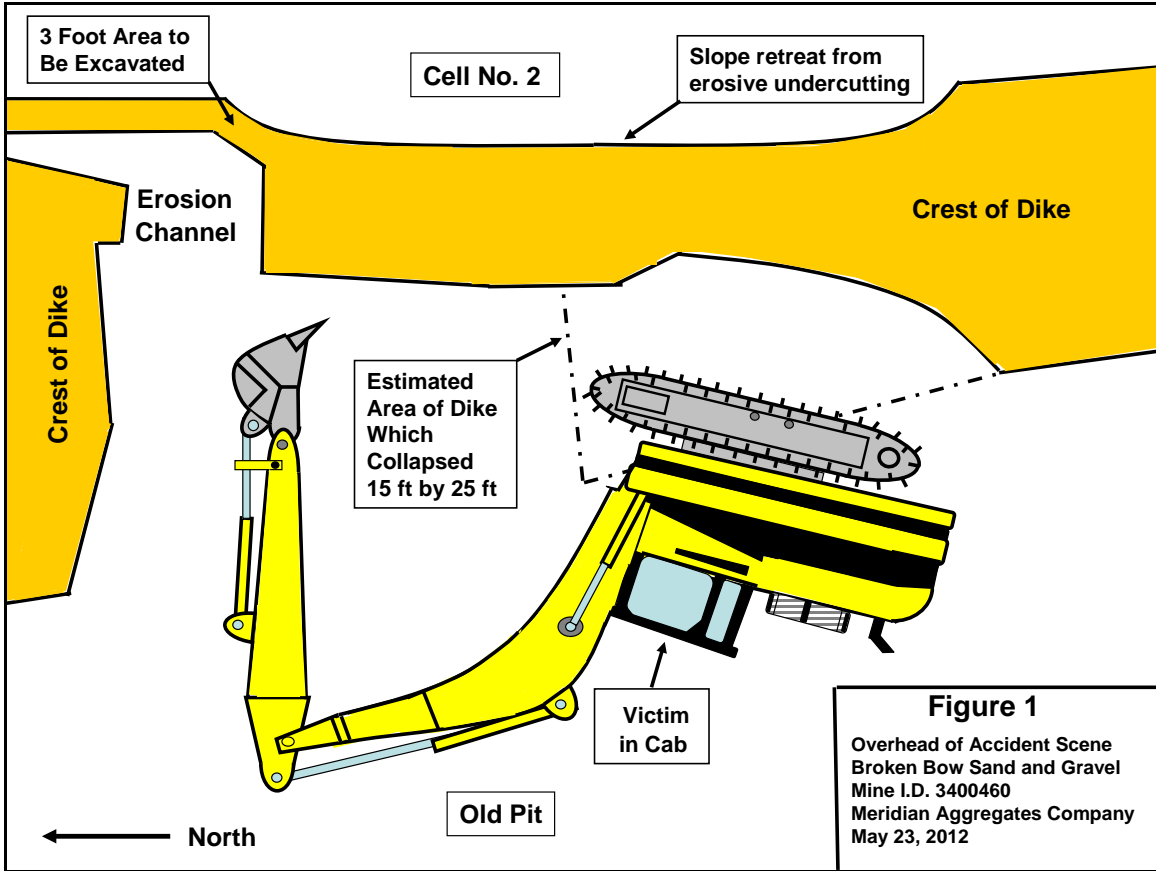
APPENDIX B

The accident occurred west of the main plant on an earthen dike separating the “old pit” and cell #2 of the settling ponds. The “old pit” had been mined about 15 years earlier. Water collected in the pit after mining ceased. The settling ponds consist of three cells formed by sandy earthen dikes in a pit mined about three years earlier. Water passed through the settling ponds to clarify it for use in the plant.

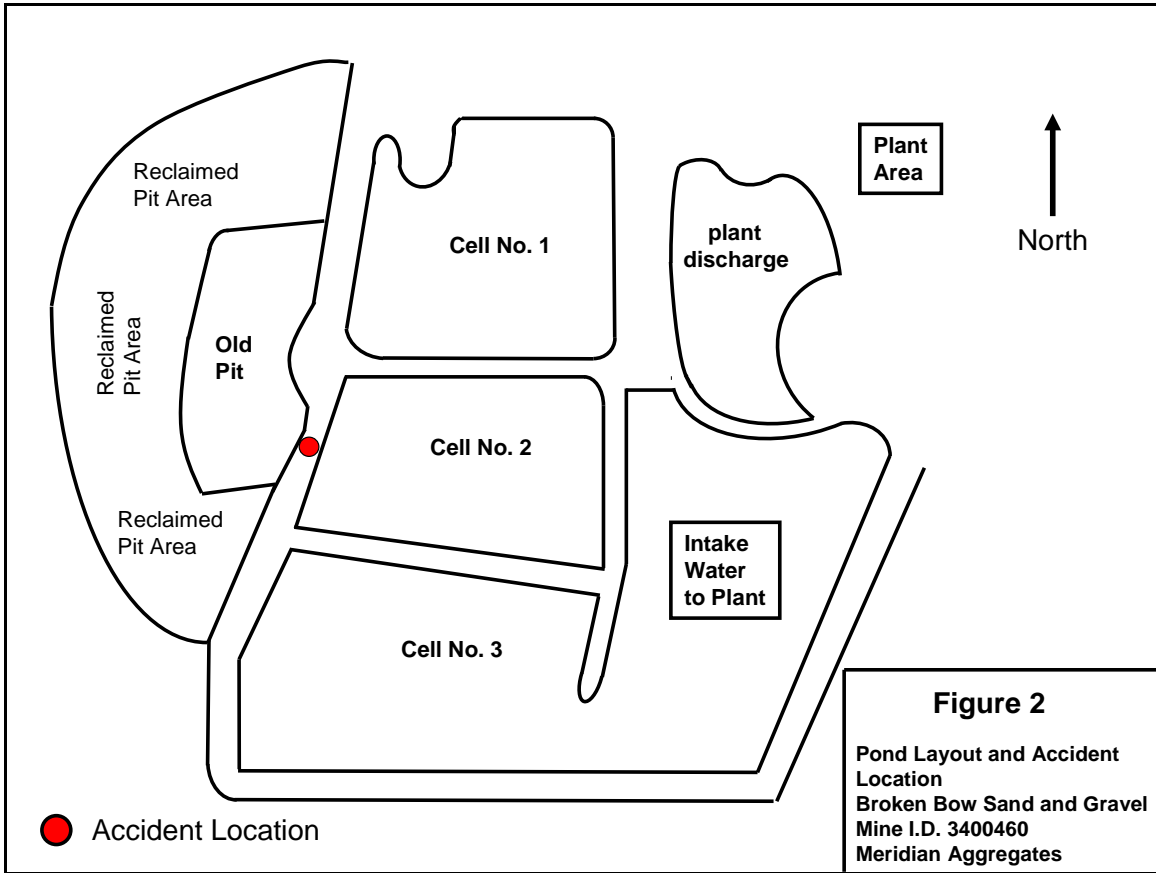
APPENDIX C

The dike previously provided access to the west side of the settling ponds. However, there was now an earthen barricade at both ends of the dike to prevent access because a portion of the dike eroded between the “old pit” and cell #2 of the settling ponds. Scott trammed the excavator over the southern barricade to gain access to the dike.

Scott intended to breach the dike, using the excavator, to drain the water from the “old pit” into cell #2 allowing reclamation of the “old pit.” The eroded portion of the dike, identified for removal, was located about 15 feet north of where the accident occurred and only 3 feet wide.

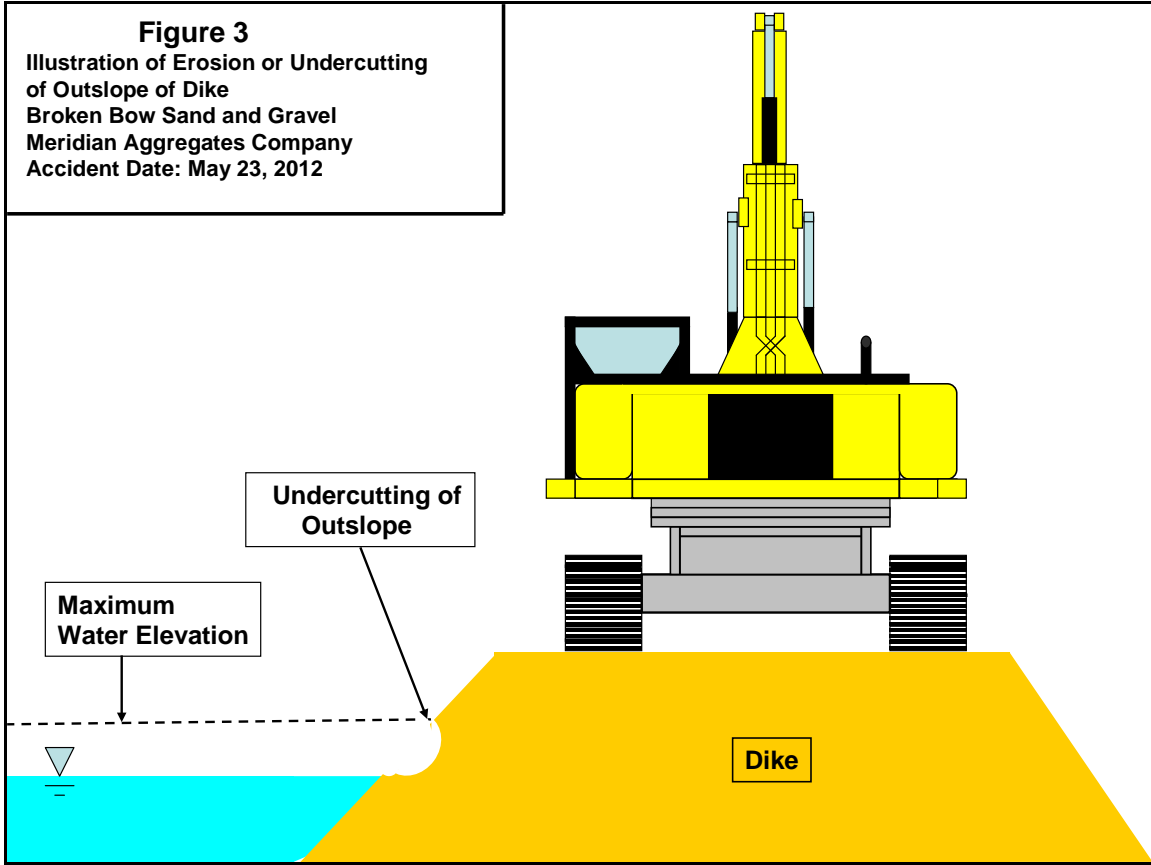
APPENDIX D

dike near the accident location stood at angles of 32-40 degrees while the top portion of the berms stood at angles as large as 60 degrees. These angles are larger than the angle of repose for dry fine sand (27 degrees); therefore, the material in them was subject to sloughing and erosion as moisture content fluctuated.

A portion of the dike, about 30 feet long, eroded by the rising and falling water levels in both the “old pit” and cell #2 of the settling ponds. The erosion affected the berms on both sides of the dike, leaving vertical drops into the water and some undercutting of the remaining dike.

**Corrective Action:** Safe access was provided by constructing an earthen ramp that was sufficient to support the weight of the excavator. Future excavator work will occur only after the work site has been inspected and safe access has been provided.
