REPORT OF INVESTIGATION

Fatal Fall of Person Accident
July 26, 2012

Portable Crushing Plant #1
Strata Corporation
Fairview, Richmond County, Montana
I.D. No. 21-02843

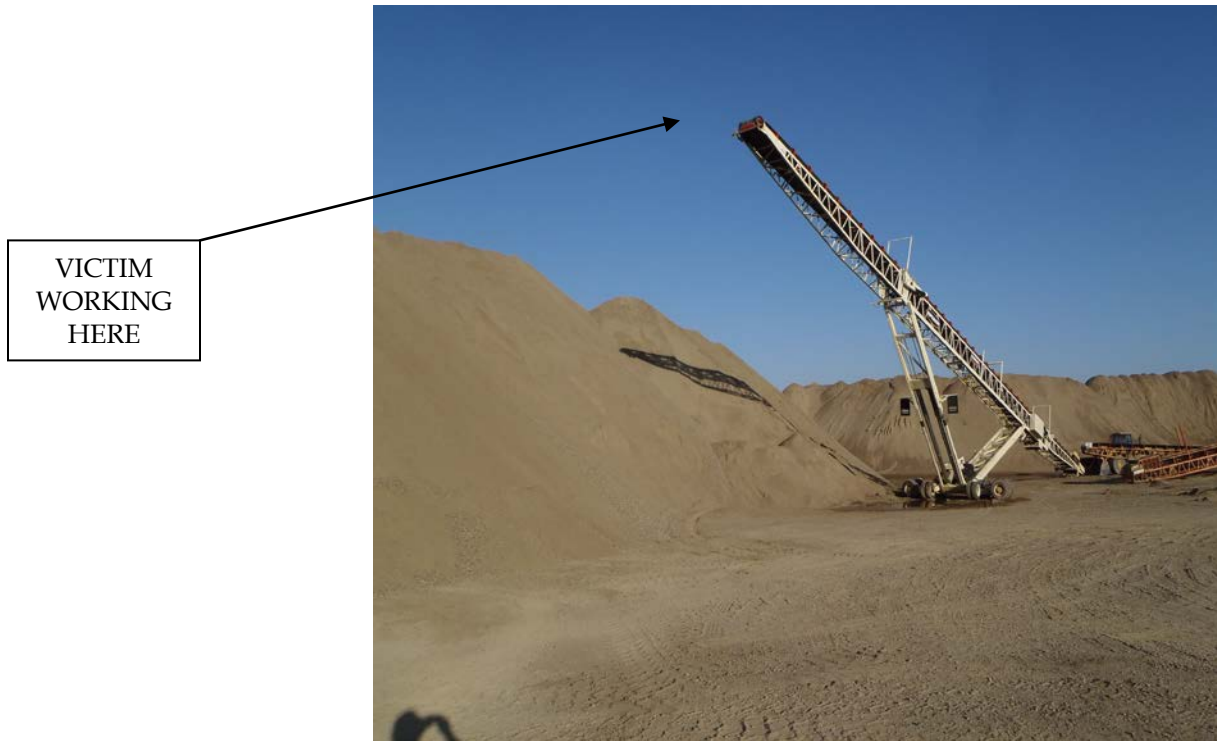
Photograph of Accident Scene

On July 26, 2012, Peter P. Faust, equipment operator, age 49, was killed when he was thrown off the discharge end of a 150-foot long stacker conveyor. Faust was standing on the belt, greasing the head pulley, when a coworker started the stacker conveyor by switching the disconnect to the “on” position. Faust fell off the stacker conveyor 51 feet to the ground below.

The accident took place at the head pulley on the Superior powerstacker belt conveyor.

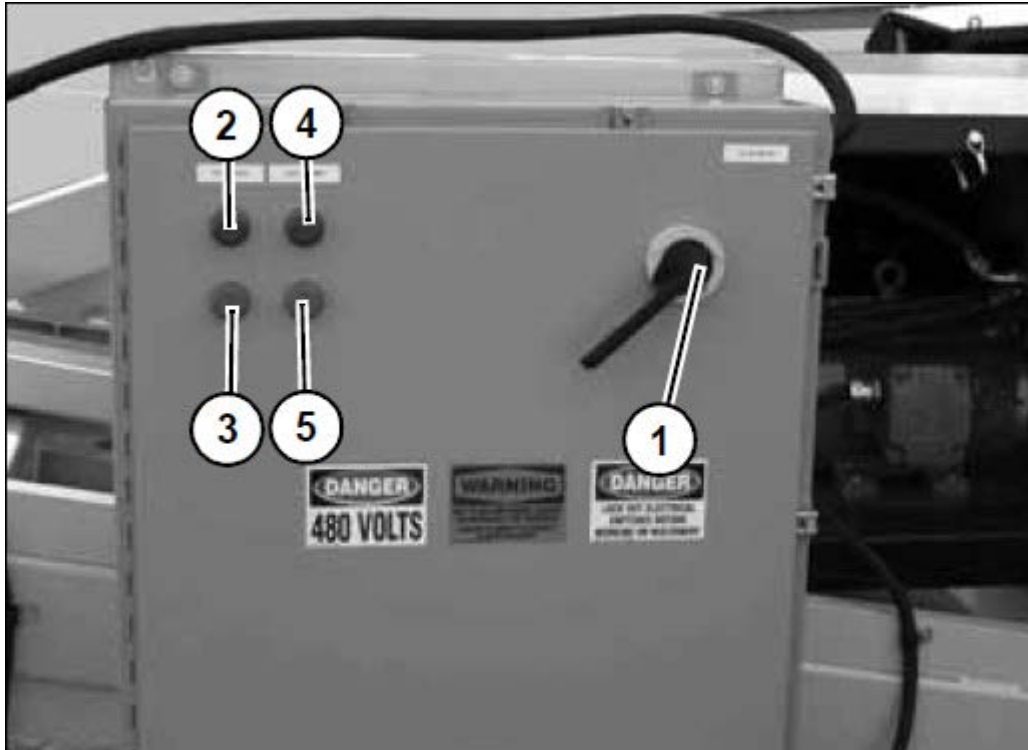
Figure 1 - Stacker Belt Conveyor Electrical Panel

- The main disconnect (Figure 1, Item 1) controlled the main breaker inside the electrical panel. When the main disconnect was in the “off” position, there should not be any power source on the load side of the main breaker which fed the electrical panel.
- Momentary push button to start the conveyor belt (Figure 1, Item 2).
- Momentary push button to stop the conveyor belt (Figure 1, Item 3).
- Momentary push button to start the hydraulic motor (Figure 1, Item 4).
- Momentary push button to stop the hydraulic motor (Figure 1, Item 5).

The electrical panel power input was controlled remotely via a push button, labeled stacker, located inside a control van. The internal electrical system of the stacker conveyor electrical panel provided by the manufacturer had been modified. The start/stop stacker conveyor buttons (Figure 1, Items 2 and 3) were inoperative and the main disconnect (Figure 1, Item 1) controlled the stacker conveyor in conjunction with the push button located inside the control van. According to interviews during the investigation, the modification was performed by the maintenance staff as directed by

the control van. Consequences of the modification included the inability to stop the stacker conveyor via the momentary push button (Figure 1, Item 3) as the label would indicate a person could. The stacker conveyor would only temporarily slow down while the momentary push button to stop the stacker conveyor (Figure 1, Item 3) was depressed. Once the button was released, the stacker conveyor would start again.

The hydraulic motor was connected to the line side of the main breaker, allowing the hydraulic motor to operate with the main disconnect (Figure 1, Item 1) in the “off” position. This was not the design of the original manufacturer but was changed by the mine operator. This allowed a person to set the position of the stacker without starting the stacker belt conveyor. Unintended consequences of this modification included the starting of the stacker conveyor after the position of the stacker was set due to the fact that a person had to turn the main disconnect (Figure 1, Item 1) in the “on” position to regain control of the stacker conveyor from the stacker push button located inside the control van. This is the scenario that occurred at the time of the accident, causing the stacker conveyor to start while the victim was on top of the belt, subsequently throwing him off the discharge end of the belt.

Corrective Action: The wiring was returned to a manufacturer approved design.

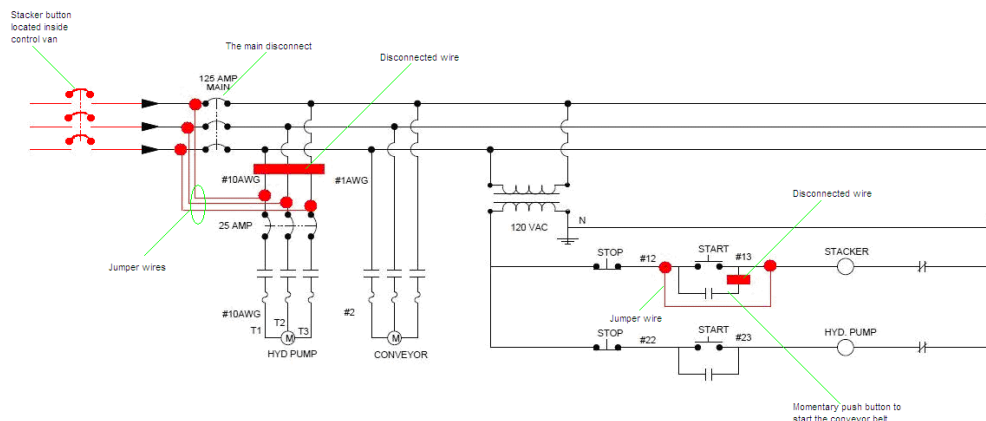
- (1) A push button in the control van connected/disconnected the main power source of the electrical panel.
- (2) The hydraulic pump breaker line side was moved from the main breaker load side to the main breaker line side, i.e. the main breaker was bypassed; therefore, the hydraulic motor could operate while the main disconnect was in the “off” position and the control van provided power via the stacker button located inside the control van.
- (3) The momentary push button to start the conveyor belt (Figure 1, Item 2) was bypassed; therefore, the stacker conveyor would turn on when the main disconnect was set to the “on” position and the control van provided power via the stacker button located inside the control van.

Figure 2 - Stacker Conveyor Electrical Panel Schematic with Modifications in Red. With the momentary push button to start the stacker conveyor (Figure 1, Item 2) bypassed, the stacker conveyor started when the electrical panel had power from the control van and the main disconnect switch (Figure 1, Item 1) was turned to the “on” position. Therefore, the stacker conveyor was controlled by the main disconnect (Figure 1, Item 1) in conjunction with the stacker push button in the control van rather than momentary push button to start the conveyor belt (Figure 1, Item 2) and the momentary push button to stop the conveyor belt (Figure 1, Item 3). This was not the design of the original manufacturer but was modified by the mine operator.

This modification to the wiring allowed persons to turn the main disconnect to the “on” position and start/stop the stacker conveyor by supplying/removing the power source from the electrical panel which was accomplished via the stacker button located inside
