REPORT OF INVESTIGATION

Surface Nonmetal Mine  
(Hydraulic Cement)

Fatal Falling Material Accident  
August 17, 2012

Tarmac America, LLC  
PENNSUCO Cement Plant  
Medley, Miami-Dade County, Florida  
Mine ID No. 08-00051

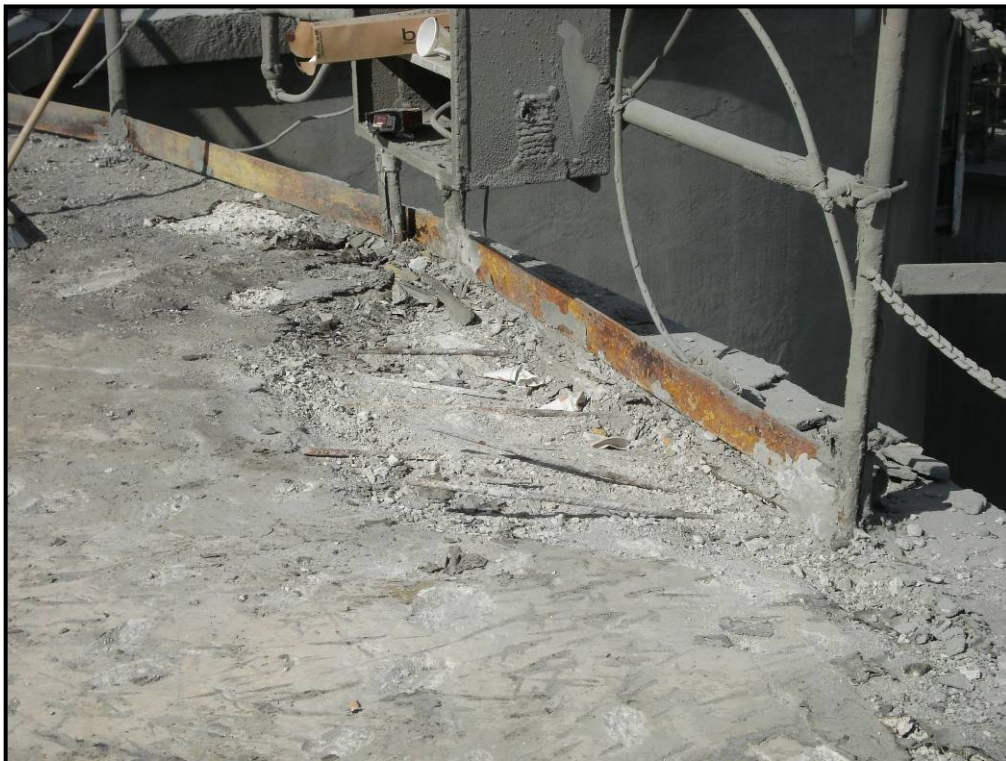
The investigators did not find any evidence or reports of previous structural inspection of any of the three silos. Even following an overpressure event in 2011 that caused the roof on Silo 11 to bulge up, and despite the significant damage, no structural inspection was conducted of the roof beams and pockets. An inspection at that time would have uncovered the problems with the buckled beams, puddle weld failures, and delamination in the beam pockets, which then would have caused concern regarding the integrity of adjacent Silos 10 and 12, and could have identified the deficiencies that led to the roof failure of Silo 12.

Photo 4 – Damage to Silo 11 roof when it was over pressured in 2011. The roof bulged and the bent over vertical reinforcing bars popped out of the slab at the perimeter when the roof relaxed.

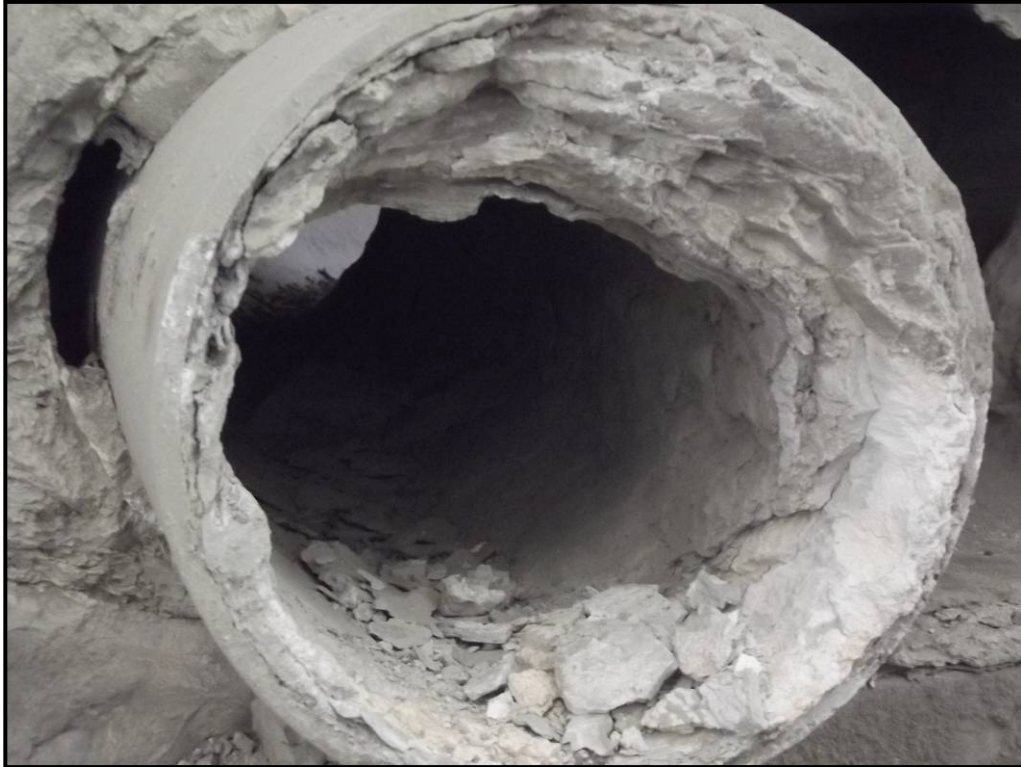
Photo 5 – Scale built up in pipes coming from the mills (recovered from Silo 12).

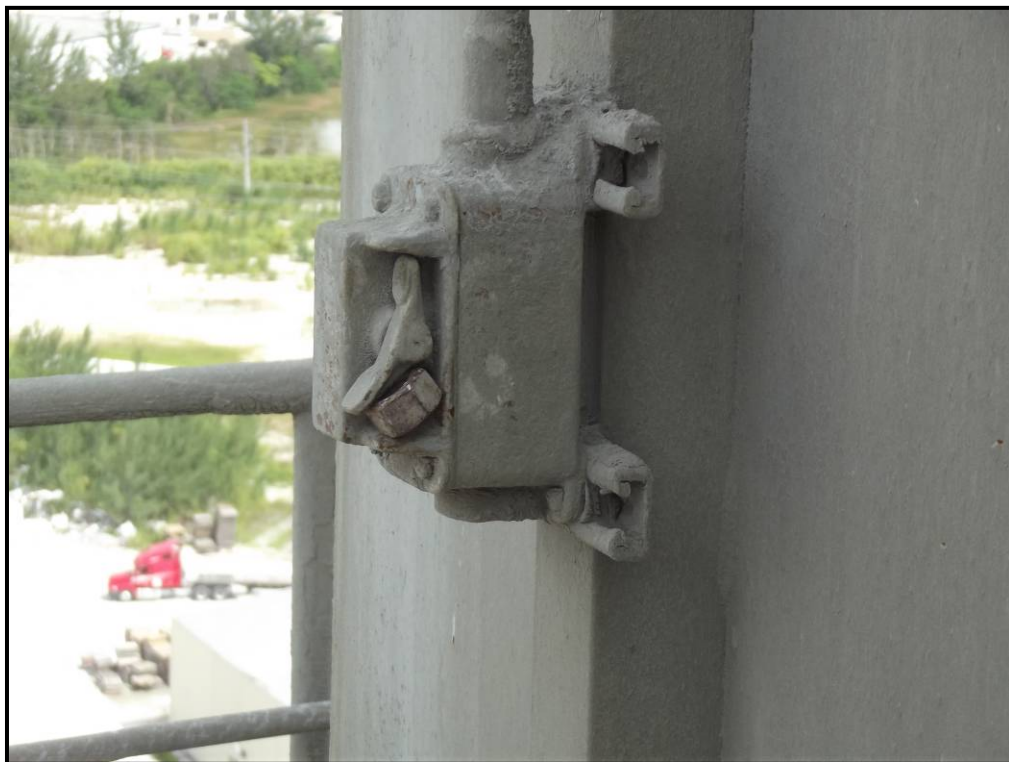
During interviews, several persons indicated the dust collectors could be operated remotely by the control room operator. They stated it was common for the silo to operate with the dust collector running even when no cement powder was being pumped into the silo. The switch on the dust collector was held in the constant run mode. This was accomplished by jamming the switch with a nut or other means to operate in a constant run mode. A pebble was found resting on the switch box of neighboring Silo 11 and a nut was found jamming the switch of the bag house located on the roof of Silo 8 (photo 6). The control room operator indicated the fan symbol on the control board was illuminated prior to the accident, which meant the dust collector was running. In addition, Jose Morales, Production Shift Mechanic, who was the last worker atop Silo 12 prior to the accident, indicated that the dust collector was running when he was there measuring the silo depth approximately an hour before the collapse.

Photo 6 – The dust collectors on the cement product silos were constantly run. The jog switches were kept on using nuts or other means to prevent shut off.

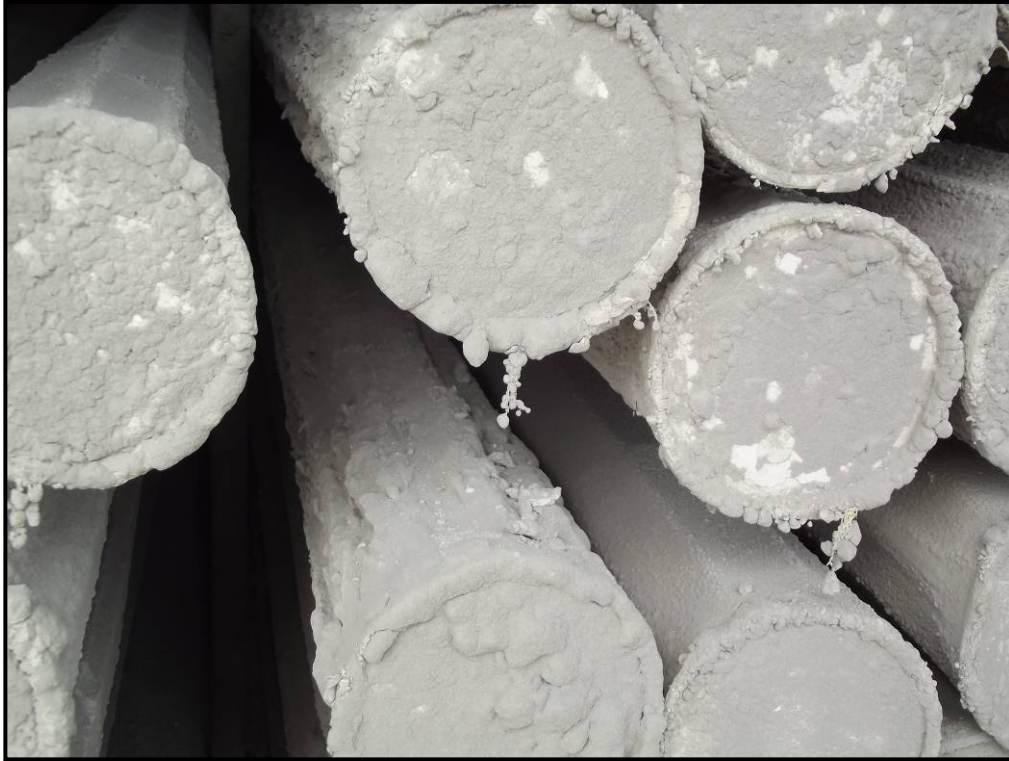
Approximately 12 months prior to the collapse, the roof on the bag house for Silo 12 had to be replaced, as rainwater was leaking onto the filters and causing them to clog. According to Hernandez, the silo measuring cap had been blowing off as a result of the baghouse filter clogging, which was when they discovered that the

bag house roof had been leaking. When the filters clogged, the dust collection suction was reduced. This could lead to a positive pressure on the silo roof when cement was being blown into the silo. In addition, as the silo level got near the top, the internal air pressure also increases.

Photo 7 – Air filter bags in the Silo 12 dust collector were partly caked.

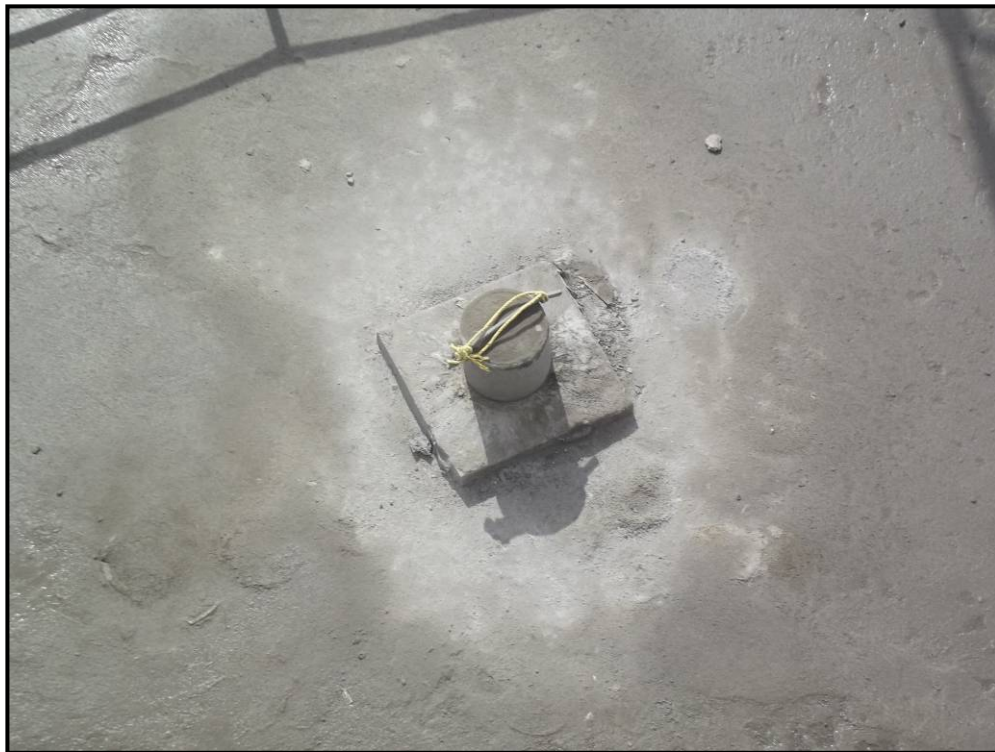
The measuring port on Silo 12 was not shown on the original engineering drawings (figure 3). It was added at a later date (photo 8). The port also served as a pressure relief valve. If the internal pressure exceeded the force required to lift the lid off the measuring port, then the lid would blow off. While the lid on the measuring port for Silo 12 was not recovered, the lid from Silo 11 was weighed and found to be 60 pounds. The lids were similar designs. The silo lid was 12 inches high, had a 12-inch outside diameter and a 3/8-inch wall thickness. One circular port recovered that was believed to be the port for measuring the cement depth had an inside diameter of 7.75 inches (photo 9). Based on that inside diameter, the pressure required to lift the 60 pound lid off the port would have been approximately 183 psf (or 1.44 psi<sup>6</sup>). Persons interviewed stated this port was not for the radio transmitter level indicator because it would have had six attachment bolts. In May, 2013, Borton Contractors and Engineers (Borton), measured the inside diameter of the ports on neighboring Silo 10 and 11, and reported an inside diameter measurement of 7.5 inches.

Photo 8 – Typical measuring cap for Silos 10, 11, and 12. Cap weighed 60 pounds and also acted as a pressure relief device.

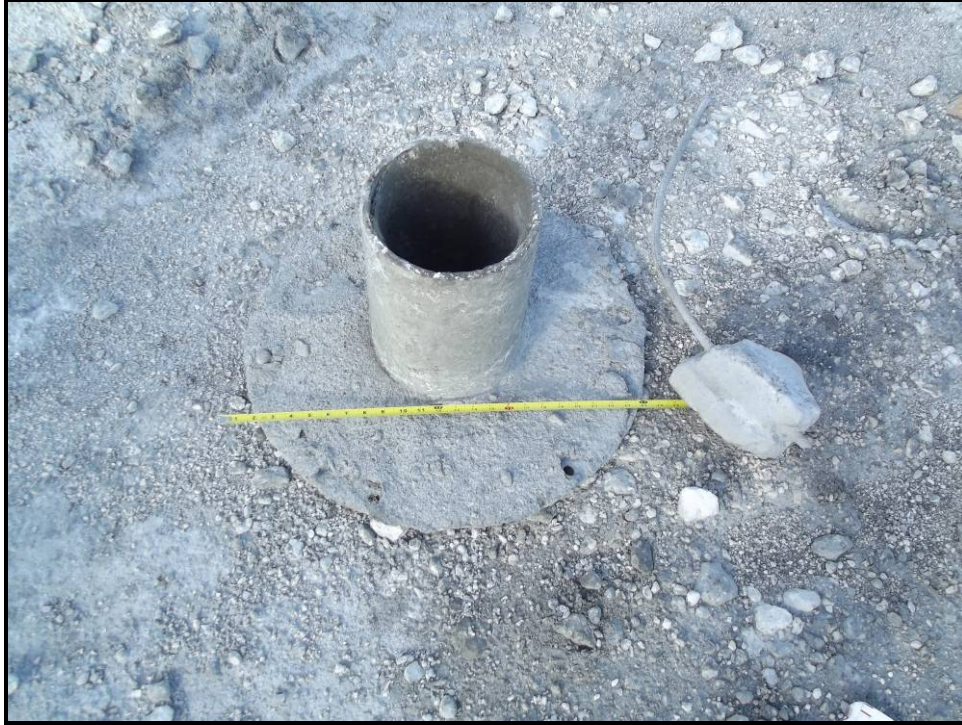
Photo 9 – Measuring port from Silo 12. Inside diameter measured 7-3/4 inches.

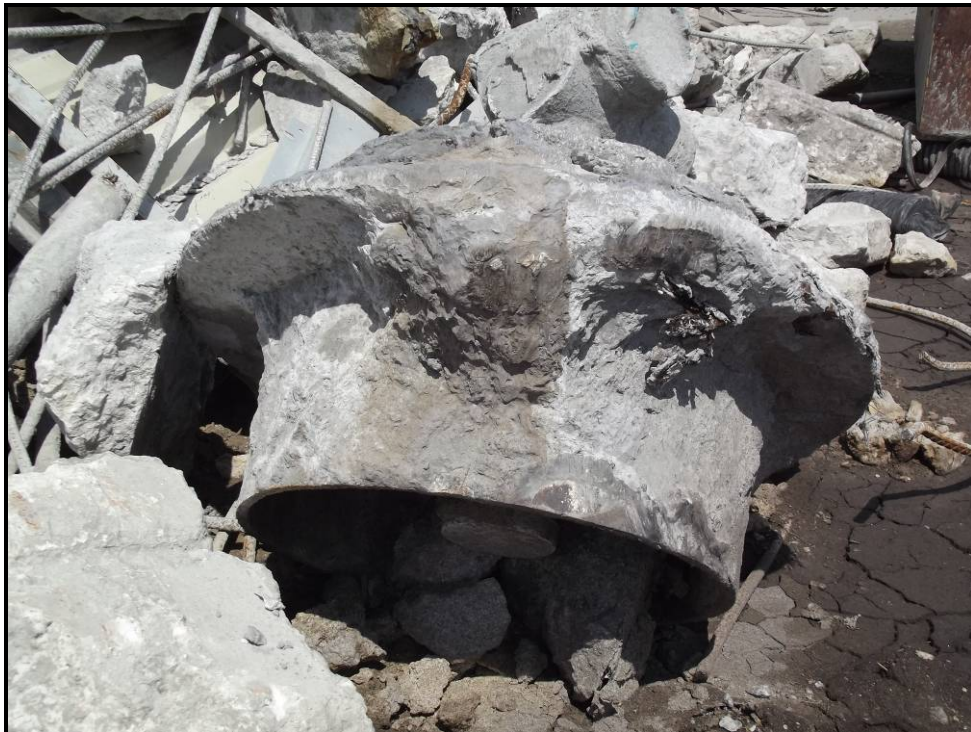
An 18-inch radio transmitter level indicator was found in the evidence lay down area for Silo 12 (photo 10). Persons interviewed stated the device did not work well and had not been operable. This device was added sometime around 2004. It is believed that the penetration of the roof to install this device likely resulted in the cutting of the top flange of Beam 3.

Photo 10 – An 18 inch radio transmitter level indicator from the roof of Silo 12. The top flange of Beam 3 was likely cut when this equipment was installed circa 2004.

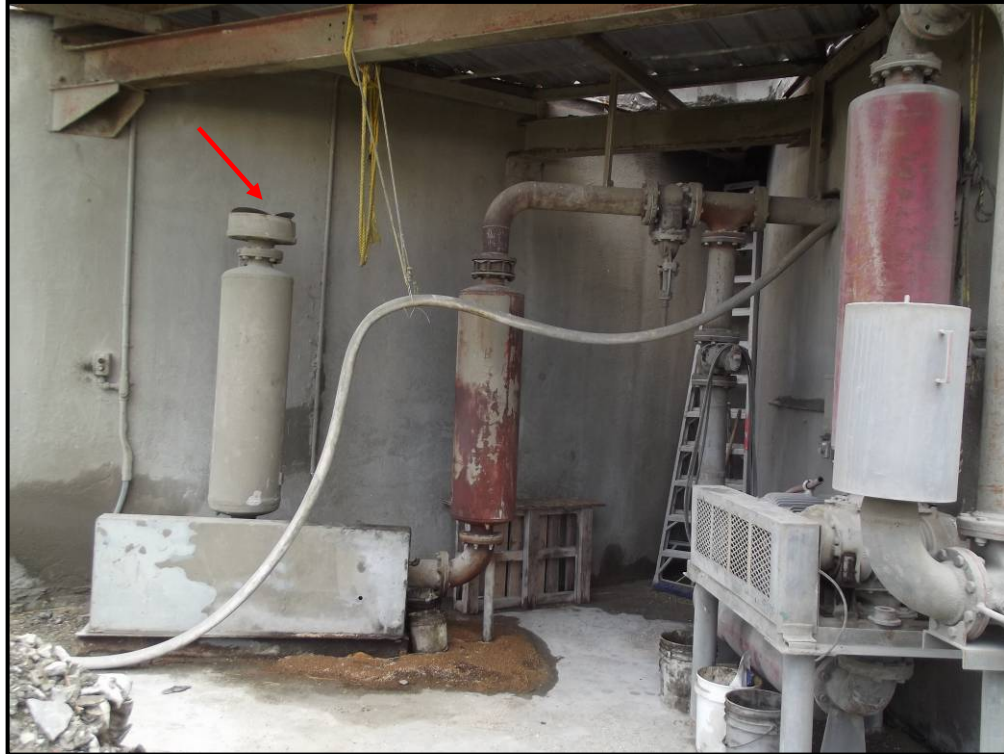
thermal dryer on the air supply; however, it was likely removed at some time, as it was not found in its specified location. The lid on the outside air intake filter next to Silo 11 was partially off, which would have further allowed moisture to get into the intake air system for the three silos. The injection of moist air, rather than dry air, into the cement powder in the silo hoppers may have caused caking of the material, which led to clogs at the outlet of the hopper and a rathole in the stored powder. Other means used to break up clogs and encourage flow included beating on the hopper shell with sledge hammers and using jam rods at the hopper outlet, the side access door, and/or the silo withdraw air slide chutes.

Photo 11 - Intake ambient air supply for the silo hopper air blaster. Cap (arrow) on intake filter was not attached.

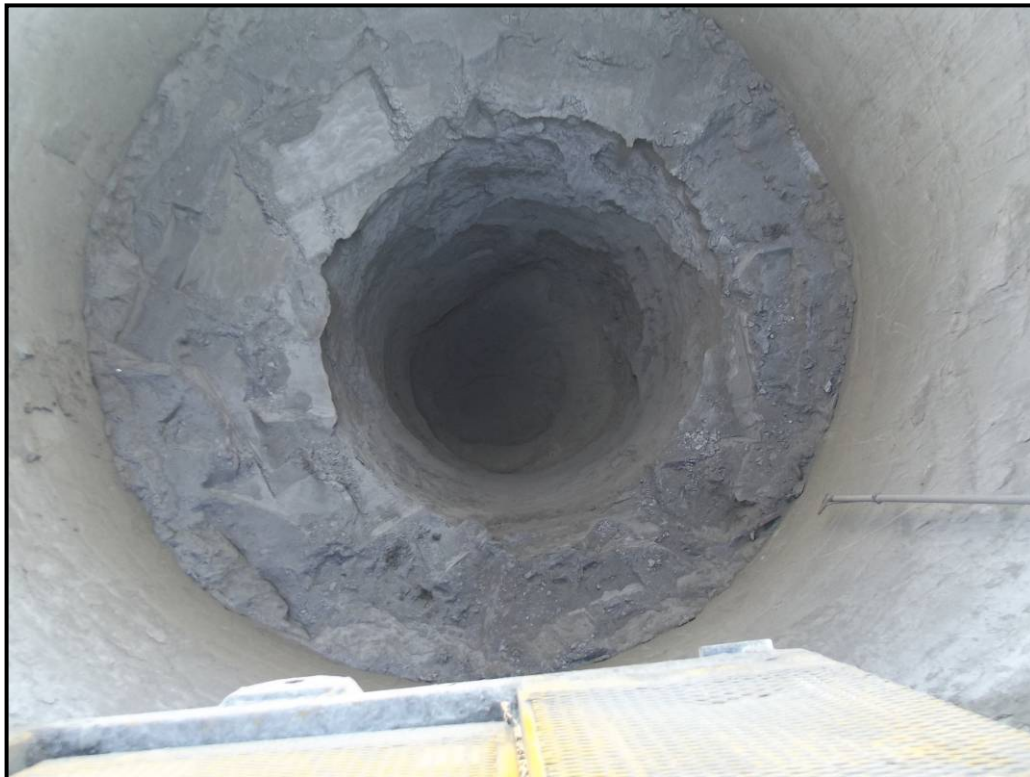
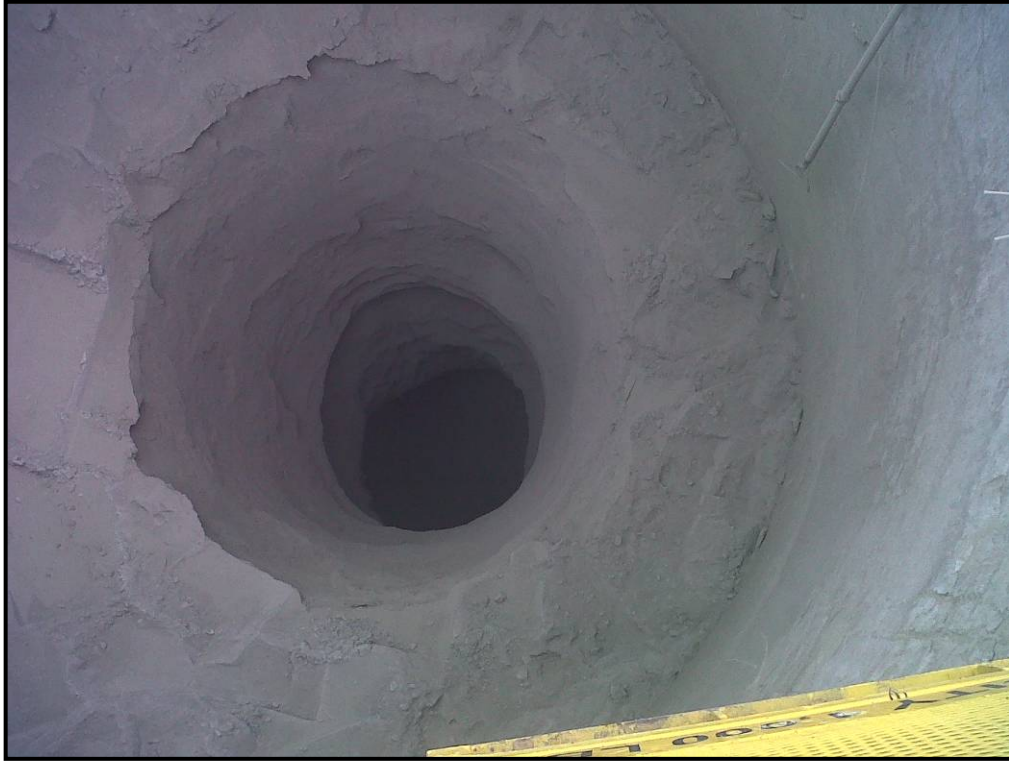
The silo was designed with a funnel flow hopper. However, over time, cement powder built up inside and formed a rathole or donut, which decreased the live storage capacity of the silo (figure 4, photos 12-13). When stored cement powder bridges over a rathole or donut and then suddenly collapses into the flow channel, it can cause large suction loads on the silo roof, depending on the amount of collapsing stored material above the flow restriction. Collapsing material caused a piston effect where high overpressures could occur in the lower part of the silo and suction could occur in the upper part. Flow-induced silo vibrations could cause significant dynamic loads. Several workers reported feeling vibrations on the roof of Silo 12.

Photo 12 – Stable rathole revealed as Silo 12 was drawn down.  
Picture taken on September 11, 2012.

Photo 13 – Stable rathole as Silo 12 was drawn down. Picture taken on September 14, 2012. The flow channel tended toward the east wall.

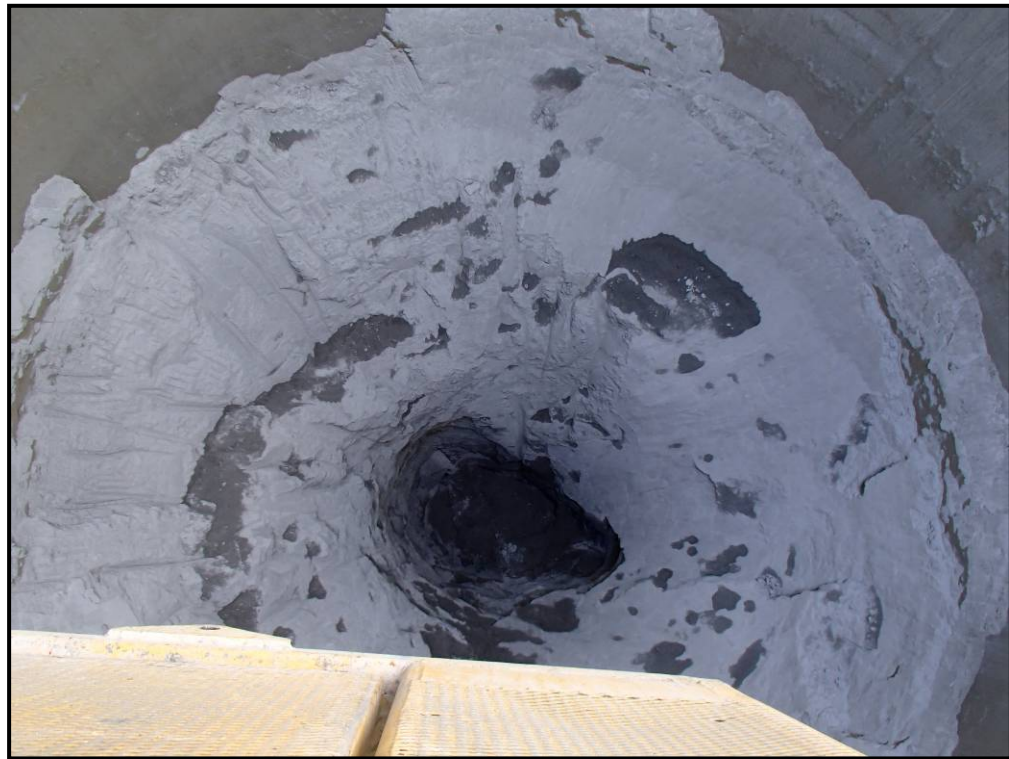
Photo14 – Bottom of rathole as of October 11, 2012, as the hardened material was removed.

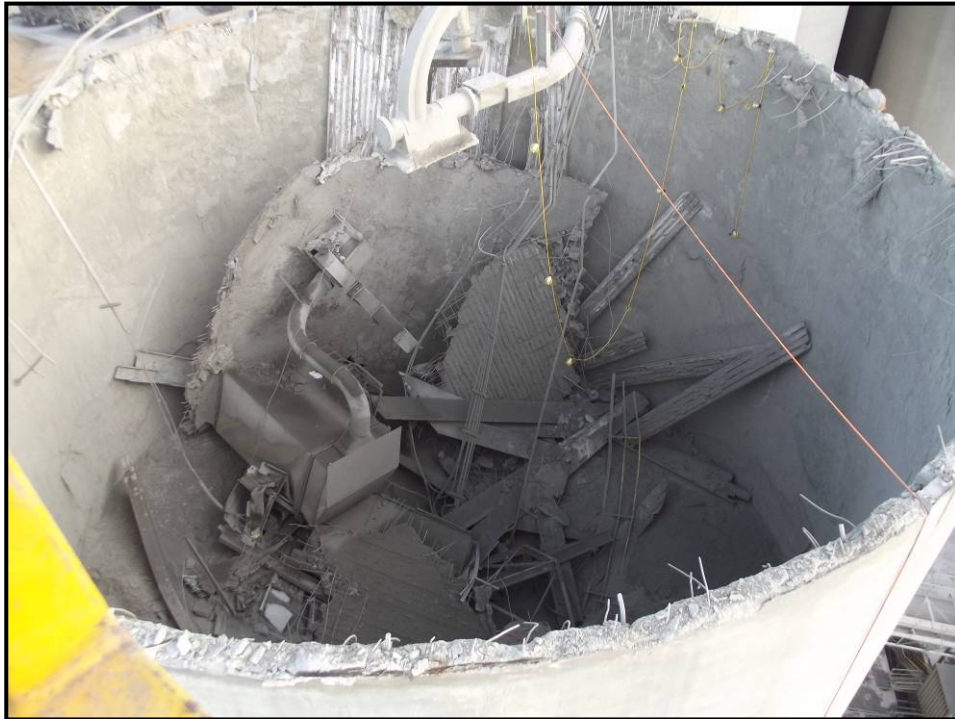
Photo 16 – Looking toward north wall. Photo taken 1 day after Silo 12 collapse. Large slab section still attached to the dust collector would have spanned from Beam 3 to the north wall.

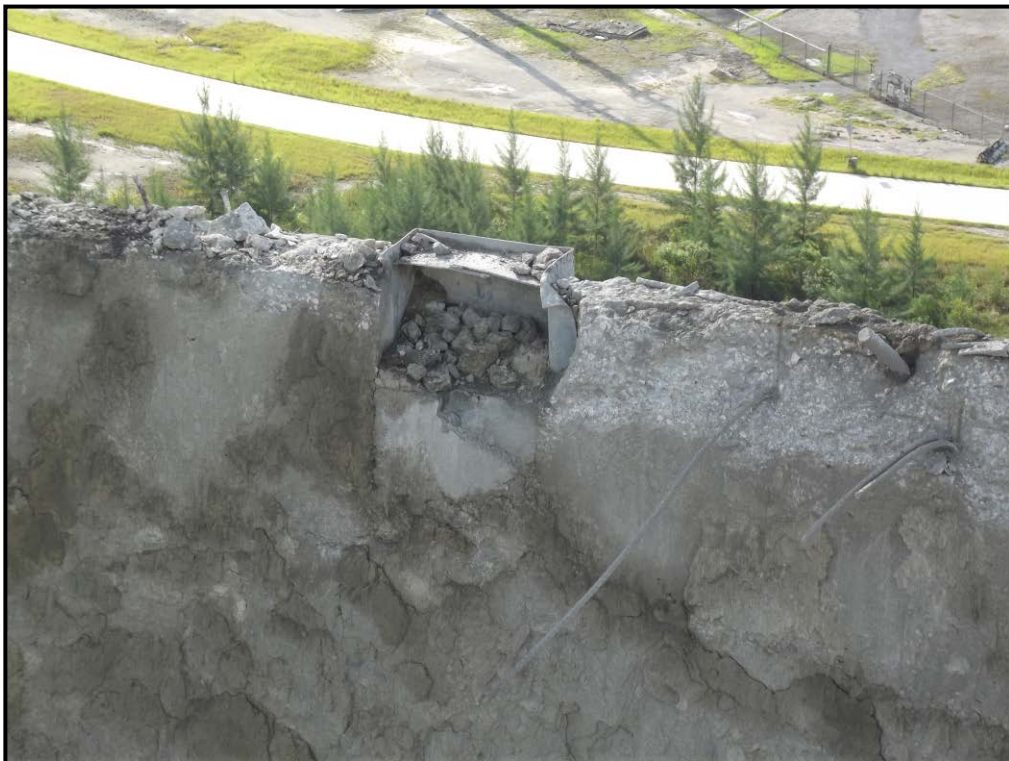
Photo 18 – East 1 pocket of Silo 12 was intact, but near surface delamination detected in 10 inch-thick grout layer.

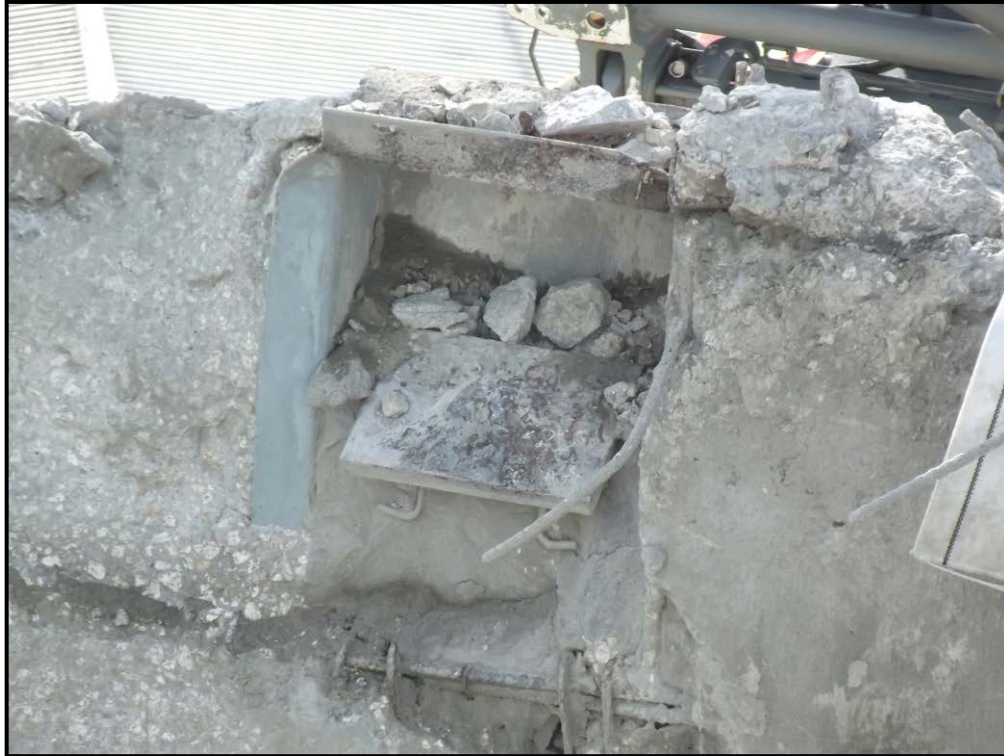
Photo 19 – At East 2 pocket of Silo 12, the grout sheared below the front half of the bearing plate and it tilted downward. Note honeycombed concrete void below the exposed shear stirrups.

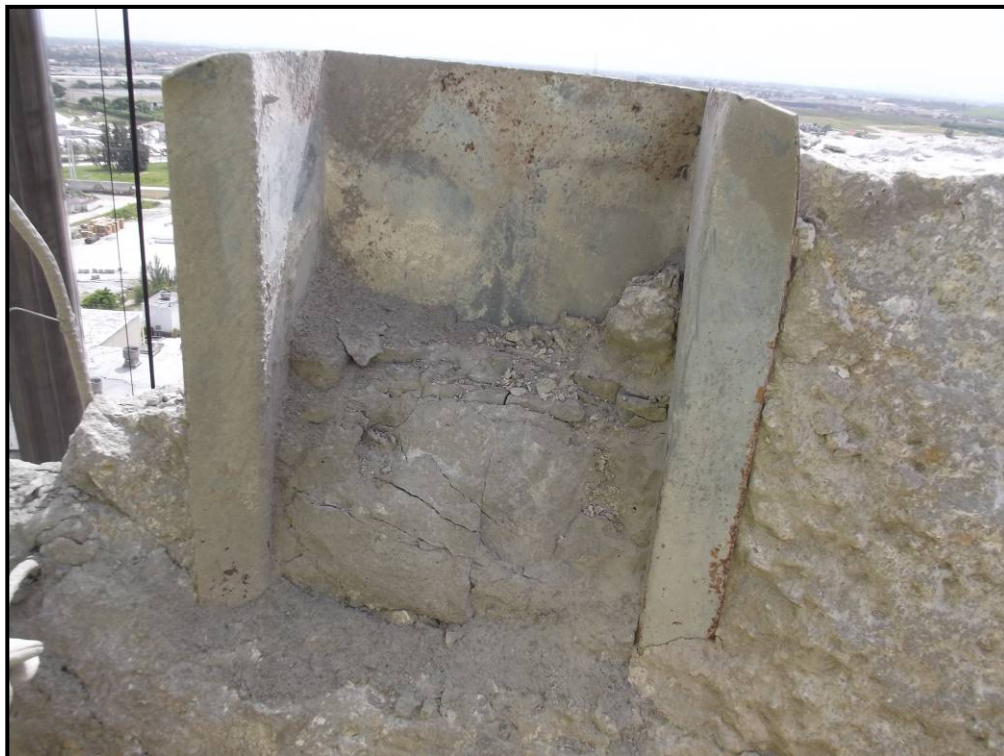
Photo 20 – Grout delaminated and sheared off at Silo 12 East 3 pocket. Multiple cracks present in 11 inch-thick grout layer.

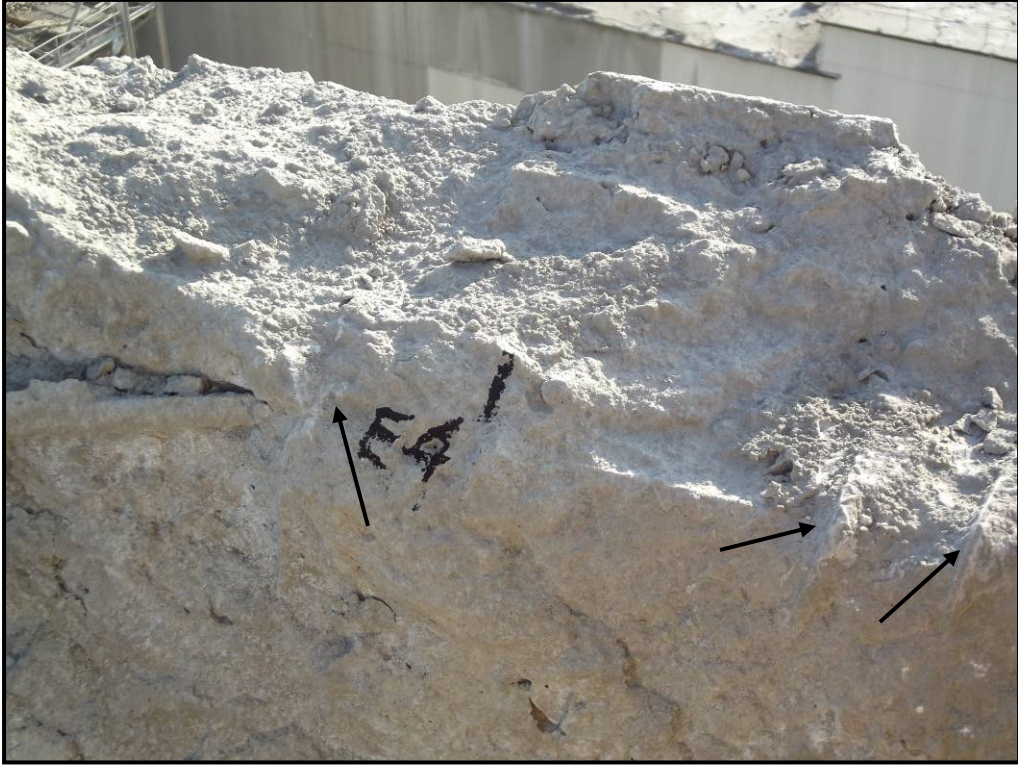
Photo 21 – Silo 12 East 4 pocket completely torn from silo wall above the location of the shear stirrups (arrows)

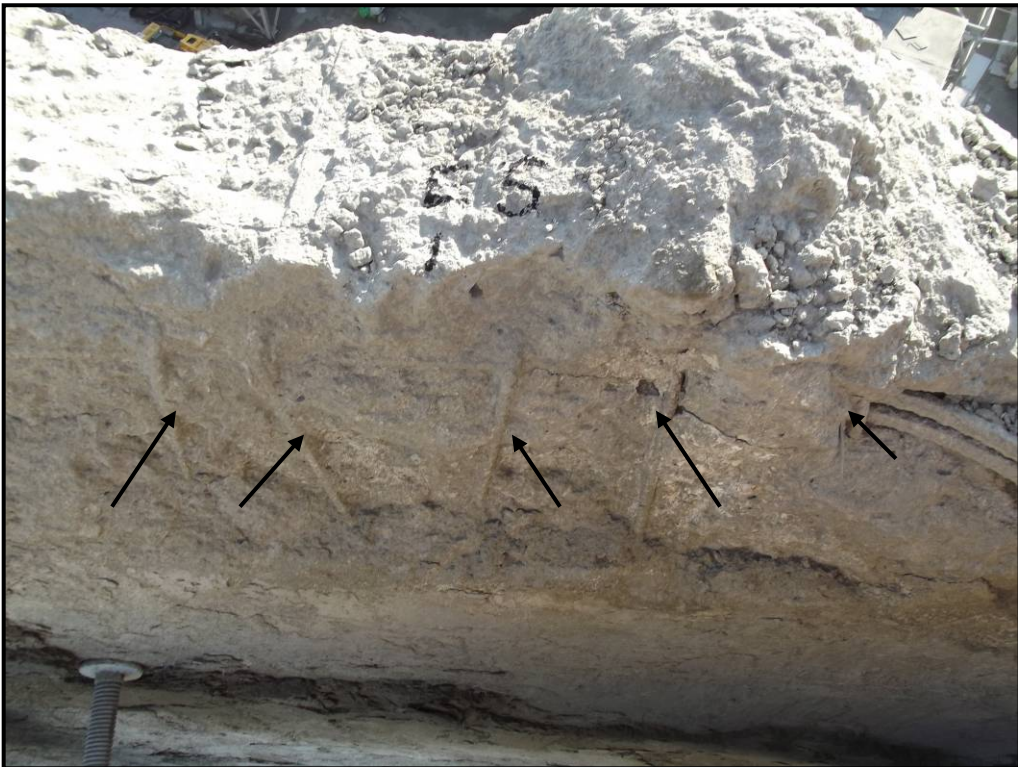
Photo 22 – Silo 12 East 5 pocket completely torn from silo wall above the location of the shear stirrups (arrows)

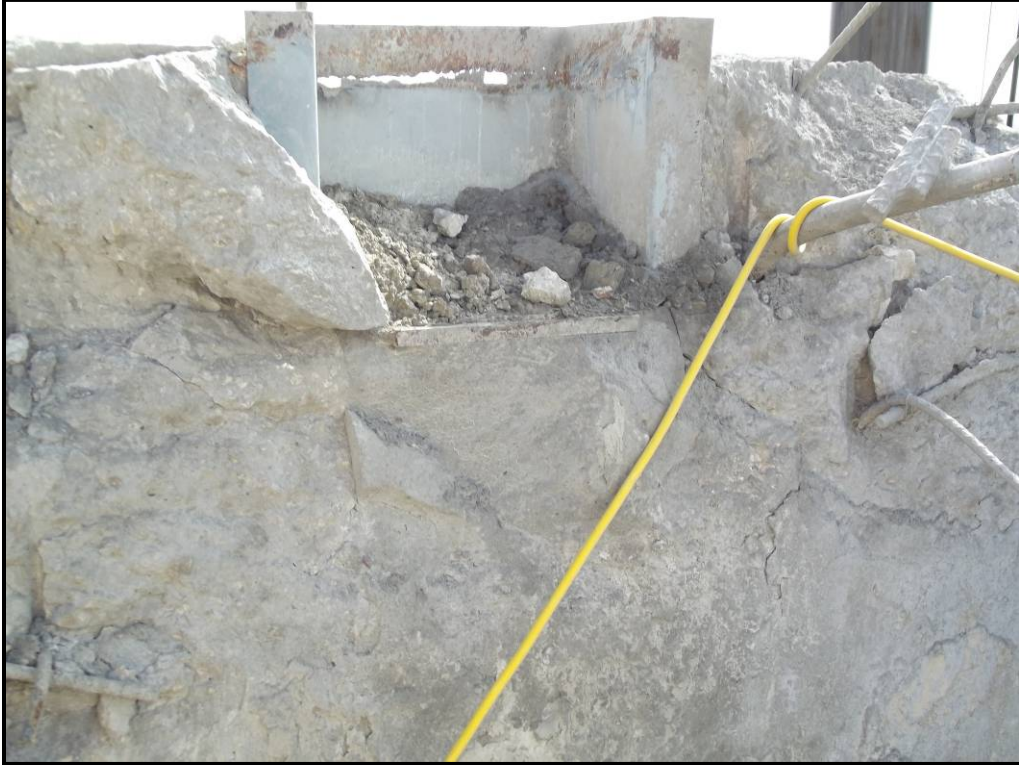
Photo 23 – Silo 12 East 6 pocket intact and no delamination detected in 10 inch-thick grout layer.

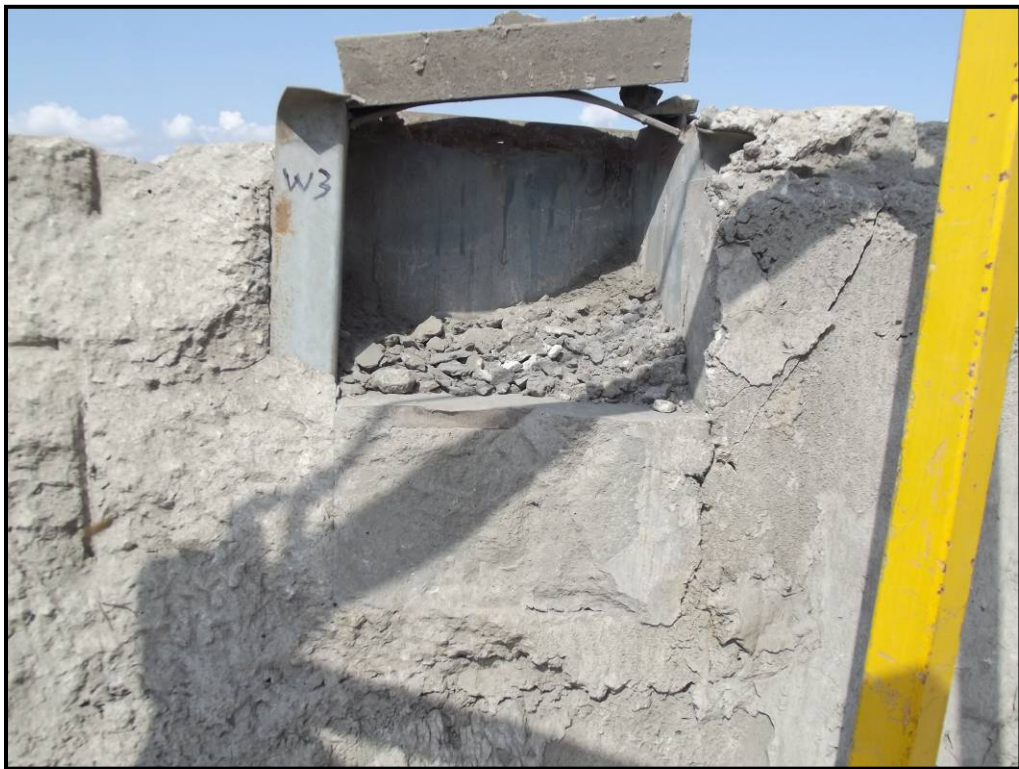
Photo 24 – Silo 12 West 3 pocket hidden delamination detected in 8.5 inch-thick grout layer.

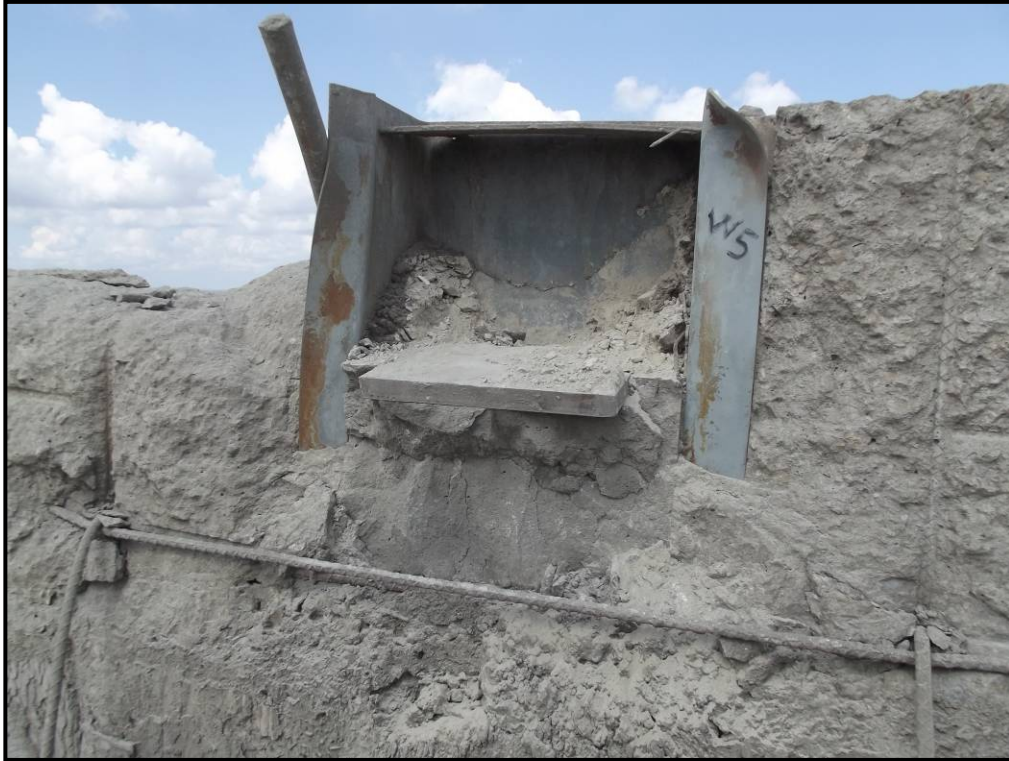
Photo 25 – Silo 12 West 5 pocket bearing plate tilted down and delamination detected in 9 inch layer of grout.

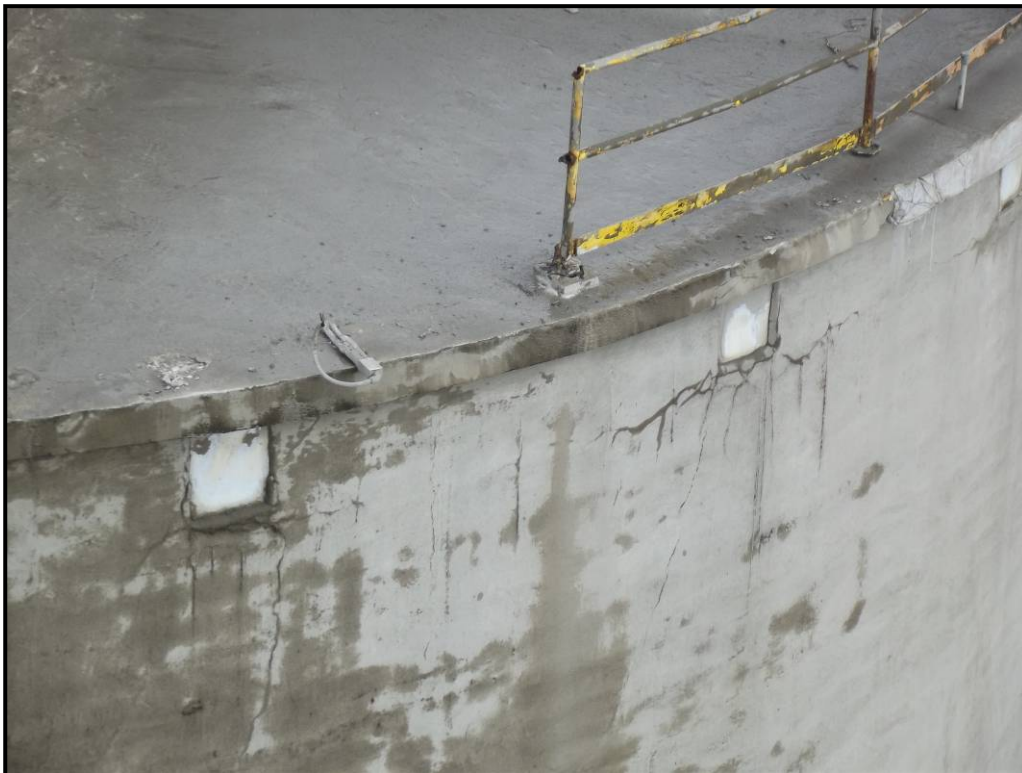
Photo 26 - Cracking at the beam pockets on the east side of Silo 11. This cracking was typical on all three silos.

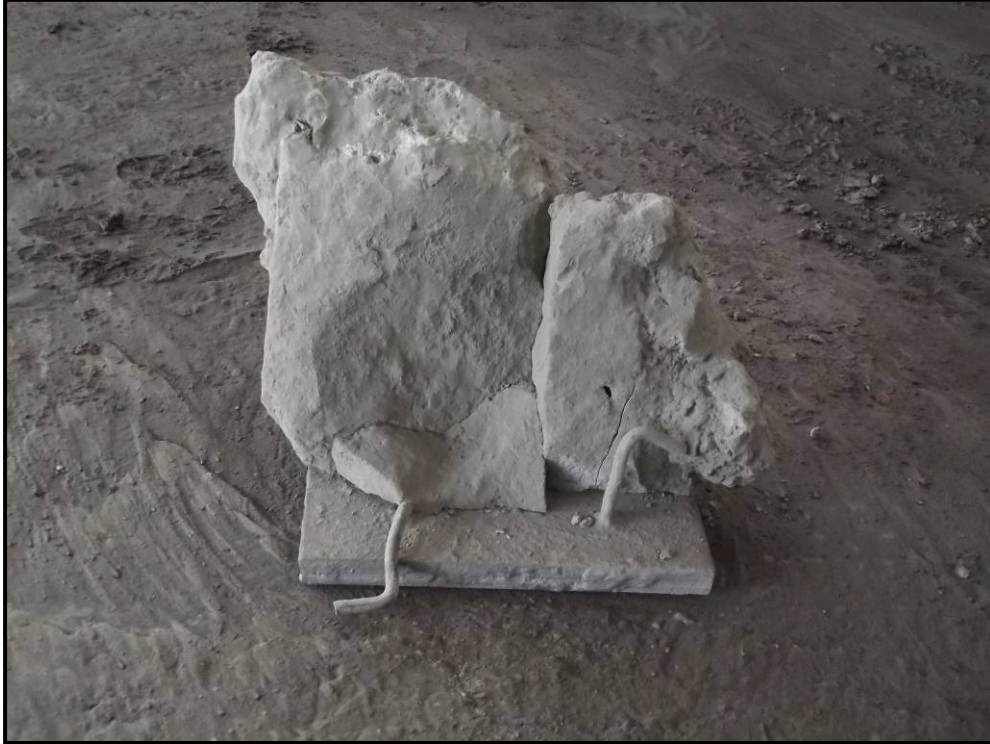
As the beams buckled, the end reactions on the beam pocket bearing plates increased when the load from one beam shed to adjacent beams. The flanges on the end channels were bent on at least one end of five of the six roof beams, indicating the beam ends were attempting to rotate prior to the final failure. Bending of the flanges applied point loading to the bearing plates. The buckling also likely caused an inward frictional drag force on the bearing plates, which was then transferred via the studs to the underlying unreinforced grout layer. Most of the beam pockets were found to be delaminated. The internal cracking from delamination reduced the shear resistance of the pocket by decreasing the length of the shear resistance path. In addition, as a result of a construction defect, the shear stirrups in the wall were placed too far away from the bearing plates, since the as-constructed thickness of the grout was much greater (11 inches instead of 1.5 inches) than shown on the engineering drawings. The delamination and the lack of shear stirrups within the shear plane of the pockets allowed at least two of the pockets, E2 and E3, to fail in shear and the bearing plate on W5 tilted down. When the east side pockets failed, the reinforced concrete slab could not support itself and the roof slab collapsed.

Photo 27 – Chunk of grout and bearing plate that sheared off. This plate was from either East 3, East 4, or East 5 pocket.

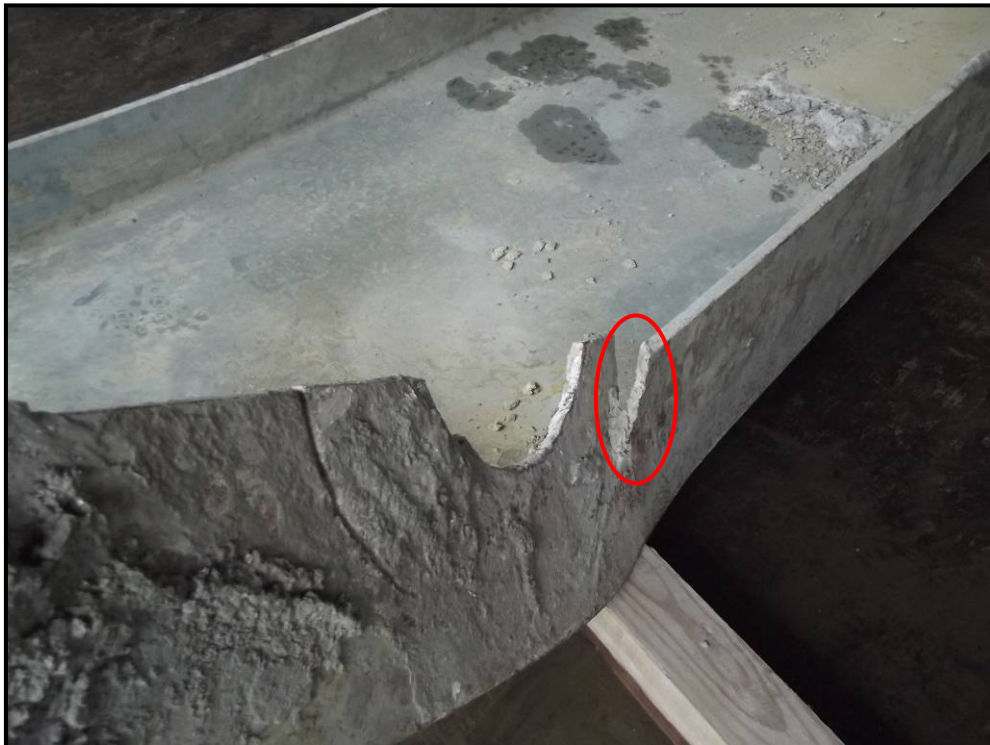
Post collapse investigation of the condition of identical Silos 10 and 11 found several roof beams buckled and detached from the roof slab. In addition, hardened cement was found on the top flanges of Silo 12 beam numbers 1, 2, 3, 4, and 6 near the buckled areas, indicating these beams were most likely buckled to some extent prior to the day of the collapse. A deflected buckled beam was unable to carry as much of the load as it did prior to the buckle, particularly if the buckle was severe enough to lose contact with the roof slab.

Photo 28 – Cut top flange of roof Beam 3 of Silo 12. Hardened concrete on flange and in the (circled) cut line indicate the beam had been buckled for some time prior to the day of collapse. Cut was likely made when the radio transmitter level indicator was installed circa 2004.

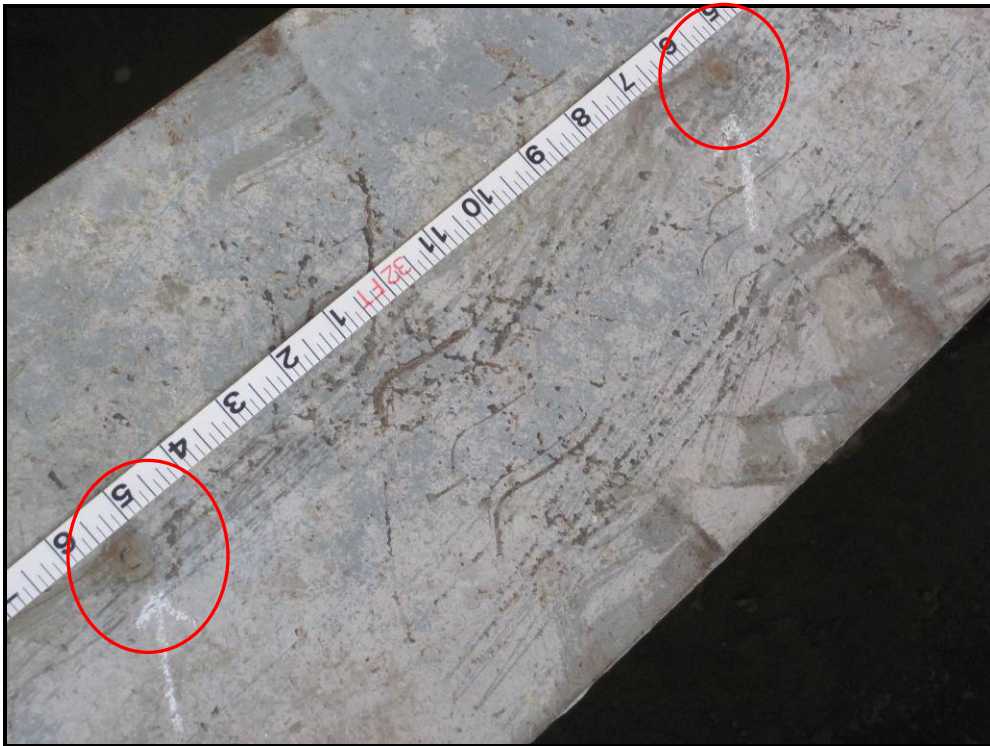
Although the original contractor generally provided the roof deck puddle welds on 12-inch centers, many of the welds were not of good quality. Specifically, while the weld metal was deposited on the top flange of the beam, the weld material had porosity and did not fuse with the steel in the beam in many instances. In some cases, it appeared that the burn holes in the decking did not penetrate both layers of decking. Therefore, the decking was not adequately attached at these areas. Both downward loading and previous instances of over pressurizing the silo (upward loading), likely caused the puddle weld connections to fail either through the weld, at the base of the weld, or through the decking material surrounding the weld. Aside from overload of the welded connections, fatigue (suction and rebound vibration loadings during flow) may have also contributed to some of the connection failures of the decking to the beams. Once the welded connections were lost, the beams were then not adequately braced to prevent lateral torsional buckling from downward loading, which likely occurred prior to the day of the collapse. Also, as mentioned above, if the welds were able to transmit the tension from the underside of the slab to the beams during an overpressure event, then the bottom flanges of the beams would be in compression. Since the bottom flanges were un-braced, the beams could fail in lateral torsional buckling, even from this upward direction of loading.

Photo 30 - Two faint markings where puddle welds did not adequately bond to the top flange of Beam 2 approximately 32 feet from the west end of the beam.

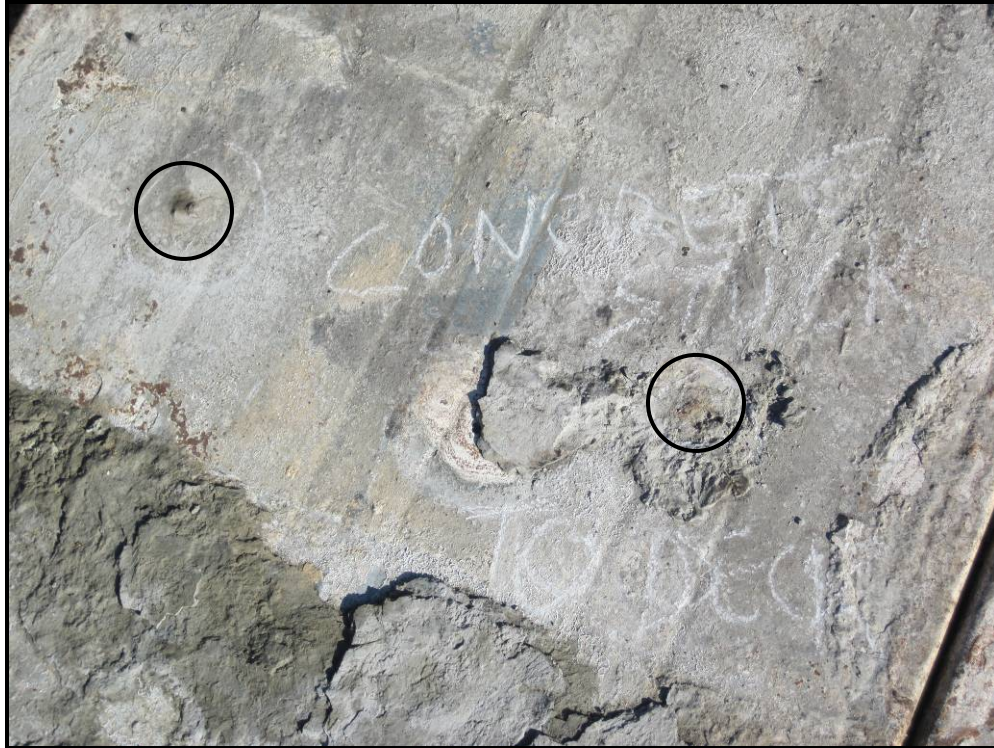
Photo 31 – Example of two puddle welds (circled) on the underside of the deck. The old residual hardened concrete next to the right weld indicates the weld had failed well before the collapse.
