REPORT OF INVESTIGATION

Surface Nonmetal Mine  
(Hydraulic Cement)

Fatal Falling Material Accident  
August 17, 2012

Tarmac America, LLC  
PENNSUCO Cement Plant  
Medley, Miami-Dade County, Florida  
Mine ID No. 08-00051

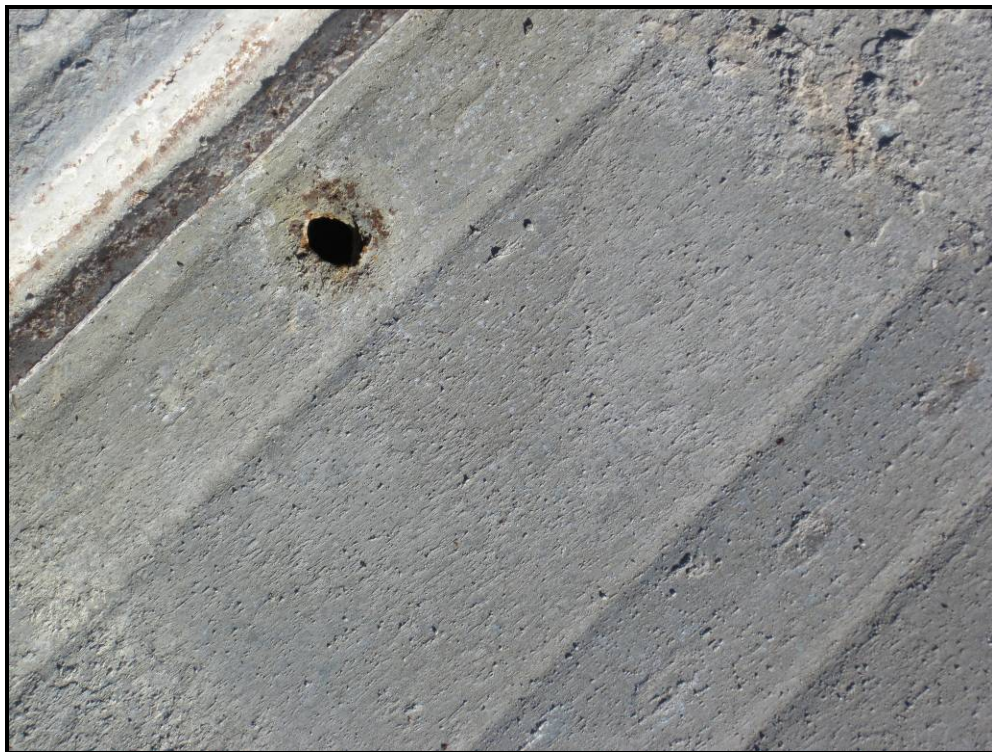
Photo 32 – Example of a decking failure around the weld. The decking was significantly corroded around the weld suggesting the failure had occurred prior to the day of the collapse. The decking metal will fail first when the weld is larger and stronger than the decking.

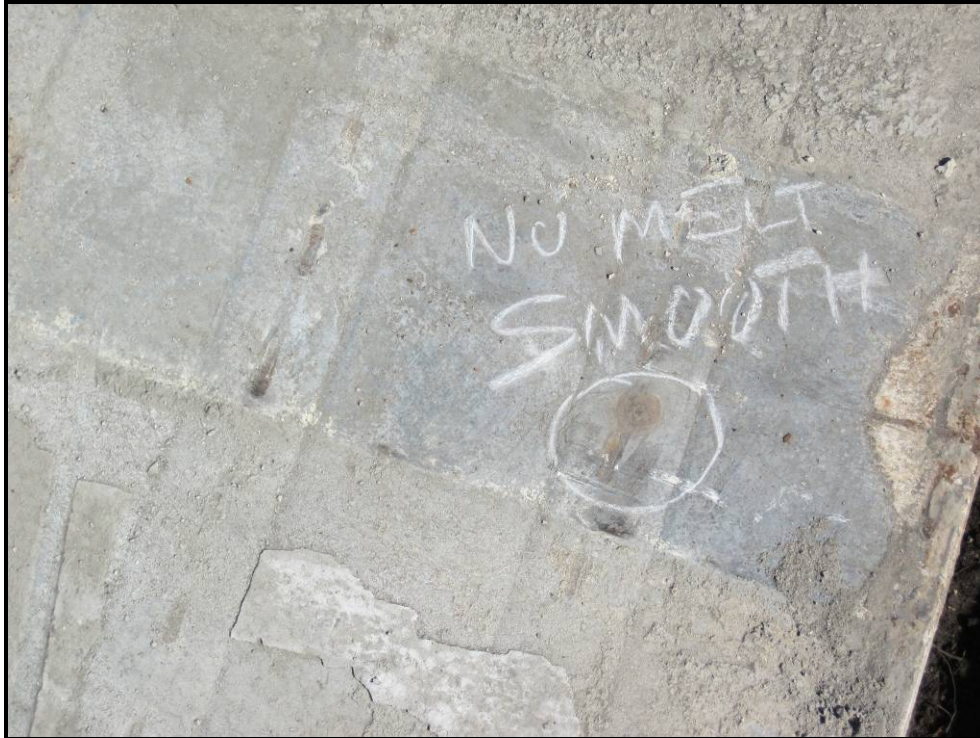
Photo 33 – Location where puddle weld did not penetrate the bottom plate of the roof deck.

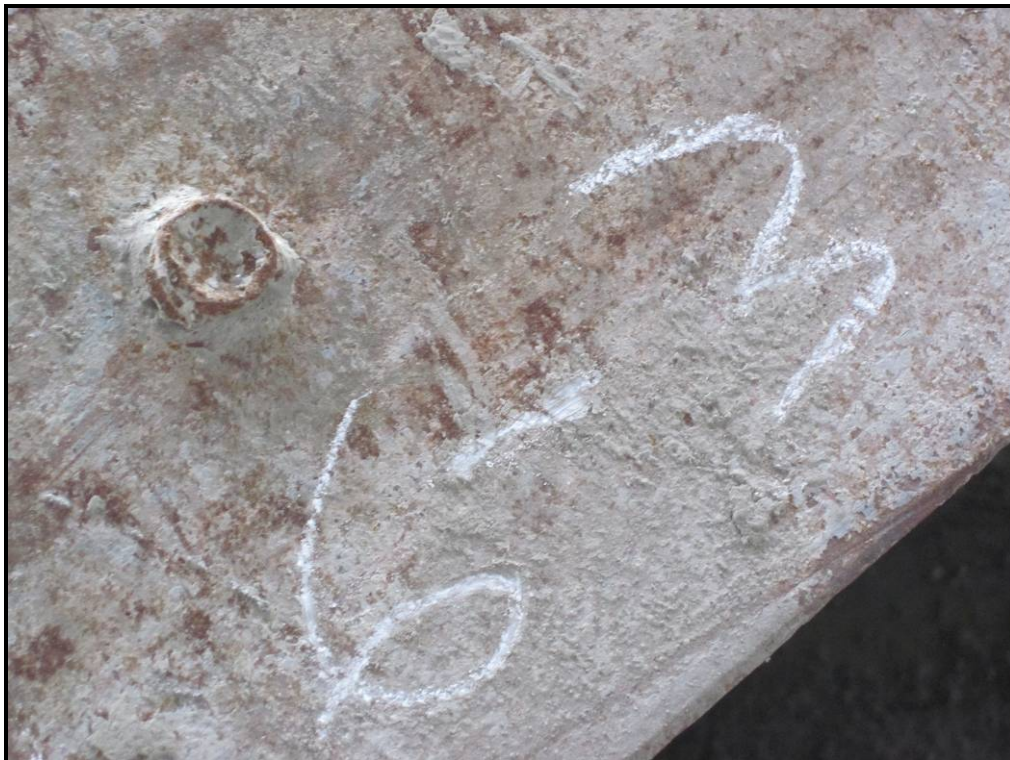
Photo 34 – Puddle weld failure on Beam 6 with a dished top surface. Weld was corroded, indicating that it had likely failed long before the day of the collapse.

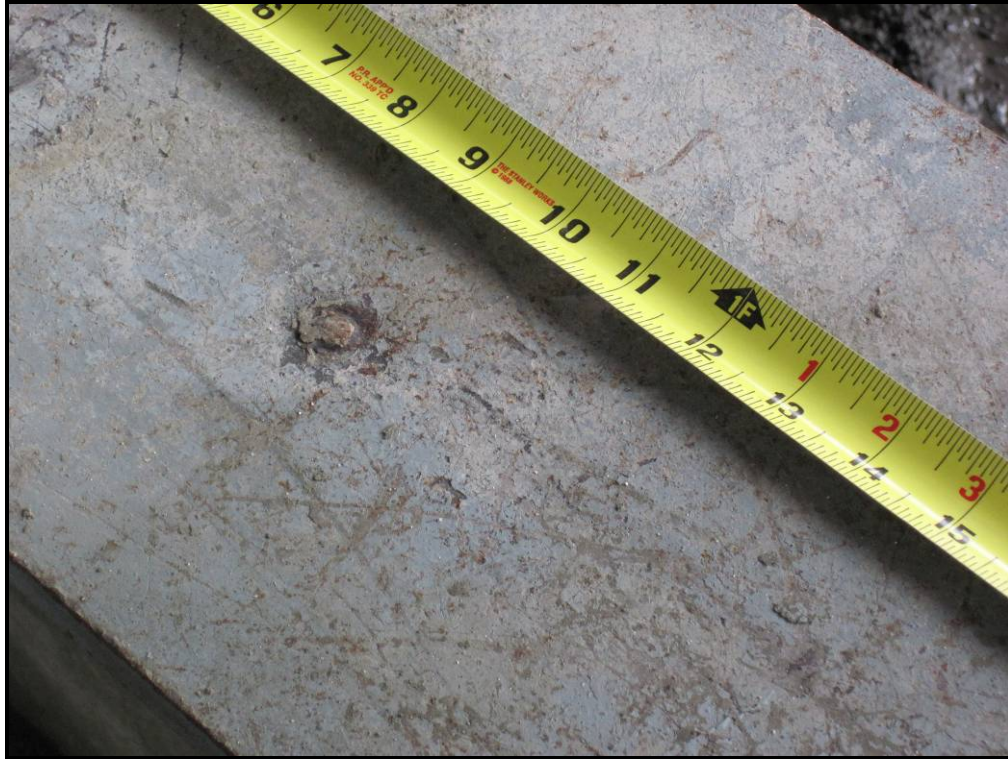
Photo 35 – Puddle weld with rubbed smooth failure surface on the top flange of Beam 5.

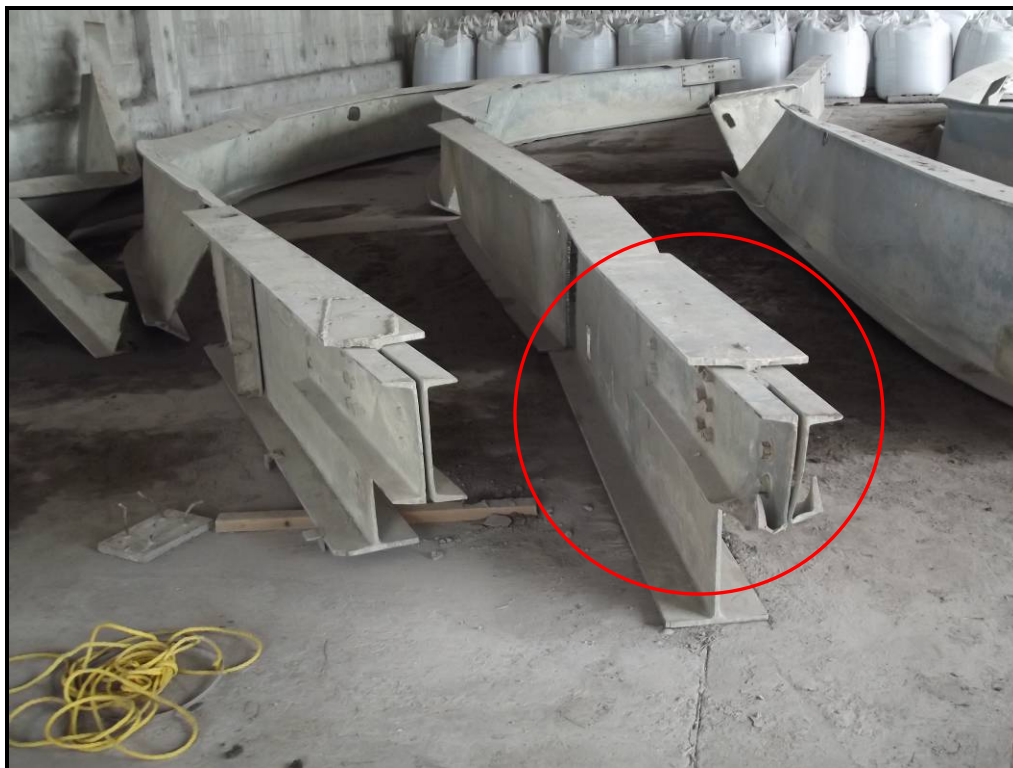
Photo 36 – Buckled webs on Beam 4's east side back-to-back end bearing channels.

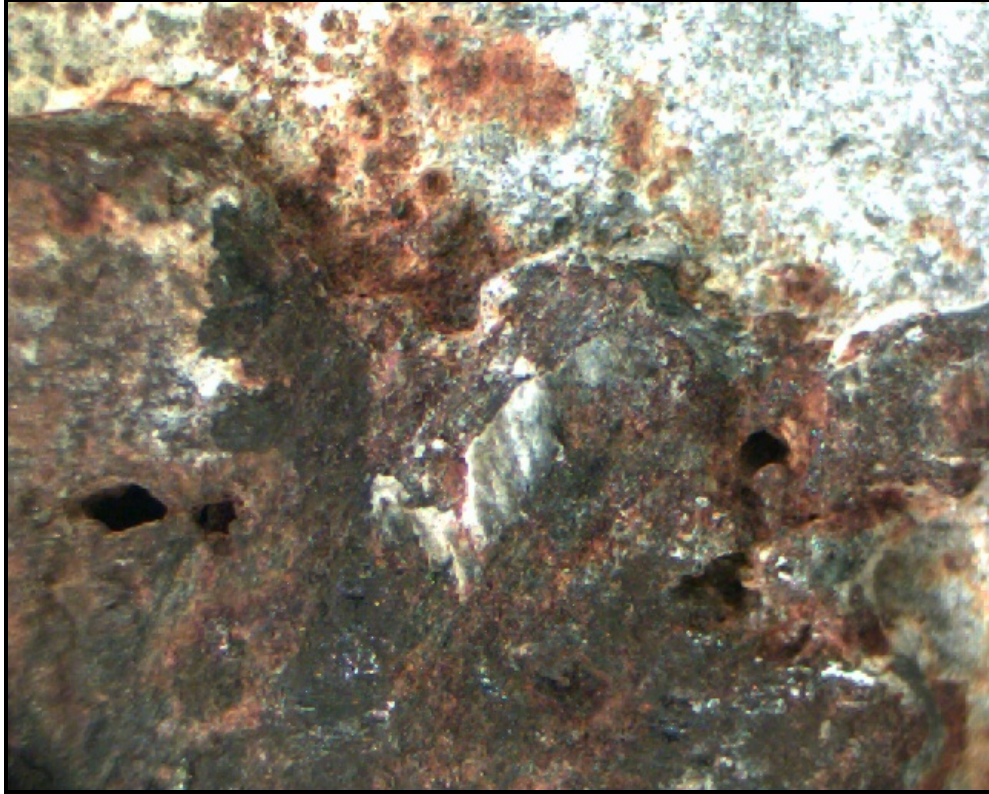
Photo 37 – Porosity and old corrosion on the failure surface of puddle weld M1. The weld was still attached to the underside of the metal decking.

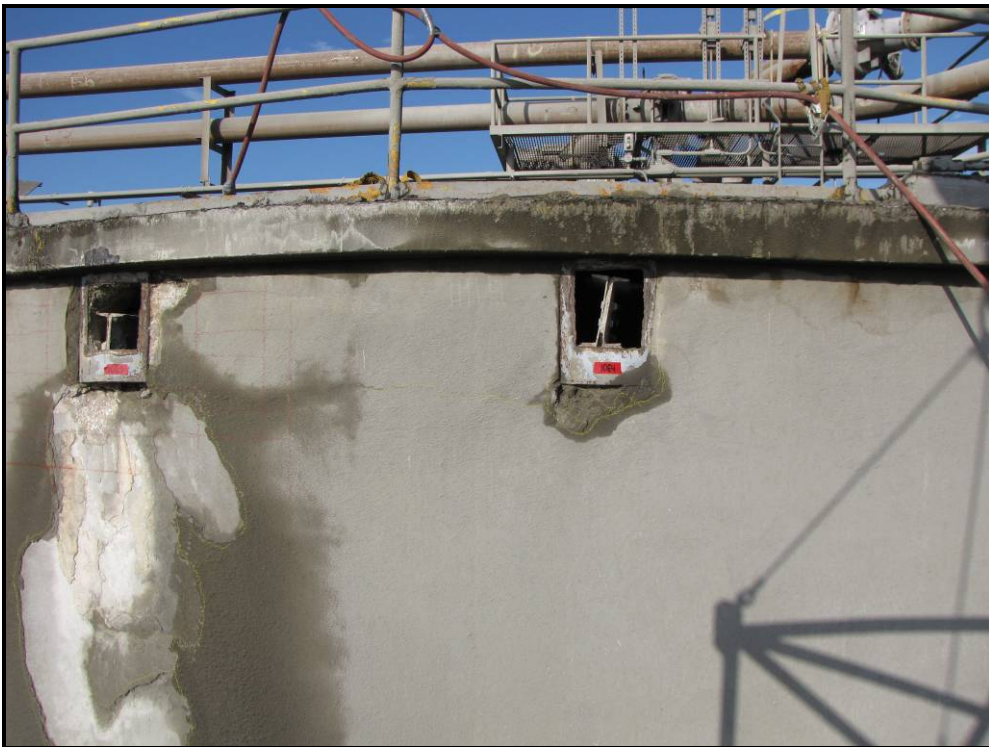
Photo 38 – Silo 10 beam pockets E3 (left) and E4 (right). Neither Beam 3 nor 4 was in contact with the roof. Beam 4 is also significantly rotated.

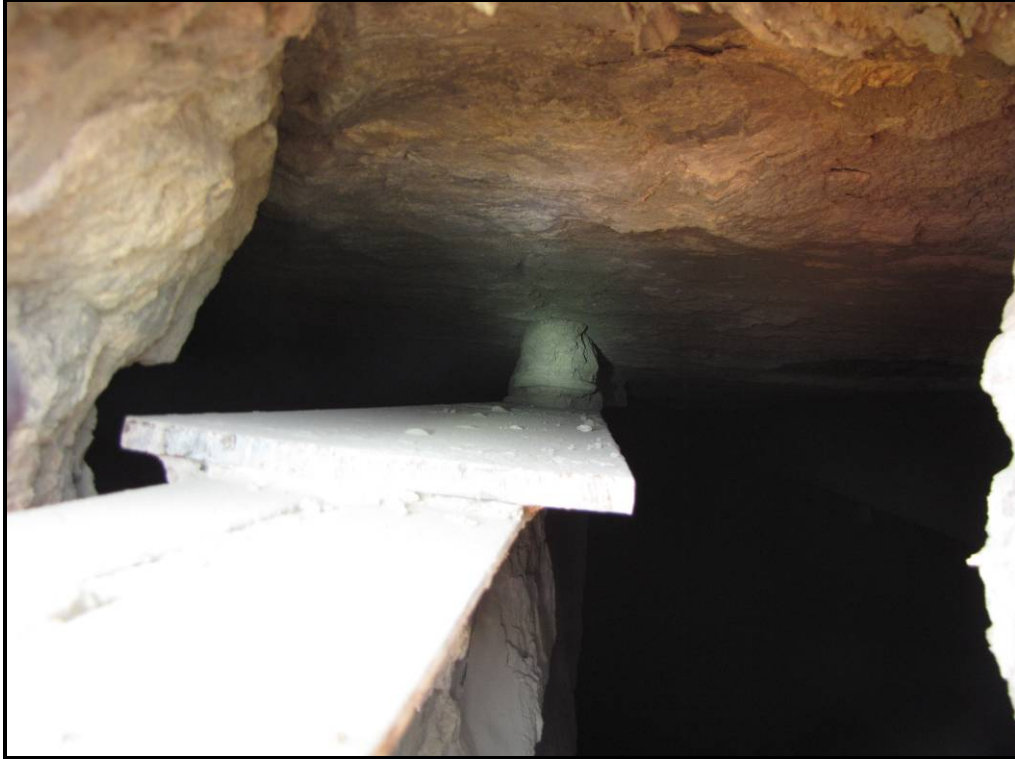
Photo 39 - View looking in East 3 pocket of Silo 10 at separation between Beam 3 and the underside of the roof slab.

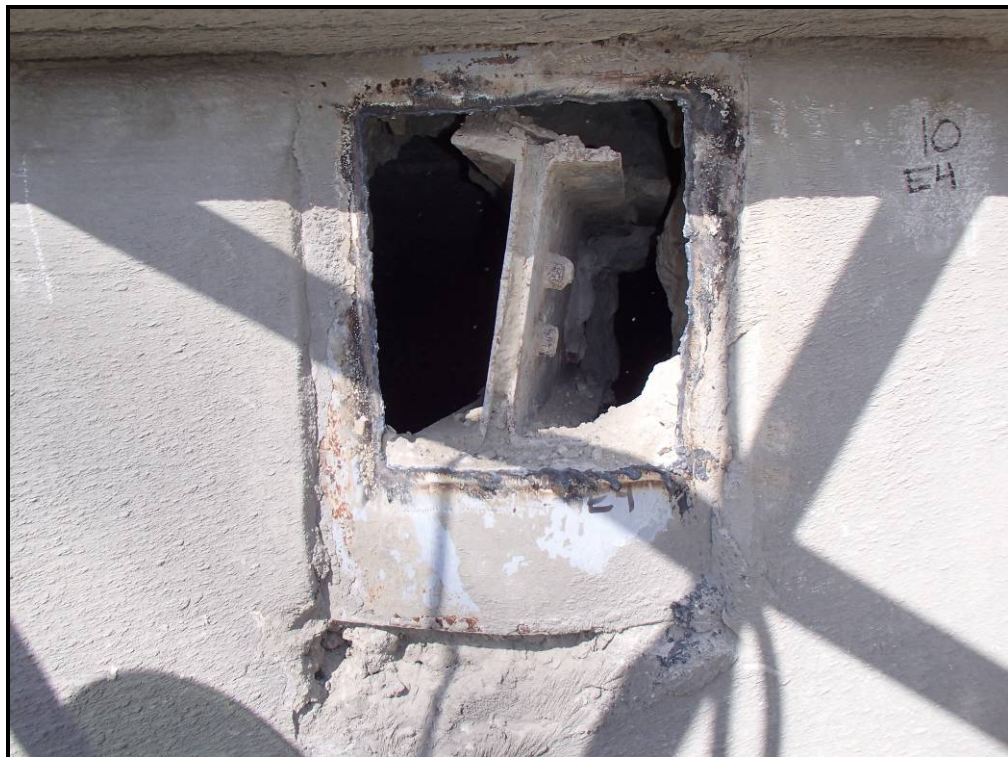
Photo 40 – At East 4 pocket of Silo 10, Beam 4 is rotated and separated from the roof slab by approximately 5 inches.

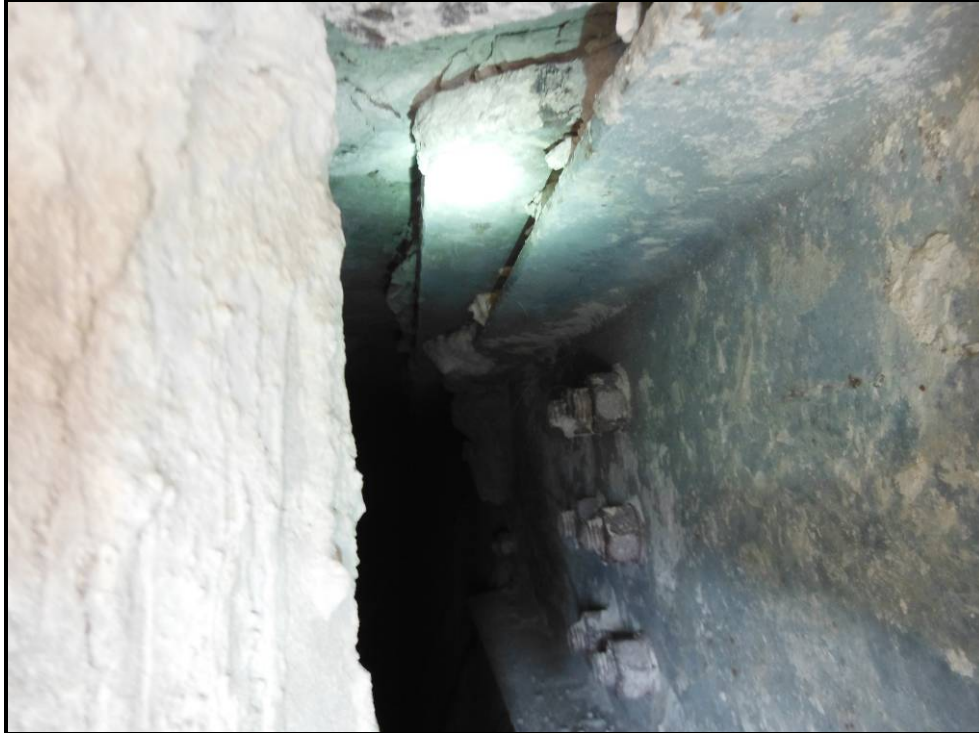
Photo 41 – View in East 2 pocket of Silo 11. Beam 2 has a rotated top flange that is separated from the underside of the roof decking by approximately 1 inch.

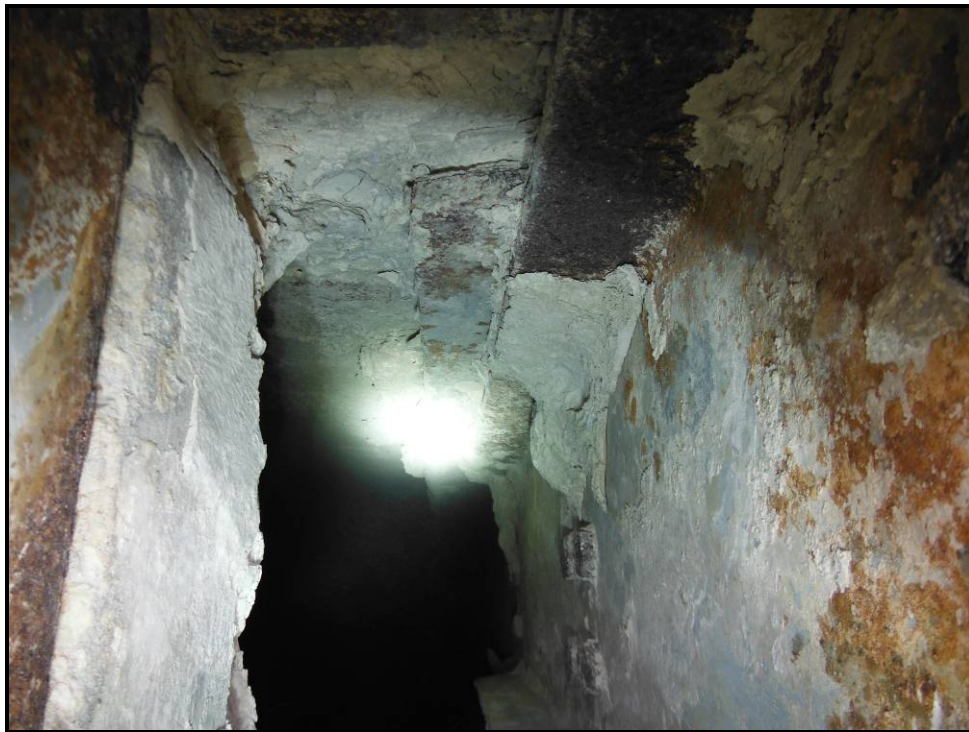
Photo 42 – View in East 3 pocket of Silo 11. Beam 3 is rotated south and slightly separated from the underside of the roof slab.

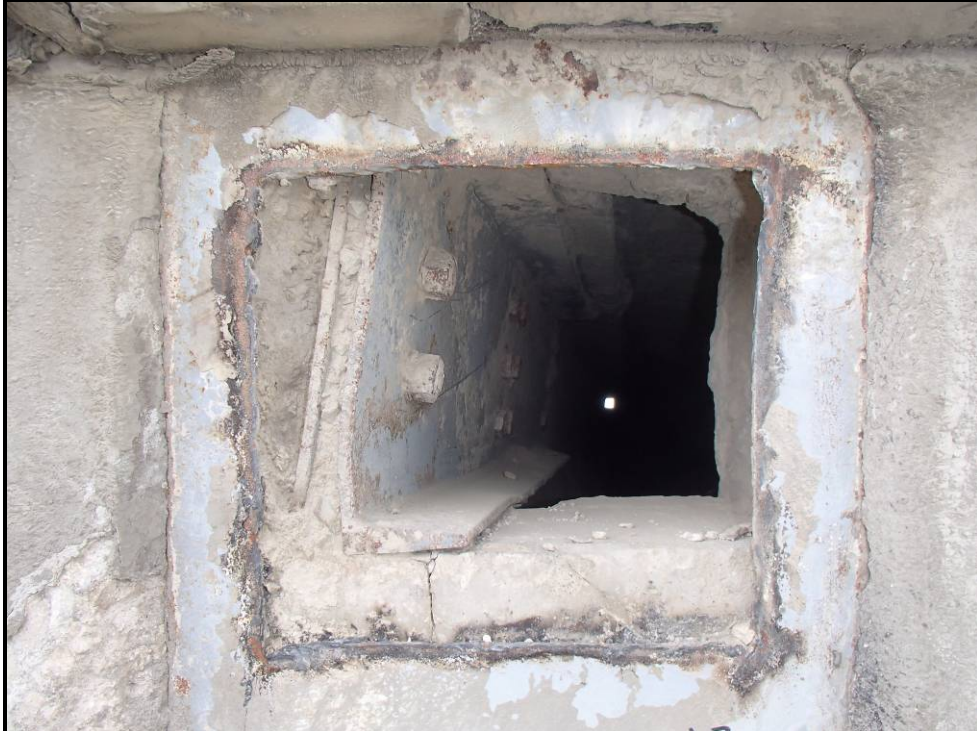
Photo 43 – Rotation of the end channels and roof Beam 3 along with cracking of the grout pad at the West 3 pocket of Silo 11

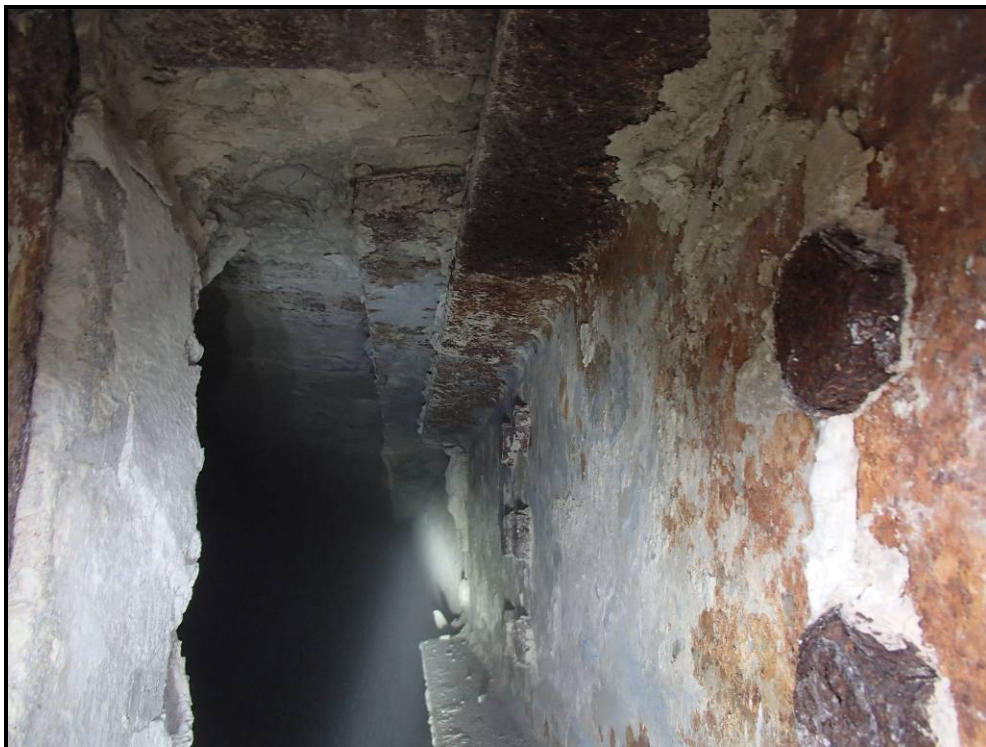
Photo 44 – Looking in East 4 pocket of Silo 11. Beam 4 is rotated to the left out beyond the end channel. A small gap existed between the top flange and the underside of the roof slab.

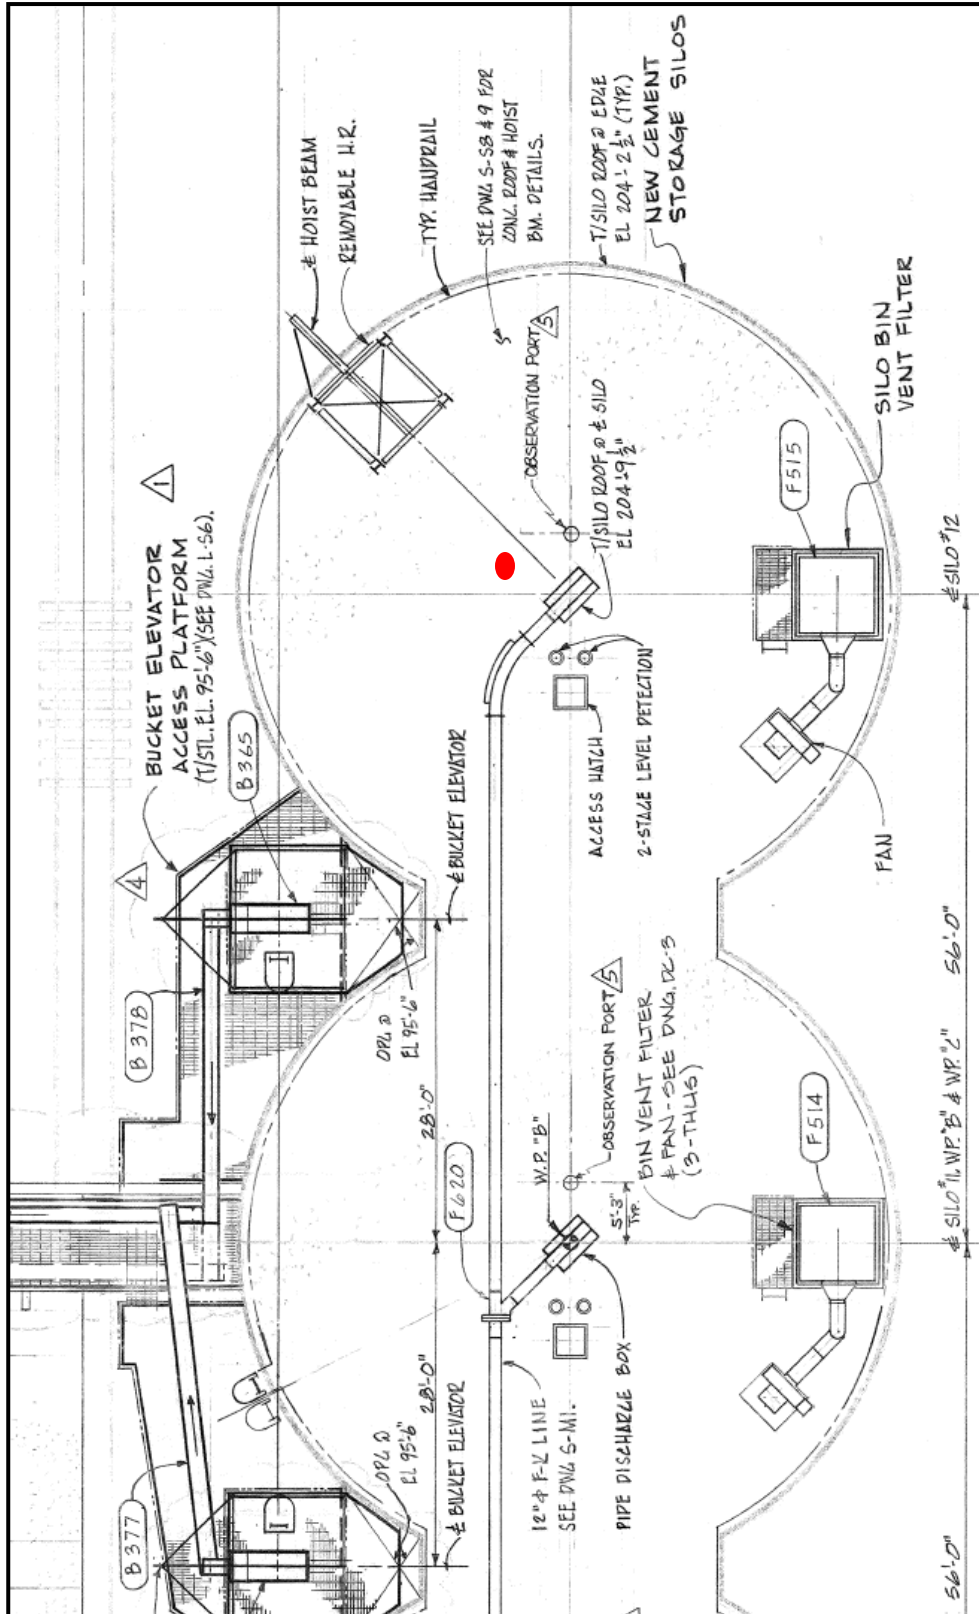
Figure 3 – R. S. Fling drawing with layout of roof ports on Silos 11 and 12. Solid circle is the location of added penetration on Silo 12 (circa 2004) for the radio transmitter level indicator.
