UNITED STATES
DEPARTMENT OF LABOR
MINE SAFETY AND HEALTH ADMINISTRATION
METAL AND NONMETAL MINE SAFETY AND HEALTH
REPORT OF INVESTIGATION

Surface Metal Mine
(Copper)

Fatal Fall of Person Accident
September 22, 2012

BHP Copper Inc.
Pinto Valley Operations
Miami, Gila County, Arizona
Mine I.D. No. 02-01049

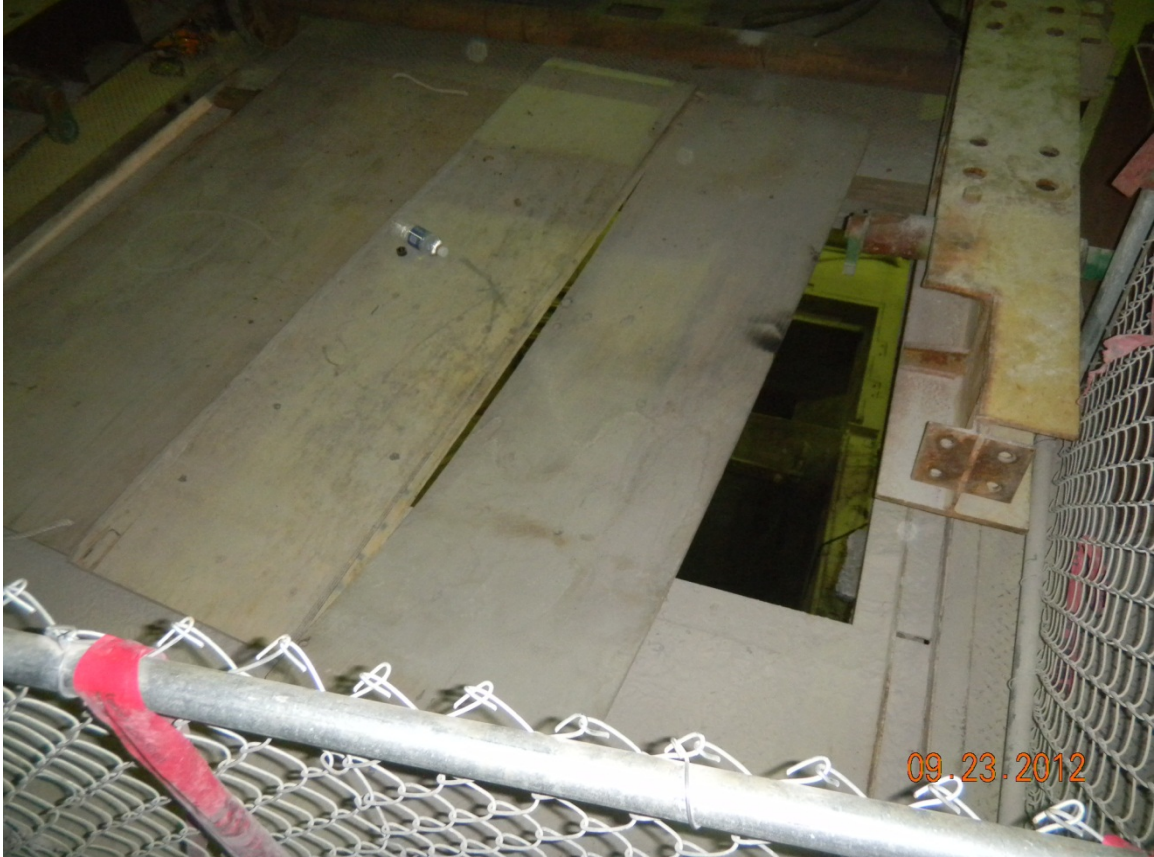
(Note: Boards added and fence moved after accident.)

The accident occurred near the No. 8 chute on the 4th floor of the secondary crusher building at the mill. This area was located 30 feet above the fall location and about 15 feet from the victim's assigned work area. Three pieces of ¾-inch plywood and three standard 2-inch by 4-inch by 102-inch long boards were covering a 6-foot by 8-foot hole where a spiling screen had been removed in February 2012. The screen was taken to another section of the mine and repaired for a future installation. The equipment in the secondary crusher building was being reconditioned. Numerous construction crews were working in this building conducting various tasks on multiple floors.

Root Cause: Mine and contract management failed to ensure the work platform covering the hole where the victim fell was of substantial construction, barricaded, and provided with warning signs to prevent a fall hazard to any person working in the secondary crusher building.

Corrective Action: Mine management instituted a policy of using engineered metal covers on all accessible open holes to prevent a future fall hazard to miners. An improved system is in place using signs and barricades to warn and prevent access to hazardous areas that are not immediately obvious to persons.
