REPORT OF INVESTIGATION

**Fatal Machinery Accident
September 26, 2012**

**Eagle Peak Rock and Paving
North Pit
Alturas, Modoc County, California
Mine ID No. 04-03367**

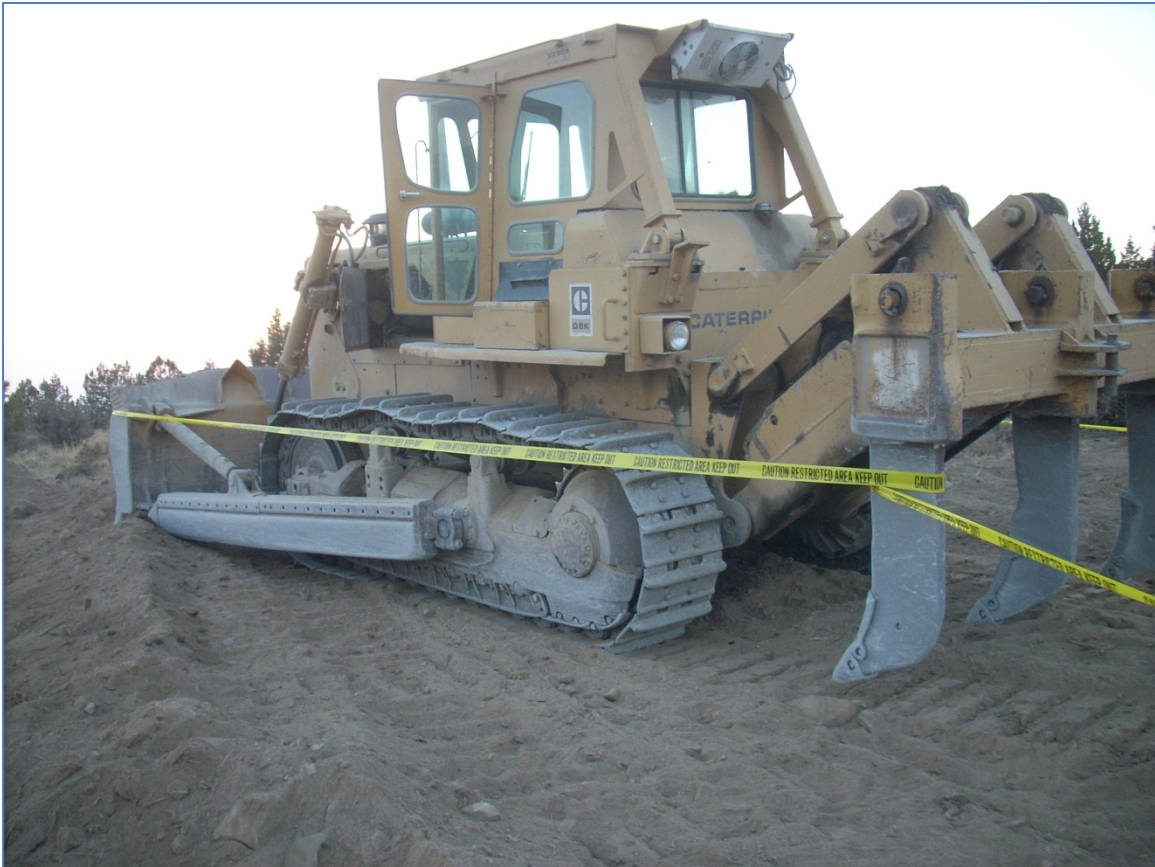
On September 26, 2012, Loren A. Bucher, Foreman, age 79, was killed when he was run over by the dozer he had been operating. Bucher exited the cab and was positioned on the left track checking the engine throttle linkage when the dozer moved forward. The dozer was parked on a 6% grade and left running in 1st gear forward with the dozer blade and ripper in the up position.

The investigators found that a connecting rod between the “hand-operated throttle lever” and the “governor control positioning mechanism” was broken. The break occurred at the threaded end of this rod where a clevis was threaded onto it. The clevis was attached to the bell crank arm of the “governor control positioning mechanism.”

The bell crank arm was found in the full throttle position, allowing spring force to pull the throttle linkage at the fuel injector pump into the “full throttle” position. The fracture surface was oxidized at the perimeter with a clean shiny final fracture surface near the center. An extra “non-factory” spring was attached to the throttle linkage that pulled in the same direction as the “factory” spring to pull the linkage into the full throttle position. A substantial amount of free-play was also present in the throttle linkage. The remainder of the throttle linkage was intact.

The investigators found the engine-side clevis of the repaired connecting rod had rubbed against the thru-hole in the firewall when the “hand-operated throttle lever” was placed in the “fuel off” position. Some of the metal in the thru-hole opening was worn away where the rubbing occurred, indicating the condition existed for some time. Also, the throttle linkage needed adjusted because the hand operated throttle lever had to be pulled toward the operator until it was nearly horizontal to obtain full throttle. The service manual for the dozer indicated the handle should be close to a 45 degree angle at full throttle.

Corrective Action: Management provided additional training to persons regarding the proper procedures to follow to ensure that equipment is blocked against hazardous motion before maintenance is performed.
