REPORT OF INVESTIGATION

**Surface Nonmetal Mine
(Common Shale)**

**Fatal Machinery Accident
November 1, 2012**

**Northeast Solite Corporation
Mt. Marion Pit and Mill
Saugerties, Ulster County, New York
ID No. 30-00287**

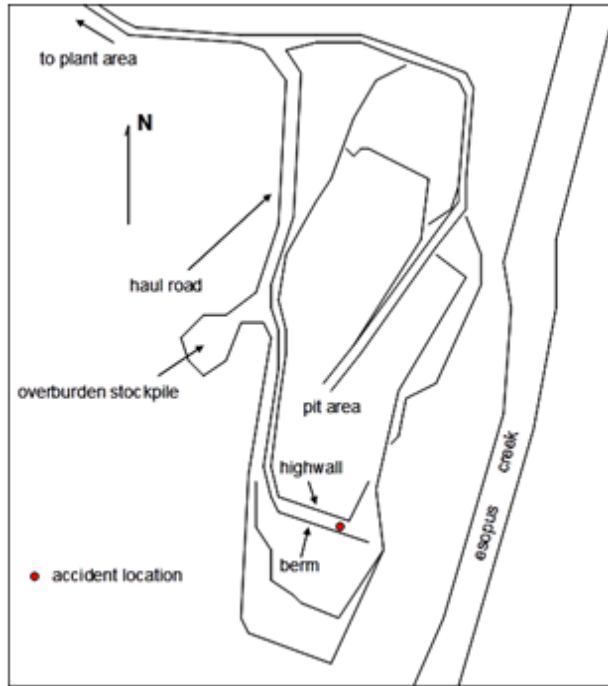
Figure 1 – Schematic of Quarry Showing Location of Accident (not to scale)

The accident occurred at the 2nd level of the Southeast side of the quarry. The accident location was relatively level and solid.

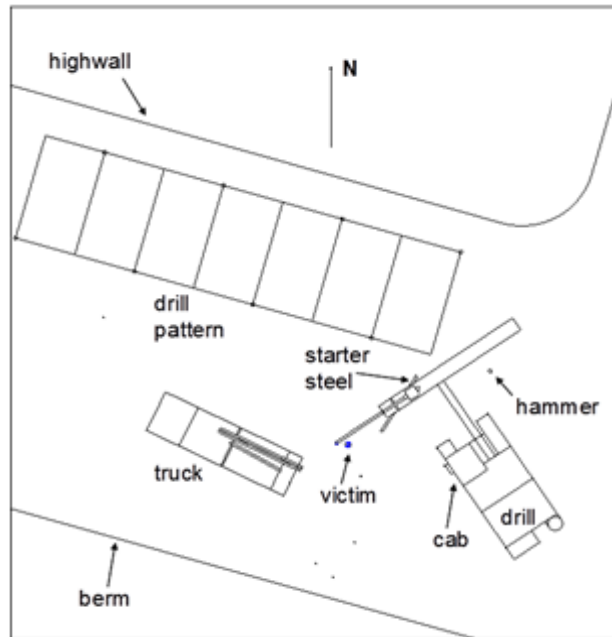
Figure 2 – Schematic of Accident Scene (not to scale)

On November 1, 2012, the day of the accident, Wickham returned to the mine and signed the visitor's log at 6:40 a.m. He drove a pickup truck to the drill. He then trammed the drill to the Southeast Side drill site (accident location) located approximately 50 feet above the active pit and approximately 35 feet from the edge of the highwall. Based on the location of the pickup truck, the investigators determined that Wickham walked back to the parking area and then drove the pickup truck to the Southeast Side location (see Appendix C – Figure 2).

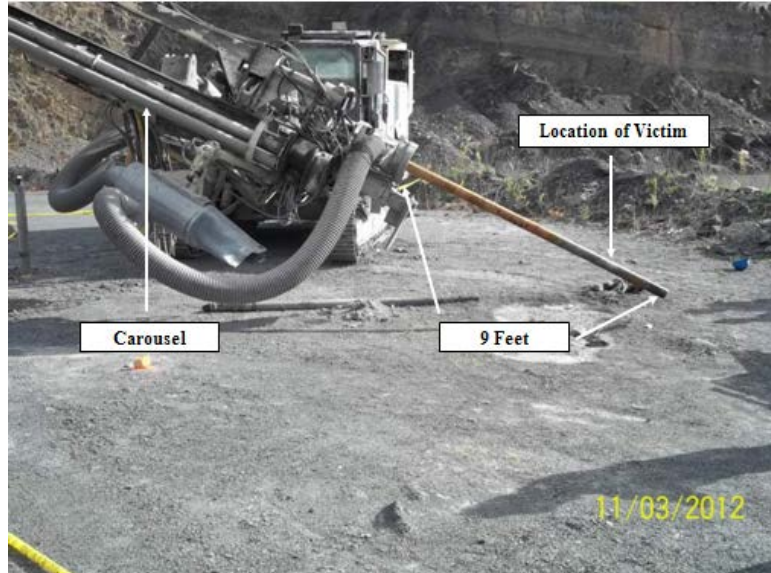
Figure 3 – Photo of Accident Scene

- After the accident, the drill was found with three drill steels (locally referred to as pipes) in the storage carousel and a fourth steel coupled to the rotary drill head. The drill guide was rotated at a 30-degree angle down from the horizontal position. The end of the drill steel was approximately 9 feet from the bottom of the drill guide (see Appendix C - Figure 3). The drill steel in the drill guide was rusted and appeared to have been in storage/unused. From interviews, investigators learned the fourth steel was being added to the drill string because the required blast hole depth, up to 57 feet in this new location (Southeast Side), was deeper than the previous drill location (East Wall) where the specified blast hole depth was 47 feet.

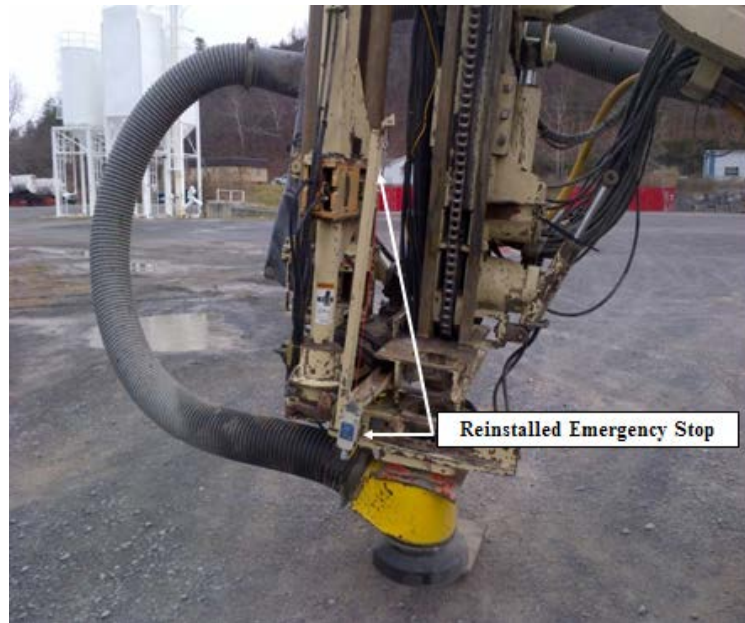
Figure 4 – Photo of Drill (Post-Accident)

The emergency shutdown (safety wire – “pull cord”) located on the bottom of the drill guide had been removed and the associated electrical component bypassed. Based on the location of the victim at the time of the accident, investigators determined that he could not have accessed the emergency shutdown even if it had been in place and fully functional. A non-contributory 104(d)(1) order was issued for a violation of 30 CFR 56.7002. The emergency stop was reinstalled after the accident (see Appendix C - Figure 4).
