MNM Fatal 2013-08

- Powered Haulage Accident
- June 2, 2013 (Nevada)
- Underground Gold Mine
- Load Haul Dump Operator
- 43 years old
- 2 years, 18 weeks of experience

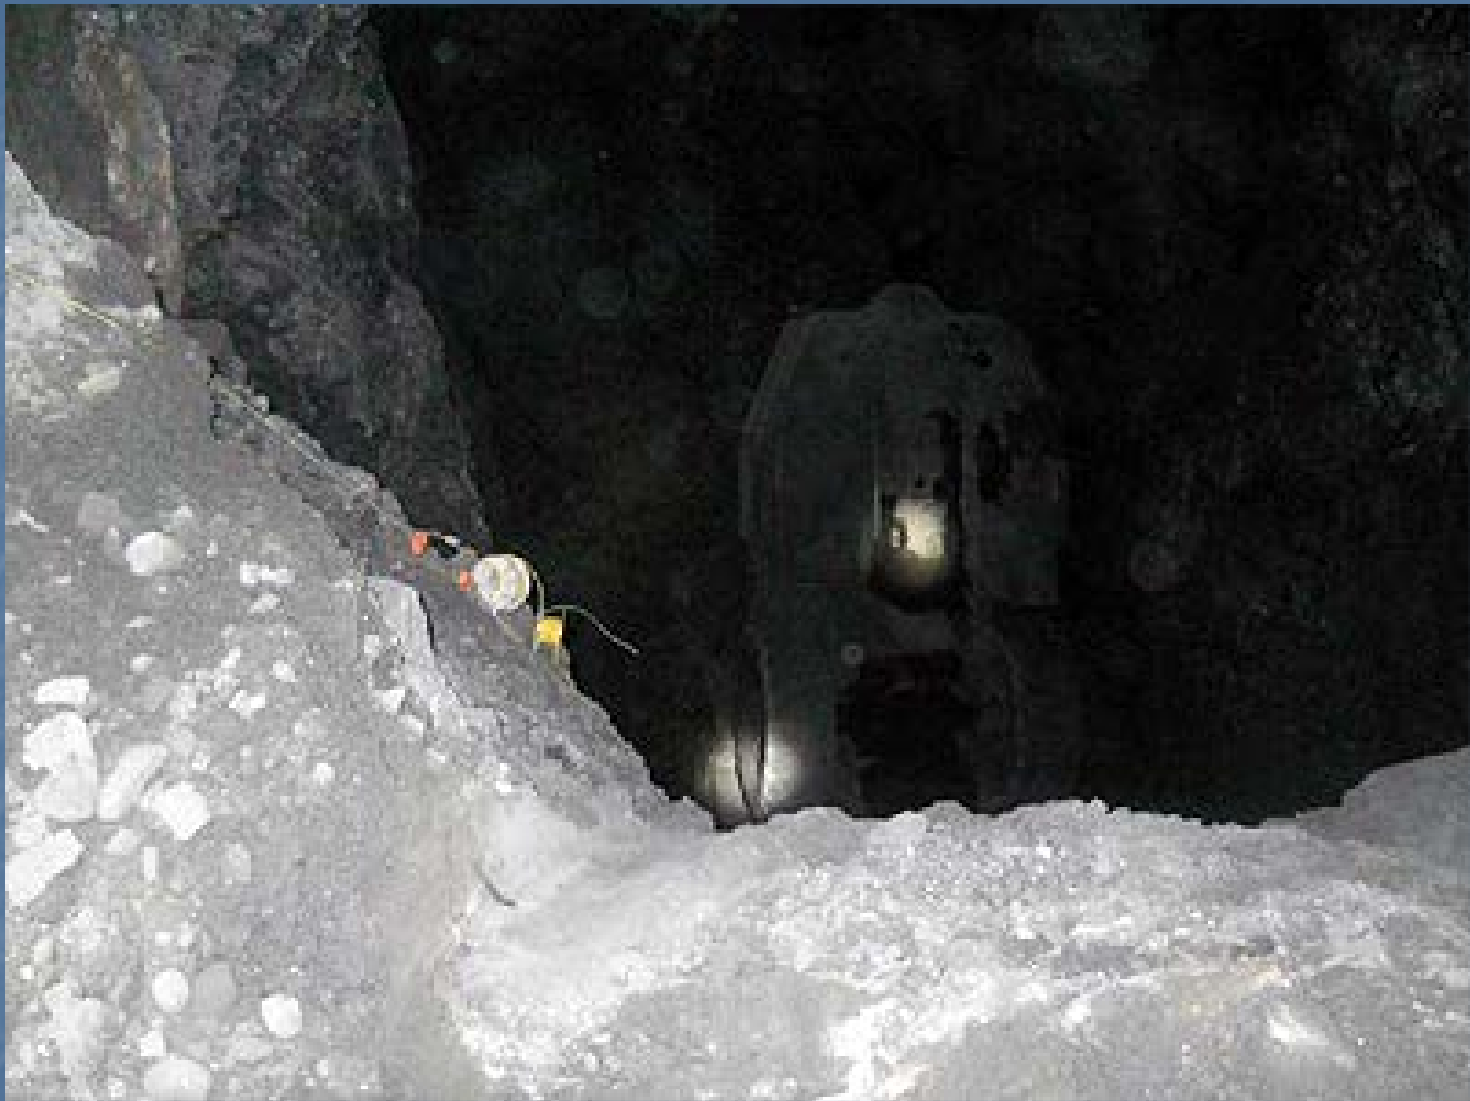
The victim was killed when the LHD he was operating overtraveled the edge of a stope and fell approximately 40 feet into an open hole. He was assigned to build a berm, using cemented rock fill material (CRF), in front of the open stope. He used the LHD to pick up a bucket full of CRF and traveled around a 128 degree left hand turn when the LHD went into the open hole.

The accident occurred due to management's failure to ensure that the established standard operating procedures to provide a safe work area near the stope were being followed by persons performing the work. Persons were not protected from overtravel while operating equipment near the open stope. Visual markers, used to identify the opening, had not been put into place to warn of a hazardous condition. Berms, bumper blocks, or similar impeding devices were not provided at the edge of the open stope where there was a hazard of overtravel.

Root Cause: Management failed to ensure that the established standard operating procedures to provide a safe work area near the stope were being followed by persons performing the work. A bumper block or similar impeding device was not used while the berm was being constructed at the open hole in the stope. Visual open hole streamers or reflective poles were not in place to identify the location of the opening. Streamers from a previous blast cycle had been left in place; however, they were 18 feet from the leading edge of the opening.

Corrective Action: Management reviewed the standard operating procedures for backfilling open stopes. The standard operating procedures have been modified to ensure that "Danger Open Hole" signs and streamers are posted ten feet from the edge of an open stope. CRF berms will be installed using remote equipment or a bumper block will be in place until a CRF berm is constructed and allowed to cure. All of the miners were trained regarding these new standard operating procedures.
