MNM Fatal 2013-13

- Powered Haulage Accident
- September 19, 2013 (Pennsylvania)
- Dimension Slate Mine
- Laborer
- 31 years old
- 14 years of experience

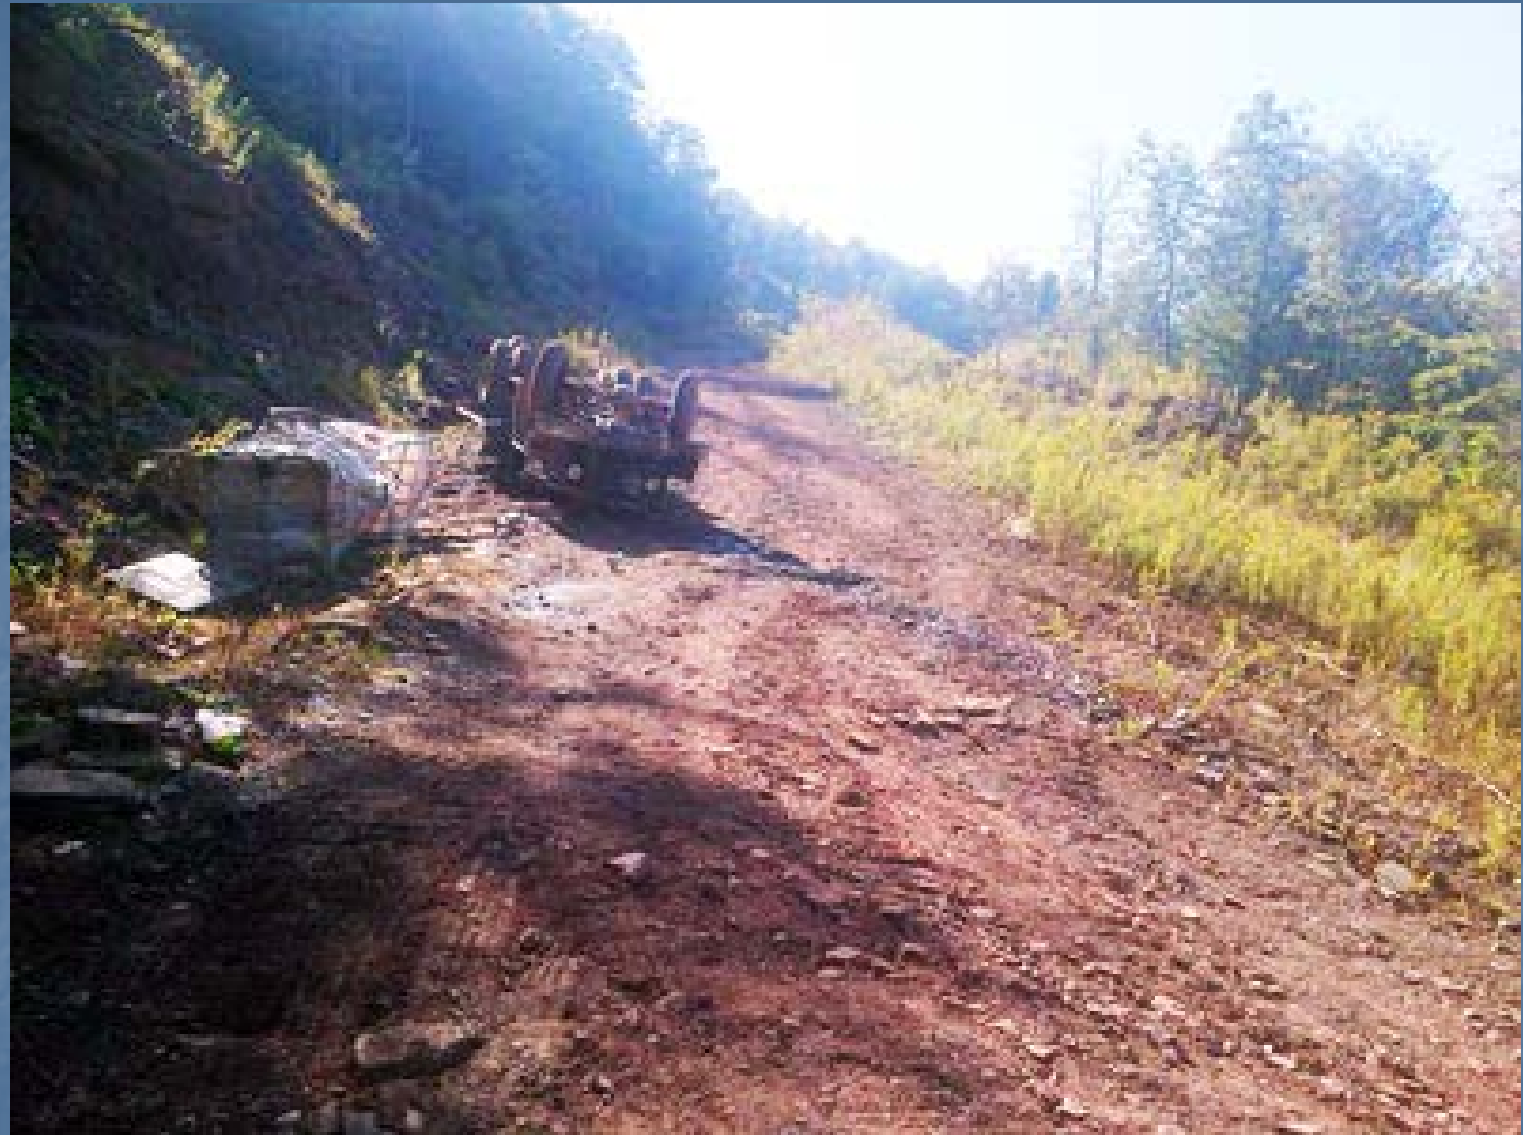
The victim was killed when the flatbed cargo truck he was operating overturned. He was transporting four full 250-gallon water totes, which were not secured, while traveling uphill on a steep mine access road. One of the totes shifted and fell off the bed of the truck onto the roadway. The truck began drifting backwards on the 25 percent grade and the remaining water totes shifted. The service brake failed and the victim could not control the truck. The truck turned sharply to an embankment and rolled over onto its roof. The victim was ejected from his seat and entrapped in the operator's cab.

The accident occurred due to management's failure to establish policies and procedures to ensure the victim could maintain control of the truck he was operating. The shifting water totes compromised the stability of the truck, the rear left wheel (driver's side) of a dual tire system (outer tire) was missing on the truck compromising the stability of the truck, the service braking system for the truck had not been maintained in a functional condition, and the main brake line on the truck rusted through, resulting in the brake fluid leaking out of the brake system. Consequently, the victim could not maintain control of the truck. Additionally, the driver was not wearing the provided seat belt; this contributed to the severity of his injuries.
