MNM Fatal 2013-22

- Other (Drowning)
- December 10, 2013 (Kentucky)
- Sand & Gravel Mine
- Dredge Deck Hand
- 27 years old
- 4½ years of experience

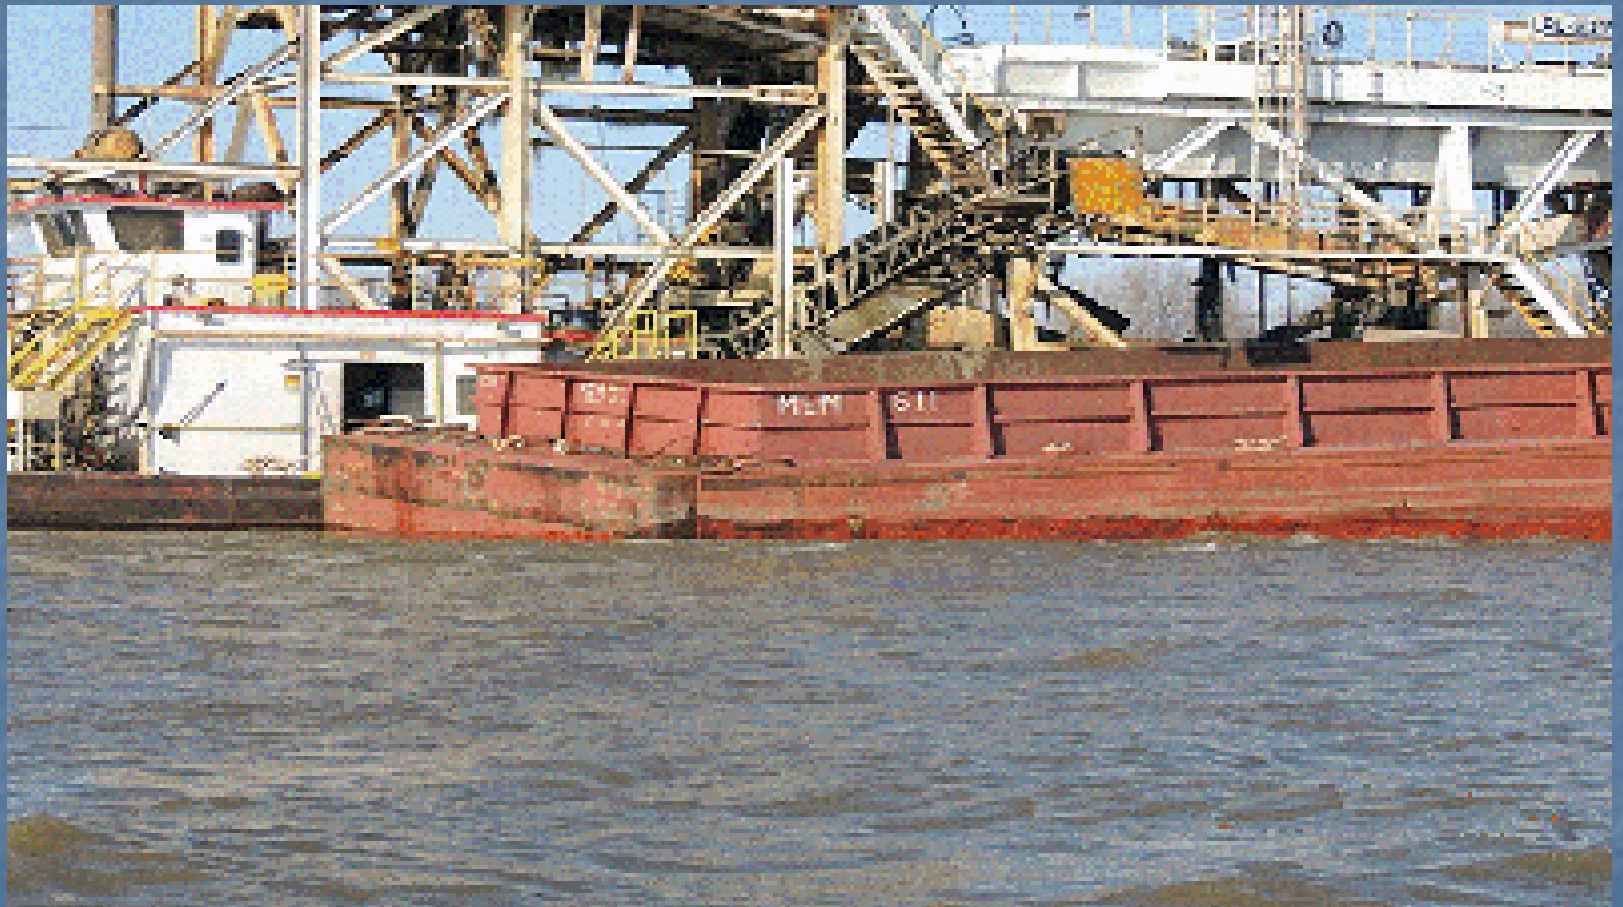
The accident occurred due to management's failure to ensure that a competent person examine each working place at least one each shift for conditions which may adversely affect safety or health. Accumulations of snow and ice were not removed from the deck of the barge. The snow and ice on the barge covered the barge rigging which created an additional slipping and tripping hazard.

Management also failed to enforce a life jacket policy. Persons interviewed stated miners were known to forget or refrain from wearing their life jackets and had to be frequently reminded. Several spare life jackets were available in the break room. The victim's life jacket was lying in a chair next to his cell phone. Additionally, management failed to provide a safety belt and line to ensure the victim could not fall into the river.
