REPORT OF INVESTIGATION

Underground Metal Mine
(Silver Ore)

Fatal Explosives and Blasting Agents Accident
November 17, 2013

Star Mine Operations LLC
Revenue Mine
Ouray, Ouray County, Colorado
Mine ID No. 05-03528

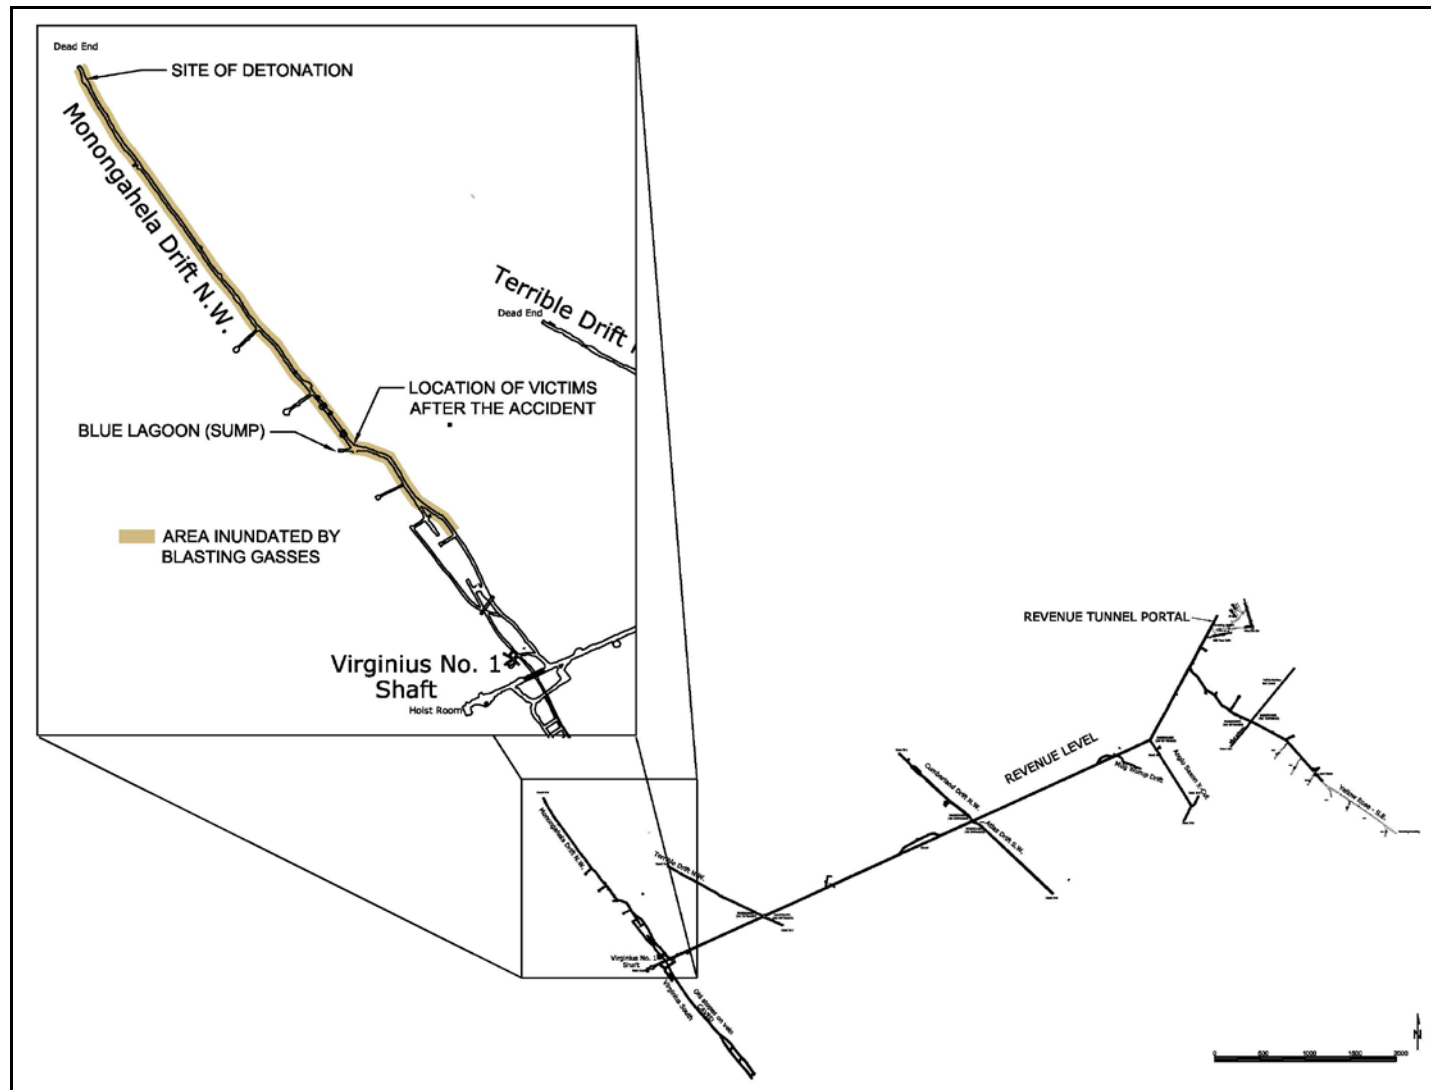
Figure 1 – Location of the Accident

The accident occurred in the Monogahela drift of the Revenue Mine. The Monogahela drift extends 2,300 feet from the Revenue tunnel to the dead end face. The average dimension of the drift is 10 feet high by 9 feet wide. Figure 1 depicts the location of the Monogahela drift as it relates to the entire mine workings. The location of the two victims at the time of recovery is shown on the map. The highlighted accident area also includes the entire area inundated by

blasting gasses. In addition to the victims, 20 other miners were exposed to toxic and noxious gasses at various locations throughout the drift.

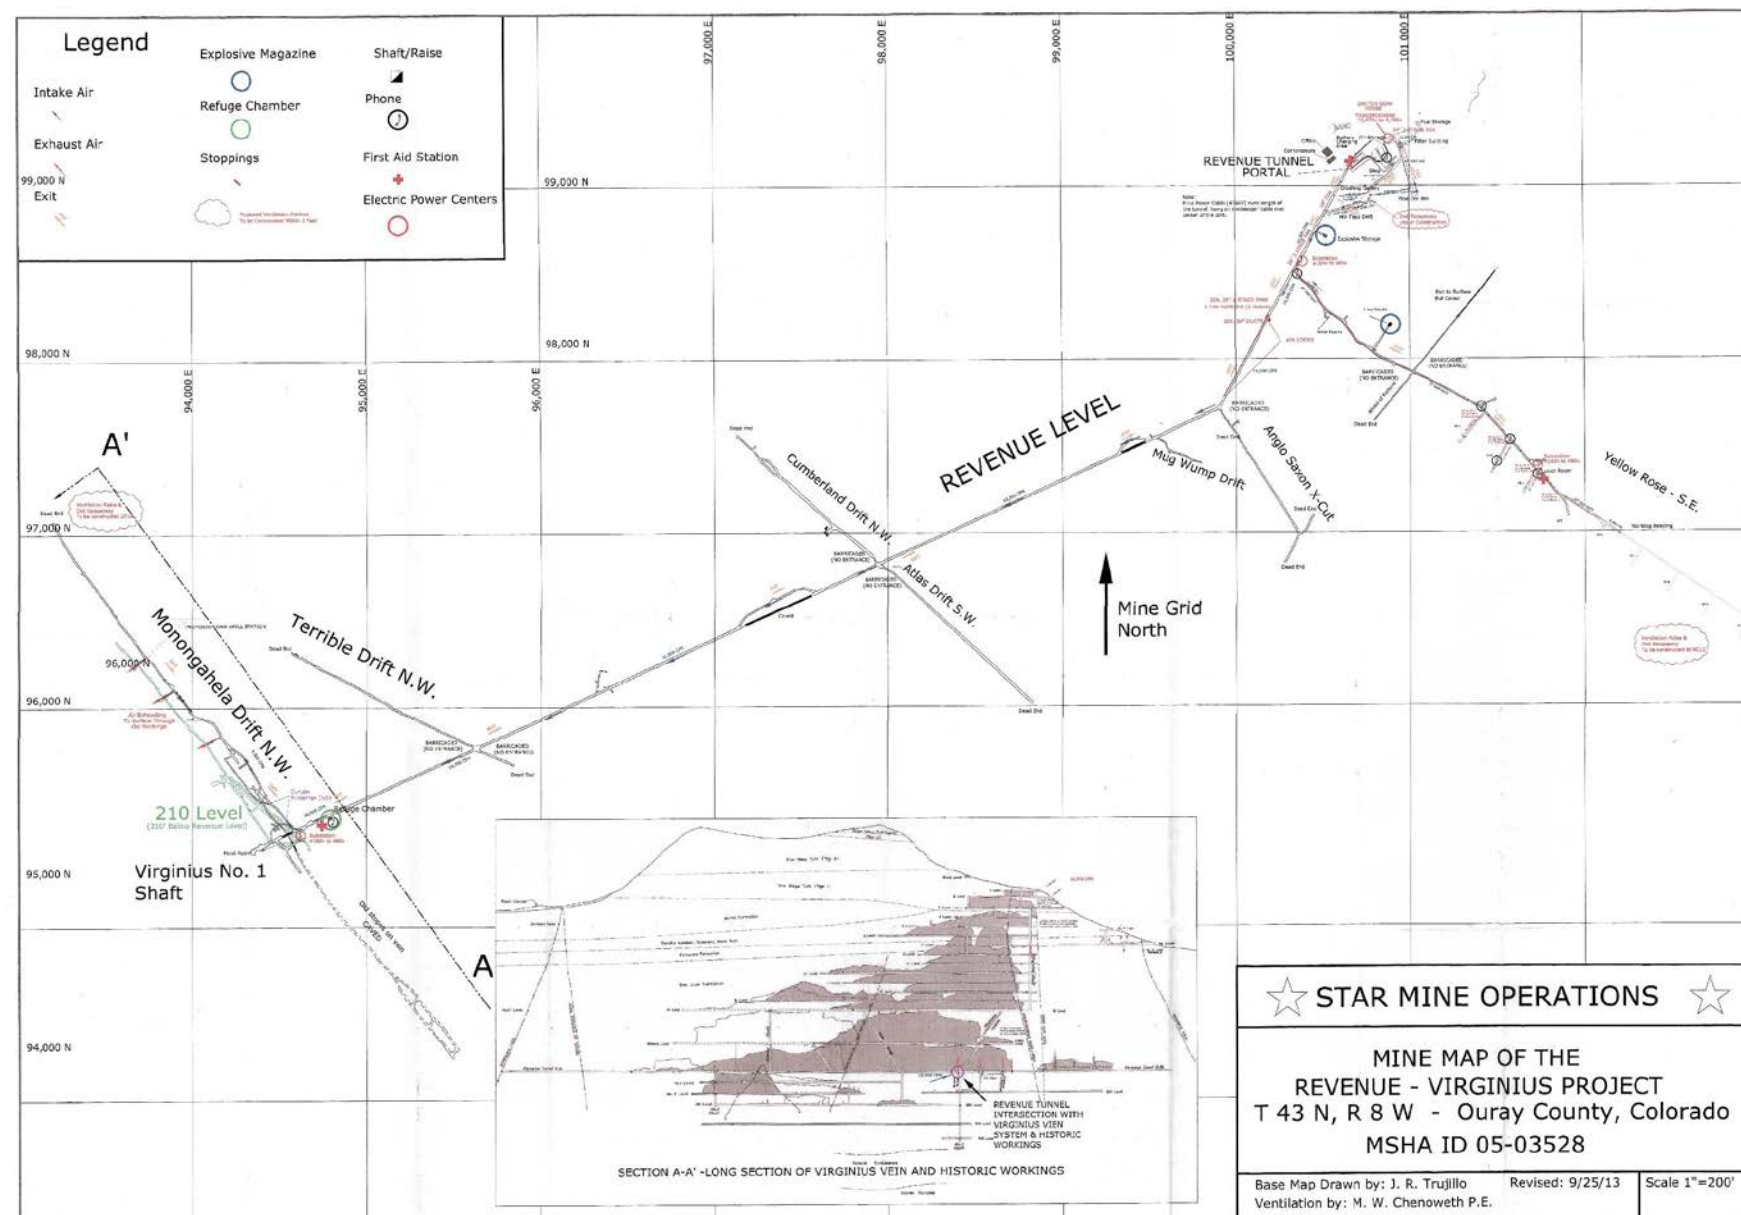
Figure 4 –Ventilation Plan Map for the Revenue Mine, September 25, 2013

Ventilation in the mine is supplied by two 28-inch diameter, double 30 horsepower Spendrup fans in the Revenue tunnel. These main fans are located approximately 950 feet in by the portal and are connected in a blowing arrangement to two, 24-inch ducts. The two ducts extend through a pair of airlock doors allowing the fans to operate as if installed in a bulkhead. This creates positive ventilating pressure in by the doors. The doors are approximately 500 feet apart. A copy of the ventilation plan map in effect at the time of the accident is shown in Figure 4.

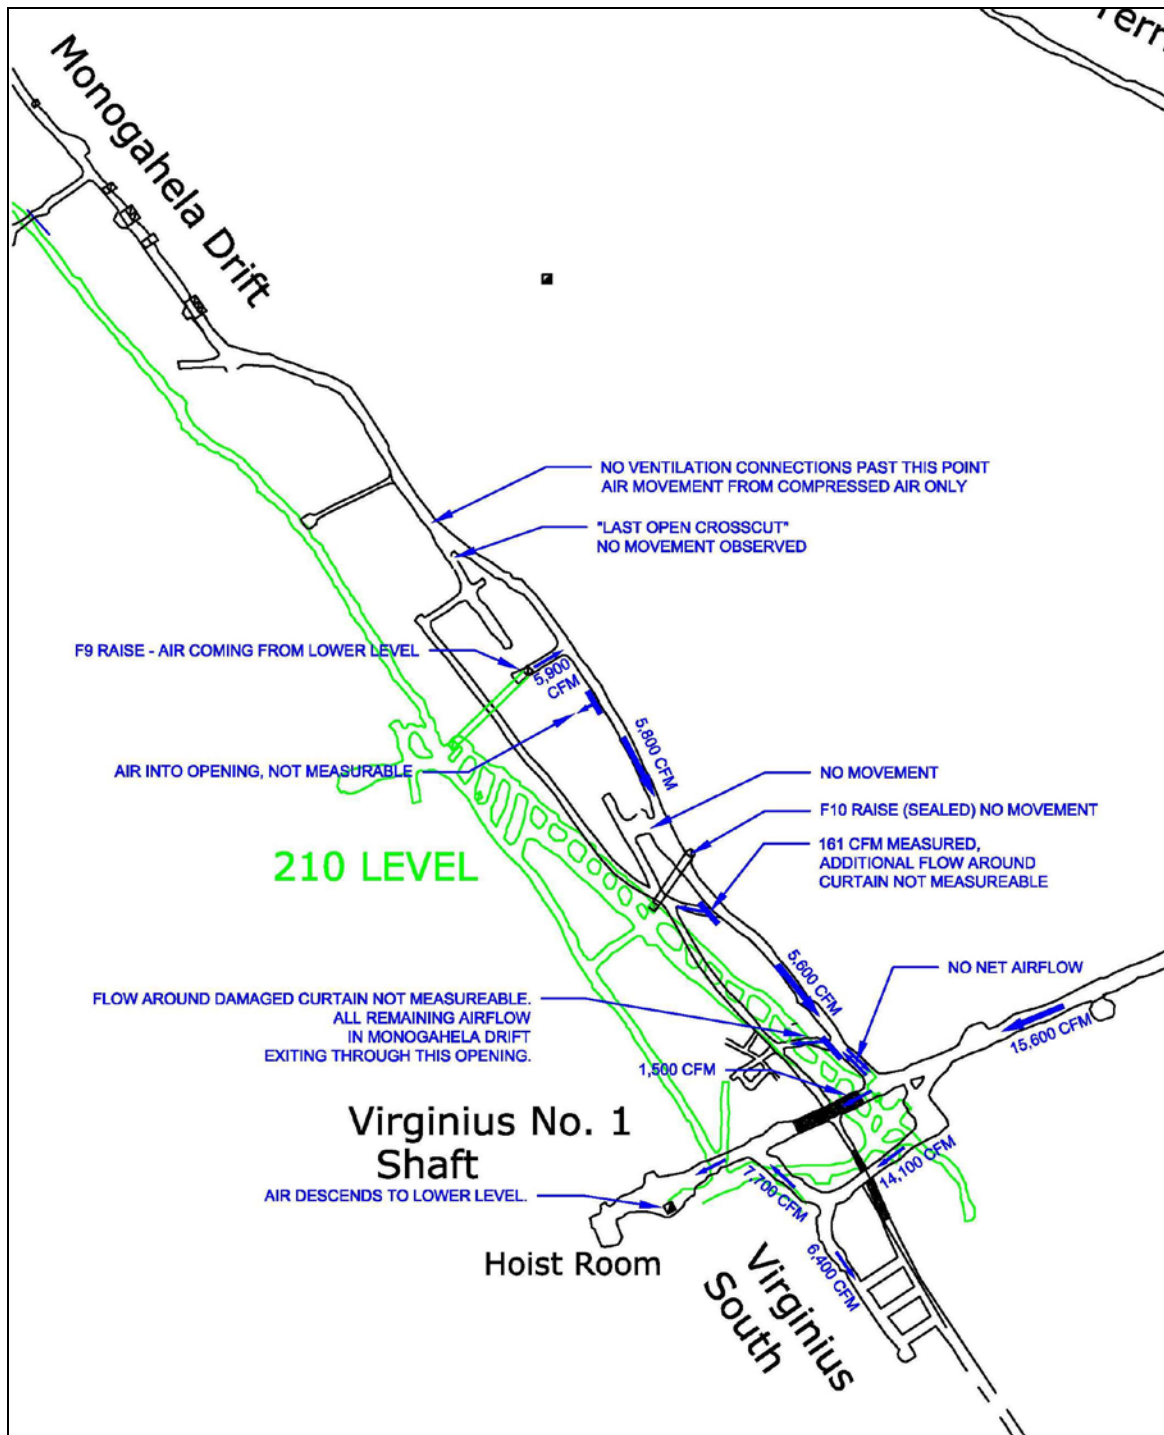
Figure 5 – Post-Accident Ventilation

Minimal air flowed from the mouth of the Monogahela drift to the first crosscut; i.e., airflow was observed moving slightly inby near the back and slightly outby near the floor. Approximately 5,800 cfm was measured coming from the F9 raise and traveling outby in the Monogahela drift to the first crosscut. One crosscut, inby the F9 raise, was referred to as the "last open crosscut" because management and the miners believed airflow entered this crosscut. Chemical smoke tests showed no airflow entered or exited this opening.

The accident investigation team used chemical smoke to check every opening off the Monogahela drift, in by the last open crosscut, and no airflow was detected entering or exiting the drift. In by the F9 raise, compressed air lines, opened during the recovery, provided the only airflow toward the face of the drift. Measurements showed this quantity ranged from 1,300 cfm to 3,100 cfm. With the compressed airline closed, there would be no ventilation beyond the F9 raise. The F9 raise was located approximately 450 feet into the Monogahela drift. The drift was 2,300 feet long. The site of the explosive detonation was 50 feet from the face of the drift (2,250 feet into the drift), 1,650 feet beyond the last open crosscut and approximately 1,800 feet in by the F9 raise. A flexible ventilation duct had been installed in a portion of the drift; however, no fan was installed to provide forced airflow.

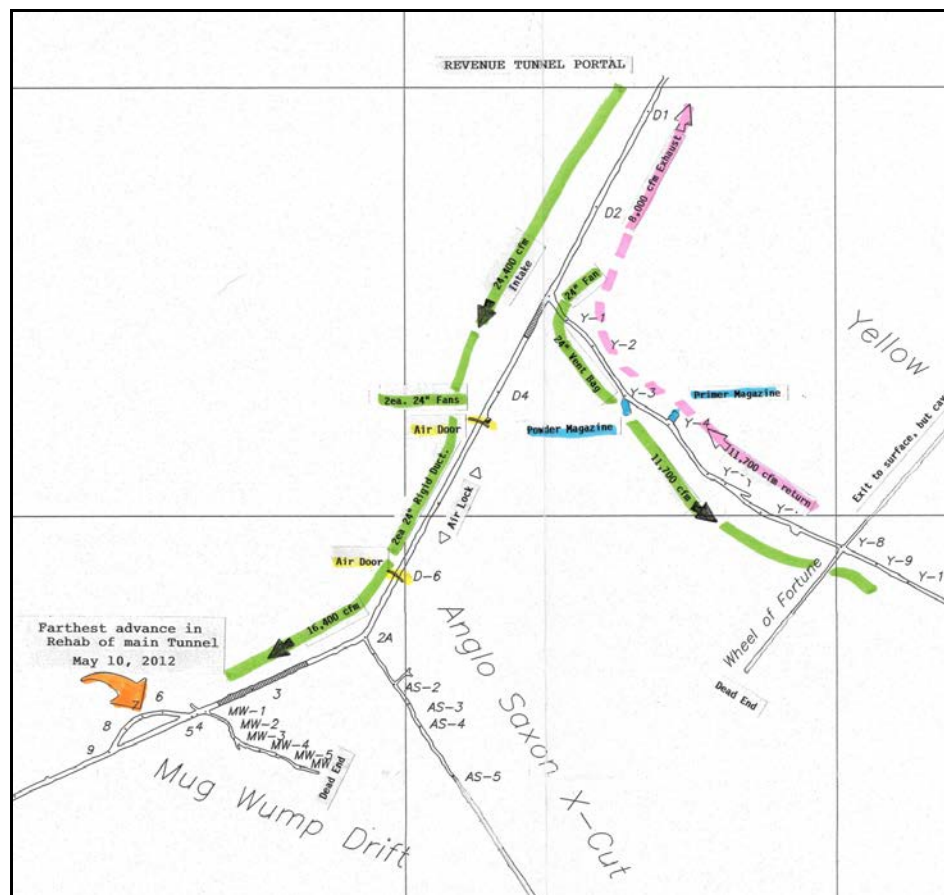
Figure 6 – Portion of the May 9, 2012 Ventilation Plan Map

The revised plan map depicted that the single-entry Revenue tunnel had been rehabilitated a short distance beyond the Mug Wump drift, approximately 2,000 feet from the portal (see Figure 6). No ventilation arrows or controls were shown on the map in by the furthest point of rehabilitation. The plan indicated that two 24-inch diameter fans had been installed in the Revenue tunnel and indicated that the fans delivered 16,400 cfm to the tunnel. The map also indicated that the operator installed a separate 24-inch fan and approximately 1,000 feet of flexible ventilation tubing (vent bag) in the Yellow Rose drift. The map indicated that the fan in the Yellow Rose drift produced 11,700 cfm of airflow in the drift.

The air quantities shown on the map in the Revenue tunnel and in the Yellow Rose drift were consistent with those measured during the accident investigation; however, the revised plan map also depicted that 24,400 cfm was flowing from the portal to the fans in the Revenue tunnel and 8,000 cfm was exhausting from the Yellow Rose drift toward the portal in the same single-entry drift. Although the resultant airflow (16,400 cfm) was shown traveling past the fans, airflow could not travel in two directions as depicted without a physical separation between the two air currents.

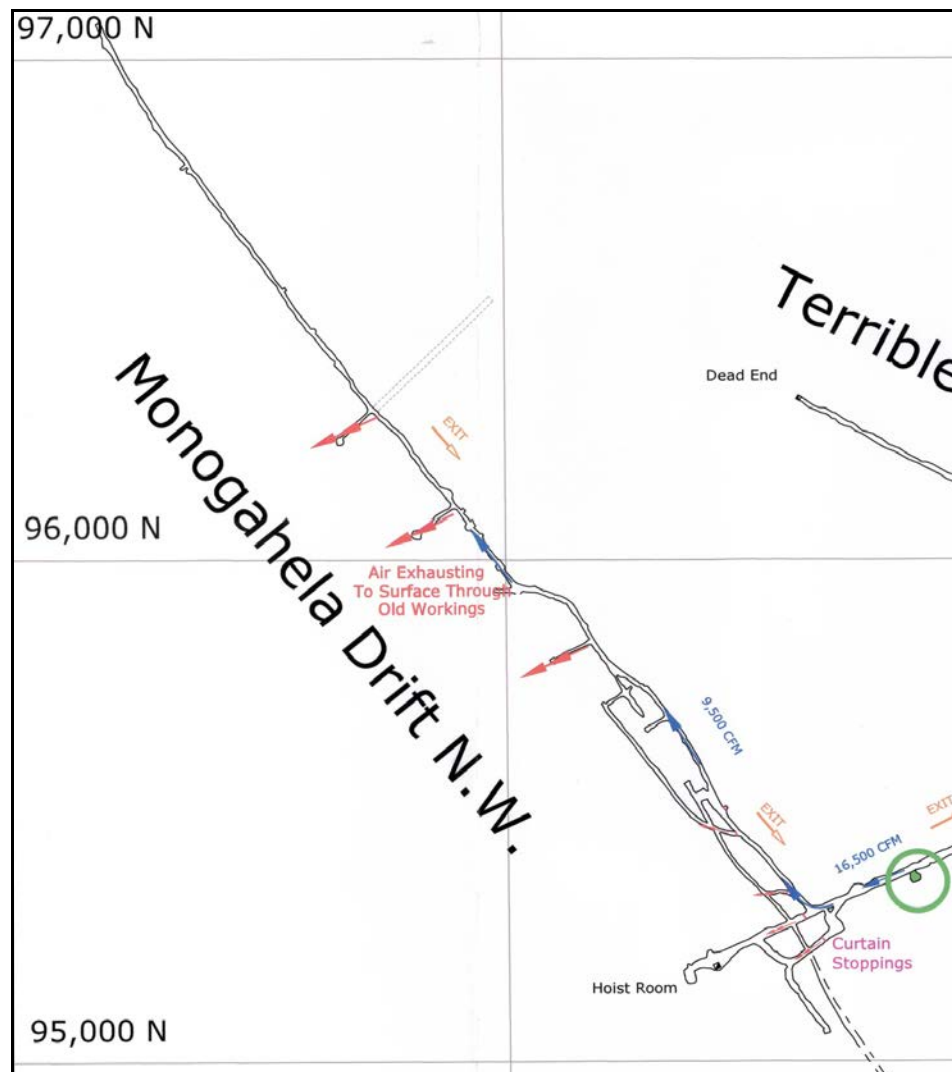
Figure 7 – Portion of the January 23, 2013 Ventilation Plan Map

According to the plan map, airflow in the Revenue tunnel exited the mine through the Monogahela drift (see Figure 7). It also showed that the Revenue tunnel, in by the Monogahela drift (the track entry to the shaft), and the first two crosscuts off the Monogahela drift were to be closed off with curtain stoppings. This would have caused the main airflow to enter the Monogahela drift before exiting through old workings. During his interview, Chenoweth confirmed that he personally measured 9,500 cfm in the Monogahela drift at the location as designated on the plan map.

The plan map depicts air exiting the Monogahela drift through three drifts (drill stations) to the southwest off of the Monogahela drift; however, the accident investigation team found that the drill stations were dead end drifts and no air could exit. When asked about this map inaccuracy, Chenoweth stated he physically had not been to the drill stations at the time the map was prepared. Chenoweth thought the air exited through the “last open crosscut.” (The last open crosscut is located 600 feet in by the intersection of the Revenue tunnel and the Monogahela drift and just out by the three drill stations.) Chenoweth said that beyond the “last open crosscut,”

there was no ventilation other than compressed air. The compressed air line normally would have been capped on the end and the air drop valves closed. Therefore, unless compressed air was being used by a miner, the remaining 1,700 feet of the Monogahela drift remained unventilated. Chenoweth stated he would have been concerned if someone had been working there; however, in January 2013, the closest active working area was located about 7,000 feet outby in the Yellow Rose drift.

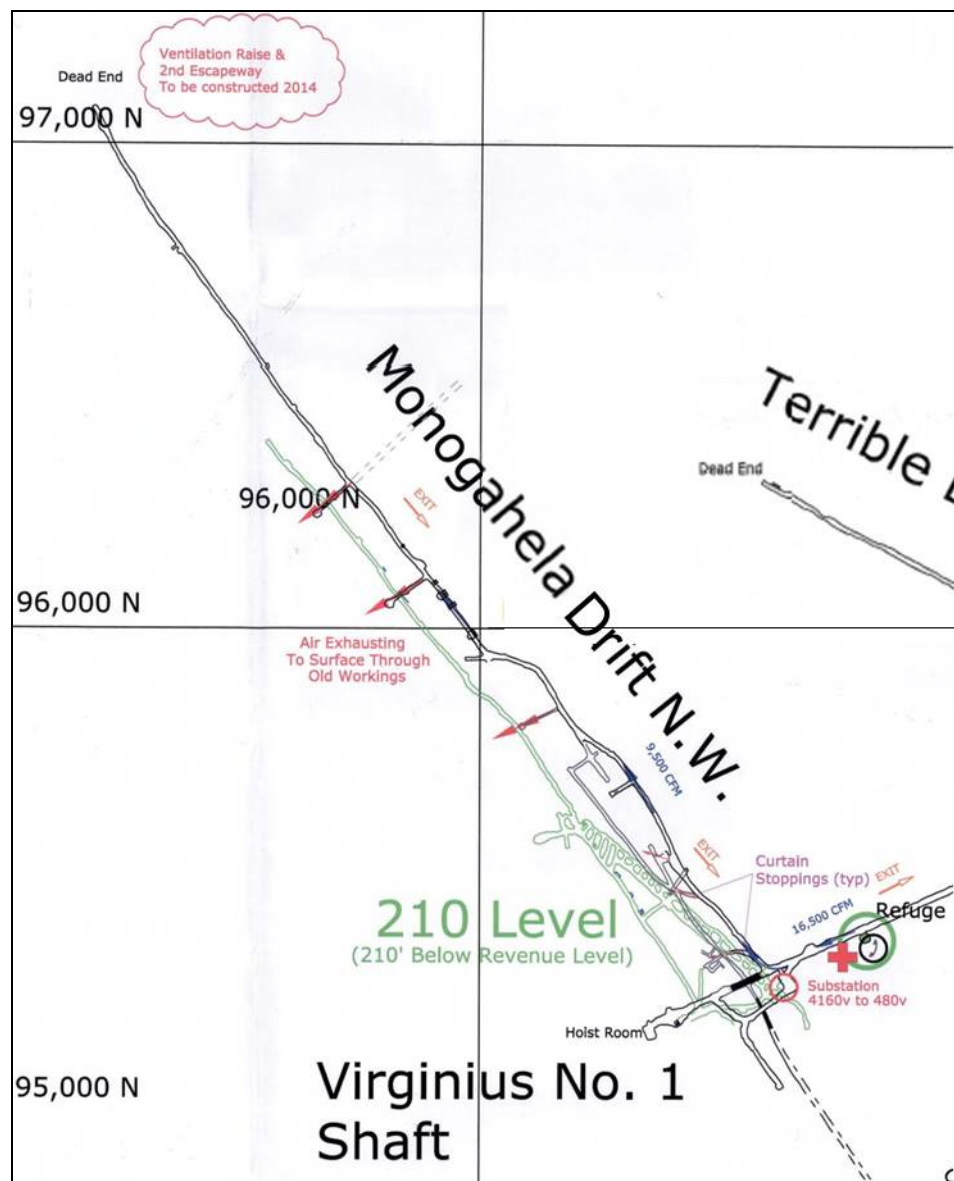
Figure 8 – Portion of the September 27, 2013 Ventilation Plan Map

Items 1 and 2 identified in MSHA's September 10, 2013, letter were directly related to the accident. With respect to Item 1, if the operator took air quantity measurements, as requested, it would have found that the drill stations off the Monogahela drift were dead end drifts. Either the operator did not take measurements or it intentionally submitted the map using false information.

These curtain stoppings also were not present during the accident investigation and the accident investigation team found that the airflow was traveling outby in the Monogahela drift as previously described. Consequently, the accident investigation team determined that the 9,500 cfm shown on the map was inaccurate.

The map also depicted the mine air exiting the Monogahela drift through the drill stations to the southwest and exhausting to the surface through old workings. As previously discussed, this was not possible because they were dead end drifts.

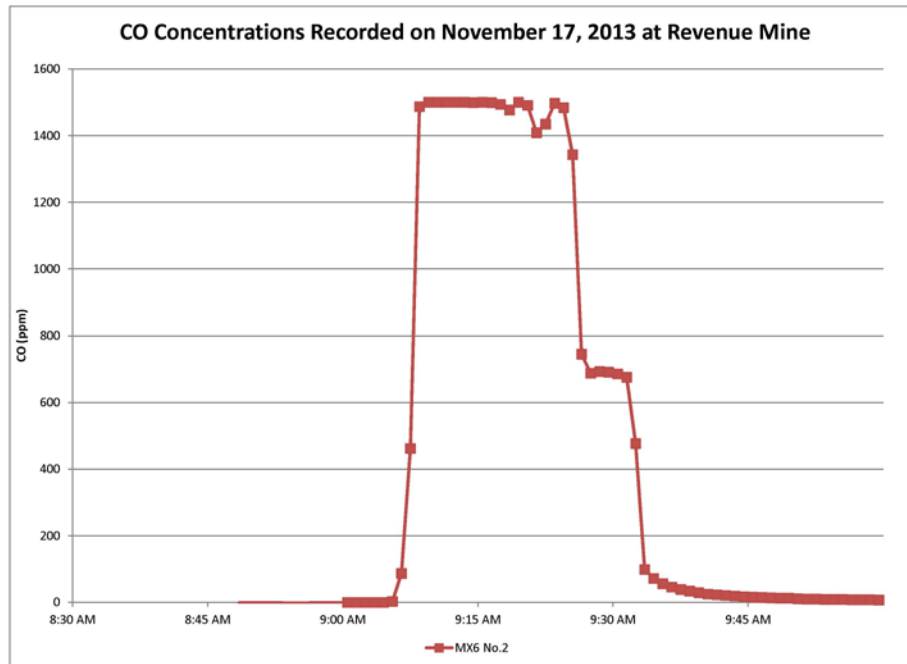
Figure 9 – MX6 No. 2

The data from the day of the accident for CO concentrations is shown on Figures 9 and 10. The data indicates MX6 No. 2 was used during the rescue attempt by Ronald Williams, who entered the gas inundated area at 9:06 a.m. The recorded CO concentrations reached the sensor maximum value of 1,500 ppm within three minutes. It is not possible to determine the actual concentration beyond the sensor maximum. The indicated concentrations began to decline at

9:25 a.m. to a level of approximately 690 ppm CO where it remained for six minutes. After 9:31 a.m., the data indicates the instrument was no longer in the area contaminated by the blast. This coincides with the approximate time that Ronald Williams left the Monogahela drift and traveled to the refuge chamber.

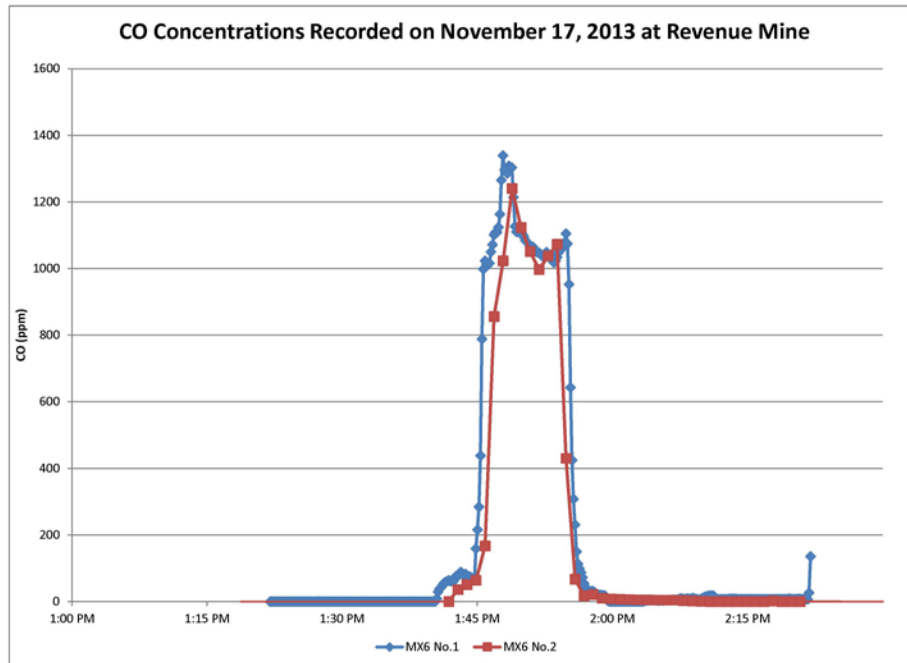
Figure 10 – MX6 No. 1 and MX6 No. 2

Data was retrieved from both MX6's indicating they were used during the recovery of the victims. During that time, CO concentrations still exceeded 1,000 ppm in the Monogahela drift (see Figure 10).

The peaks shown on the instruments during the initial rescue attempts show that the victims and injured miners were exposed to CO concentrations exceeding 1,500 ppm. The momentary plateau (at approximately 9:30 a.m.) shown in Figure 9 coincides with the time during which Ronald Williams had retreated to the compressed air line in the Monogahela drift after his low-air alarm sounded. The response of the gas detectors during the rescue attempts shows that, if the instruments had been used to conduct a post-blast examination, they would have alerted persons to the deadly atmosphere in the Monogahela drift..

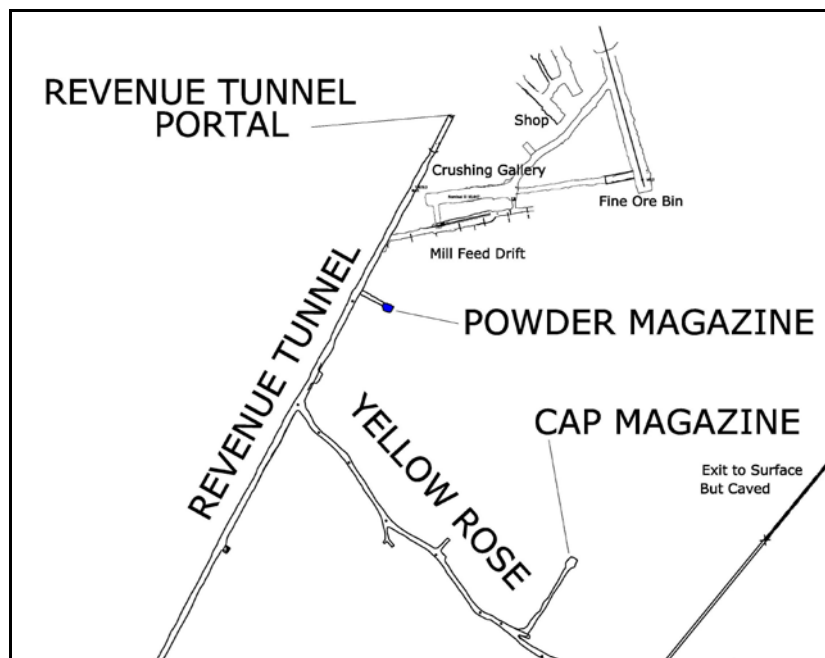
Figure 11 – Location of Explosives Storage Facilities in the Revenue Mine (each designated as “Magazine” on the map)

(2) So that a fire or explosion in the storage facilities will not prevent escape from the mine, or cause detonation of the contents of another storage facility.

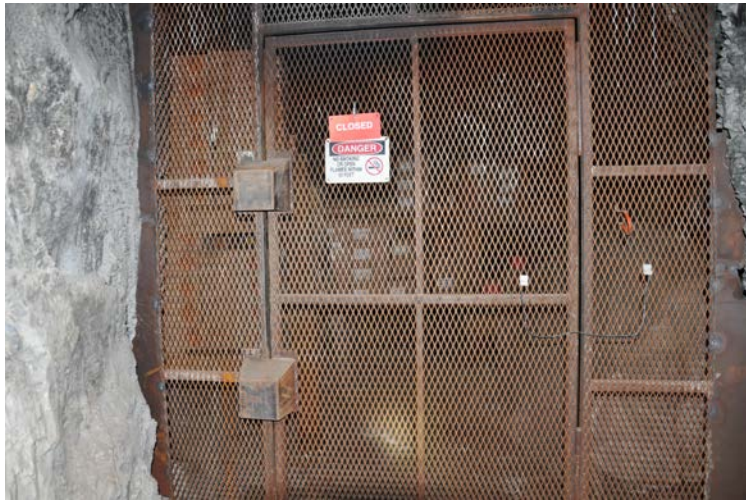
Figure 12 – Entrance to Powder Storage Facility

The front of each storage facility had an expanded metal security gate in place and the roofs were bolted with chain link wire to secure the top (see Figure 12). Although an insulating material had been applied to the interior of the facilities, there were several areas found in each facility with exposed bare metal.

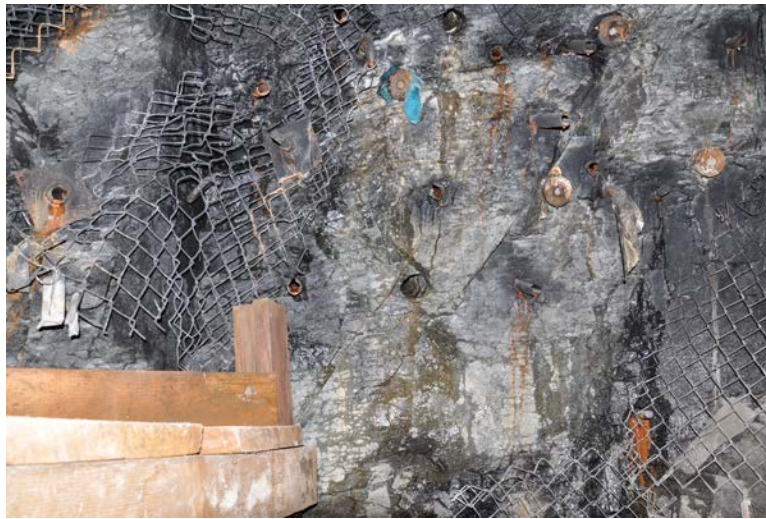
Figure 13 – Inside of Powder Storage Facility

The back was not grouted or coated with shotcrete inside the powder storage facility; therefore, water constantly dripped onto the explosives (see Figure 13). The wet conditions damaged and deteriorated the explosives inside the facility. Water infiltration was not evident in the cap storage facility.

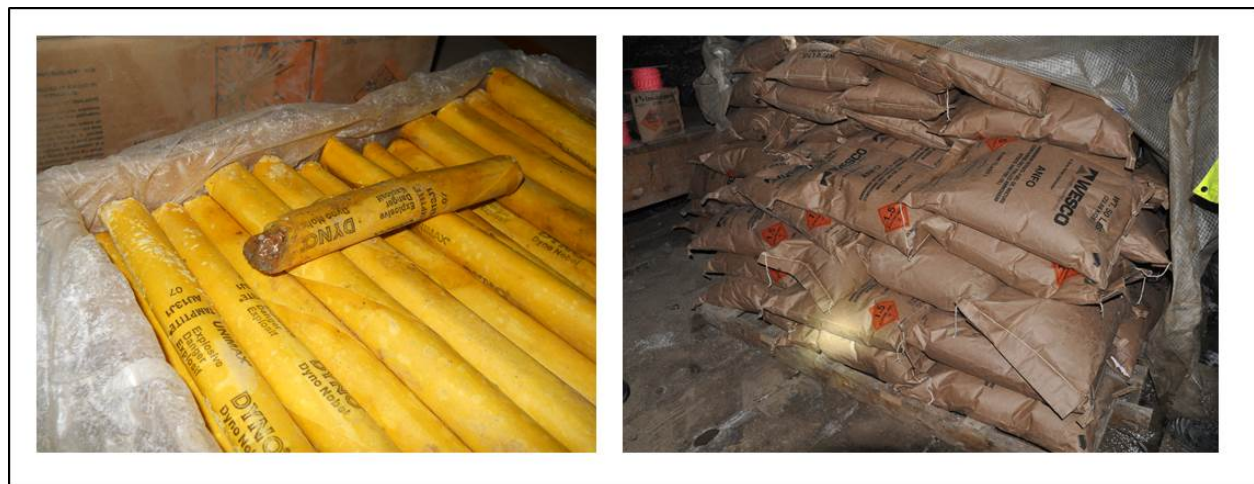
Figure 14 – Explosives in the Powder Storage Facility

The explosives were stored inside the powder storage facility on wooden shelving built along each rib. The shelves were located approximately 30 inches and 60 inches above the floor level. Explosives were stored in the original cardboard containers, but were not stacked to facilitate the use of the oldest product first. Some stacks had three or four different manufacturer's date coded boxes stored together. Approximately 3,750 pounds of blasting agent in the form of bagged ammonium nitrate / fuel oil mixture (ANFO) was stored on wooden pallets on the floor. Exposed metal nails protruding from the pallets presented an additional hazard to the bagged

The accident investigation team conducted a physical inventory in each storage facility. The results showed that the operator, and specifically the responsible shift bosses, did not keep either facility's inventory current; i.e., the inventories did not reflect the actual amount of explosives in the storage facilities. Approximately 2,400 separate units of explosives were missing based on the total amount of each explosive type.
