MNM Fatal 2013-04

- Falling Material Accident
- April 4, 2013 (Arizona)
- Copper Operation
- Contract General Foreman
- 30 years old
- 6 years of experience

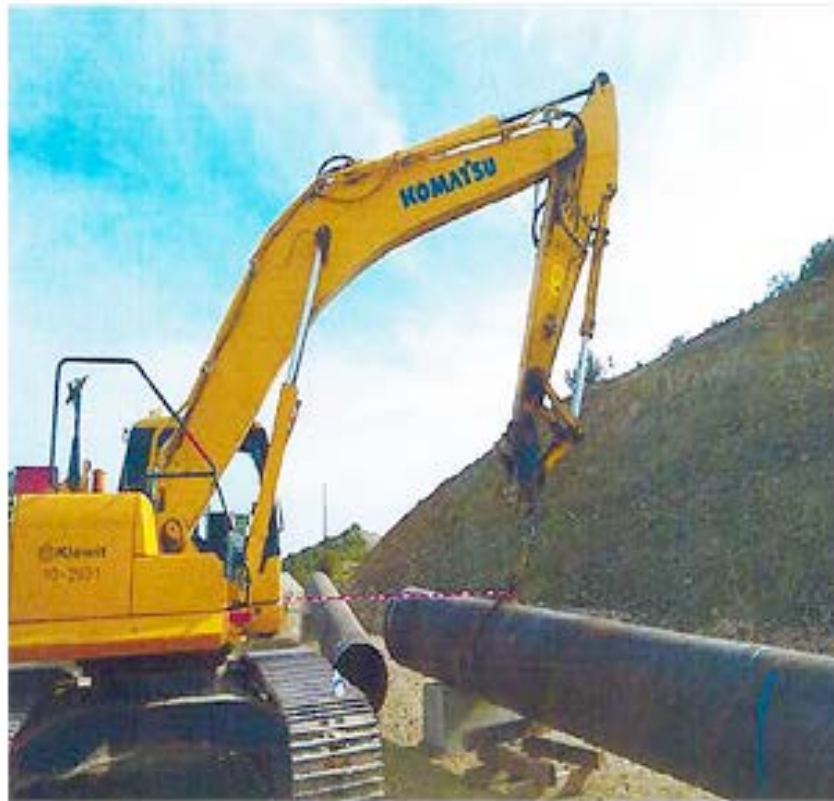
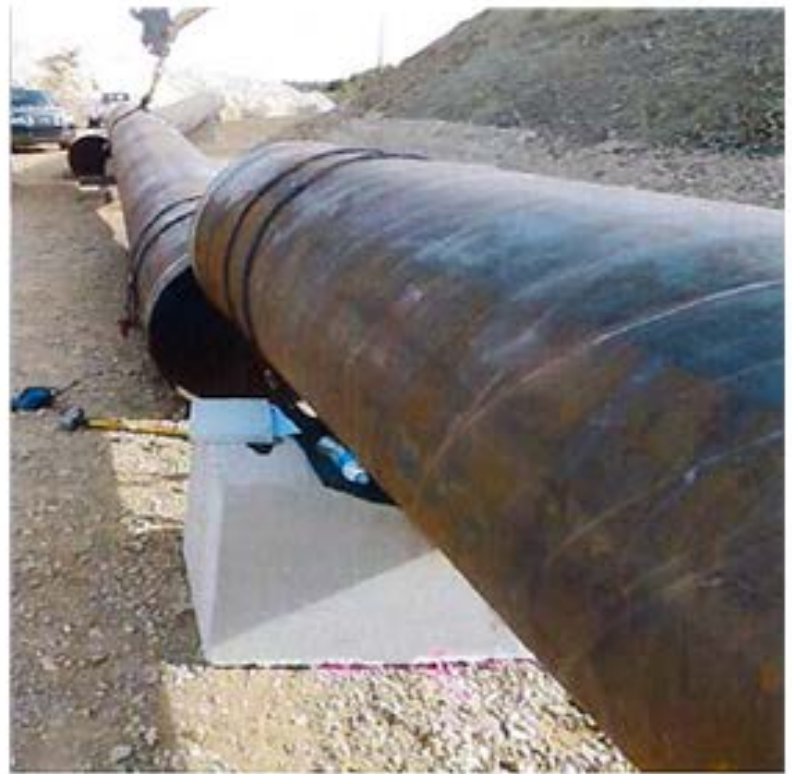
The victim was killed when a suspended 40-foot long section of 36-inch diameter steel pipe fell and struck him. An excavator was being used to position the pipe to connect it to another section of pipe. The pipe, attached to the excavator by a lifting strap, shifted and fell on the victim. The pipe was being installed as part of a new system to flow waste water from the flotation tanks back to a new impoundment.

The accident occurred due to contractor management's failure to identify the risks associated with the task of installing the pipe. The contractor had established policies and procedures; however, management failed to follow them. Additionally, the victim had not received task training before installing the pipe. He was working under a suspended load when the load shifted and fell on him.

Root Cause: Contractor management failed to follow the policies and procedures that had been established to install the pipe. The problems installing the pipe were not properly addressed. Contractor management also failed to ensure that all persons working on the pipe project had received the proper task training prior to starting work on this project.

Corrective Action: Contractor management developed a Master Task Plan to ensure all safety items regarding the pipe installation have been addressed. This plan requires that trained and qualified personnel will install the remaining pipe. Engineered metal supports will be used to hold up the spigot end of a pipe while it is inserted into the bell end of the adjacent pipe and all the pipe joints will be tack welded prior to moving to the next section of pipe to be installed.

Contractor management had a pipe support designed and engineered to prevent persons from working under a suspended load when putting together spigot and bell end 36 inch pipe. This pipe support will prevent the pipe from falling or rolling side to side.

A task training program regarding these new procedures for handling 36-inch spigot and bell pipe design was established. All persons assigned to work on the pipe project have received the task training. Any new persons assigned to work on the pipe project will receive this training.
