REPORT OF INVESTIGATION

**Surface Nonmetal Mine
(Lime)**

**Fatal Machinery Accident
January 21, 2013**

**Lhoist North America of Arizona Inc.
Apex Quarry and Plant
North Las Vegas, Clark County, Nevada
Mine ID No. 26-00081**

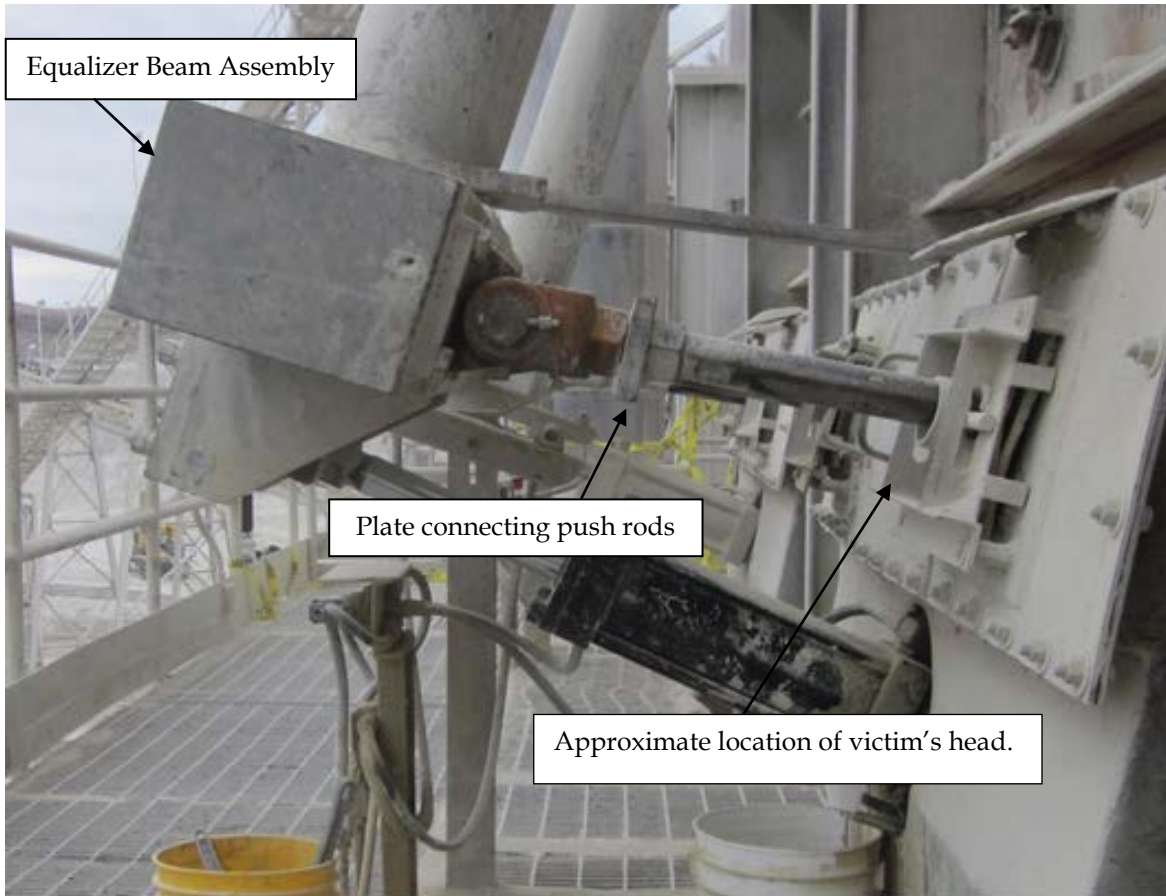
Equalizer Beam Assembly

Plate connecting push rods

Approximate location of victim's head.

On January 21, 2013, Kenneth Korakis, Maintenance Leadman, age 54, was killed when he was caught between a push rod connecting plate for a ram and a kiln hood on the kiln preheat deck. Korakis was attempting to repair a leaking hydraulic cylinder that activated a pusher arm on the kiln. He was working on energized hydraulic equipment near moving machine parts when he was caught in a pinch point.

The accident occurred due to management's lack of safe work procedures that ensured Korakis could safely perform work on the kiln deck. He was positioned between the push rod connecting plate and the kiln hood; however, the energy source was not deenergized and the ram was not blocked against hazardous motion. The kiln had three lock-out features but none of them were being used when the accident occurred.

At full retraction of the hydraulic cylinder, there were approximately 4½ inches of space between the push rod plate and the angle iron support for the push rod gaskets. There was less space between portions of the gasket bracket surrounding the point where the push rod entered the preheater.

Corrective Action: Management revised the lockout, tag out, and blocking procedures and established policies to ensure that safe work procedures are followed when maintenance work is performed. Persons performing the task were trained in the new procedures and policies. Management will monitor maintenance work to ensure the procedures are being followed.
