REPORT OF INVESTIGATION

Surface Metal Mine  
(Copper)

Fatal Fall of Material Accident  
April 4, 2013

TIC - The Industrial Company  
Contractor ID No. K48

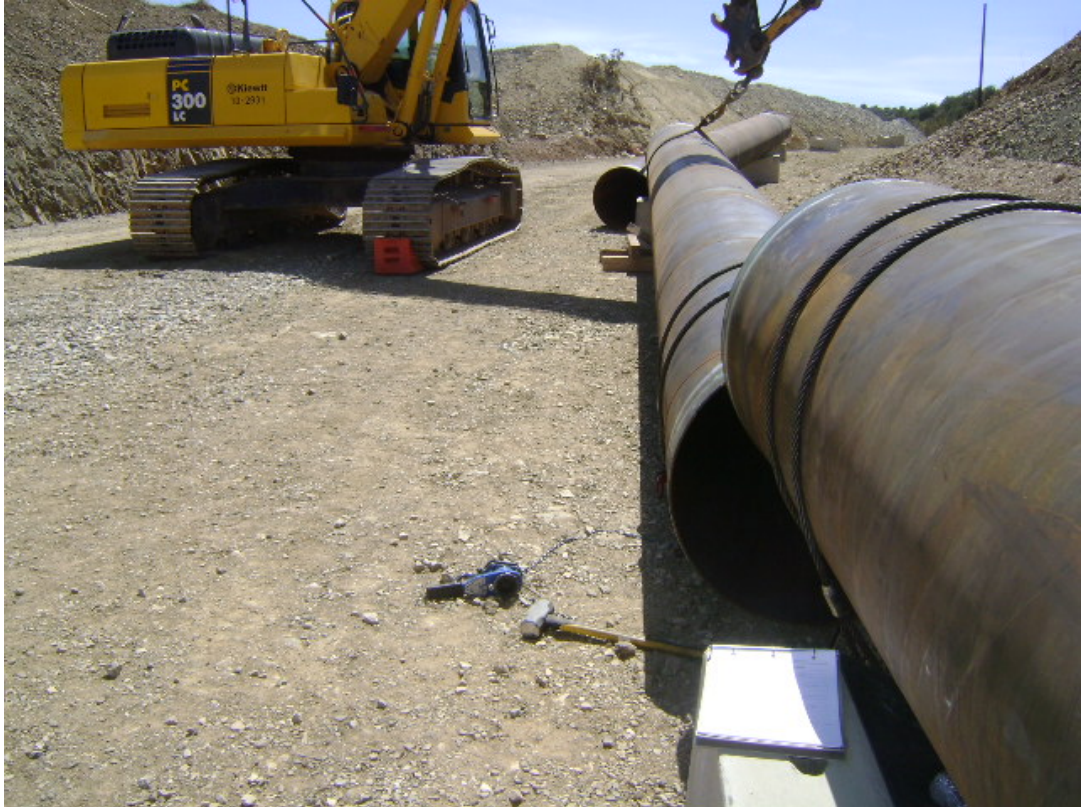
Alvin H. Thomas, Contract General Foreman, age 30, was killed on April 4, 2013, when a suspended 40-foot long section of 36-inch diameter steel pipe fell and struck him. An excavator was being used to position the pipe to connect it to another section of pipe. The pipe, attached to the excavator by a lifting strap, shifted and fell on the victim.
