**REPORT OF INVESTIGATION**

**Underground Nonmetal Mine  
(Salt)**

**Falling Material Accident  
April 16, 2013**

**North American Salt Company  
Cote Blanche Mine  
Franklin, St. Mary Parish, Louisiana  
Mine ID No. 16-00358**

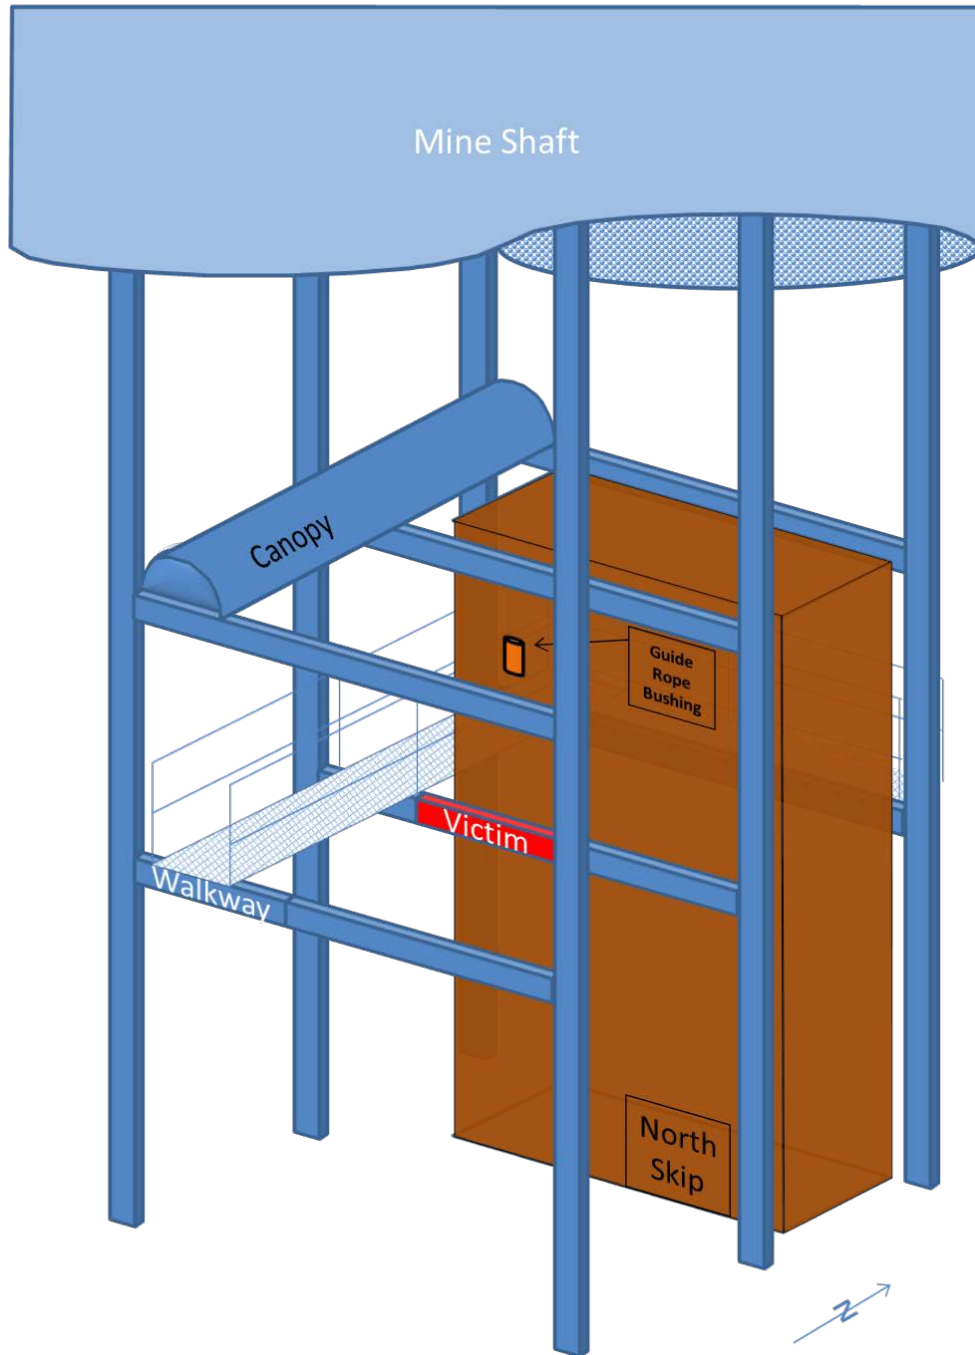
CONCEPTUALIZED VIEW OF THE ACCIDENT SCENE

Charles, Battle, and Hamilton used the elevated walkway at the 1525-foot level to access the upper guide rope bushings on the south side of the north skip. Since they could not reach the bushings from the walkway, Charles climbed over the inside handrail and stood on a 6-inch wide steel beam. He was wearing fall protection and was tied off to the handrail of the walkway. Another 6-inch wide beam was less than a foot above his head.

The victim and his coworkers were working at the west side of the north skip. He had climbed over the handrail on the east side of the walkway and was standing on a 6-inch wide steel beam at the time of the accident.
