**REPORT OF INVESTIGATION**

**Fatal Powered Haulage Accident  
June 13, 2013**

**Stevens Creek Quarry Inc.  
Stevens Creek Quarry  
Cupertino, Santa Clara County, California  
Mine ID No. 04-01676**

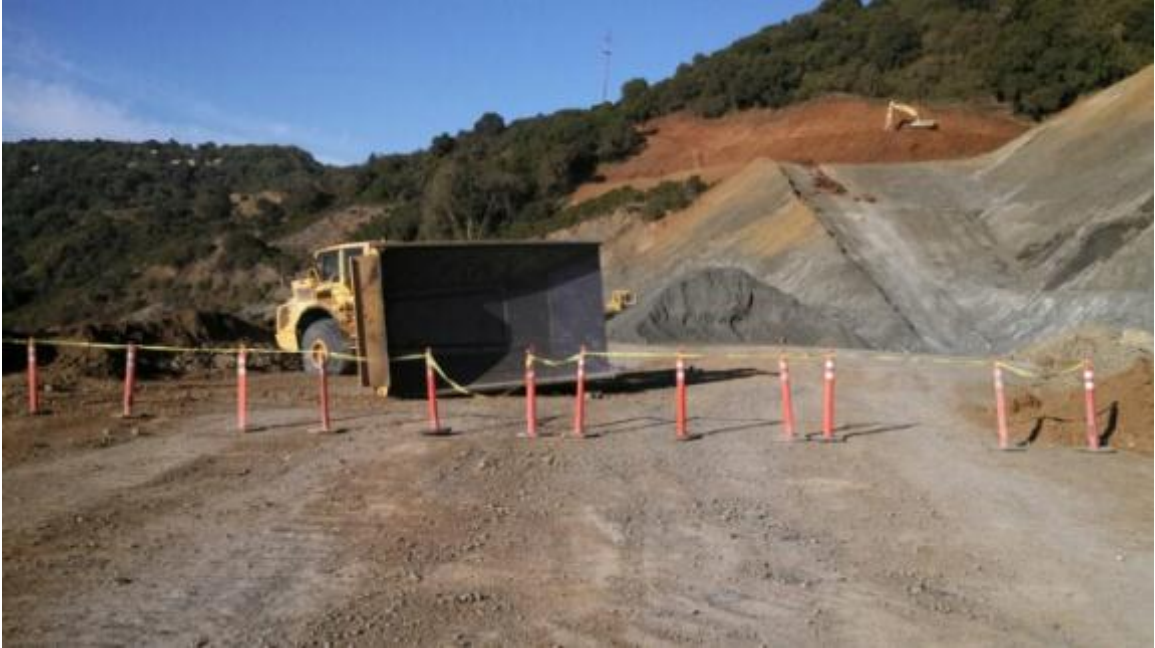
On June 13, 2013, Jose A. Gonzalez Sr., Lead Mechanic, age 49, was killed when the haul truck he was driving went out of control, struck a berm, and was propelled into the air. The haul truck came to a stop with the bed overturned and the cab upright. The victim was ejected from the haul truck.
