**REPORT OF INVESTIGATION**

**Fatal Machinery Accident  
August 5, 2013**

**MJL Crushing LLC  
MJL Crushing LLC  
Lowville, Lewis County, New York  
Mine ID No. 30-03570**

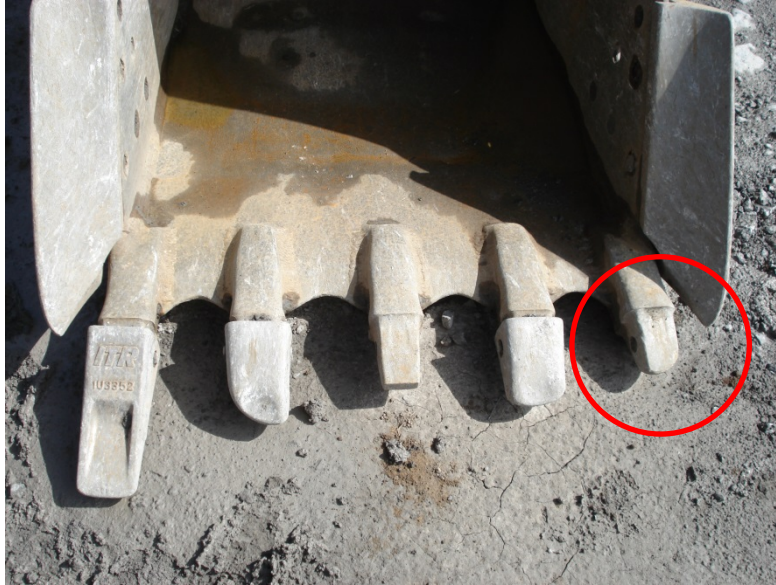
### EXCAVATOR BUCKET PHOTO

A Komatsu PC220 track-mounted excavator was the primary machine for loading broken limestone from the quarry; however, at the time of the accident, it was off site for repairs. On July 24, 2013, the mine operator brought a Hitachi EX200-5 track-mounted excavator to the mine to maintain production. It was equipped with a John Deere dipper boom and had a 36" bucket (capacity 1.16 cubic yard). During the short time the Hitachi excavator was used in the quarry, two teeth were lost from its bucket. The excavator manufacturer's recommendations stated that the bucket should be checked for bent, broken, loose, or missing parts. This recommendation was not being followed (see Appendix C).

**Figure 1** - The excavator bucket was poorly maintained. The right side shank (as shown) experienced a considerable amount of wear from using the excavator without reinstalling a tooth over the exposed shank.

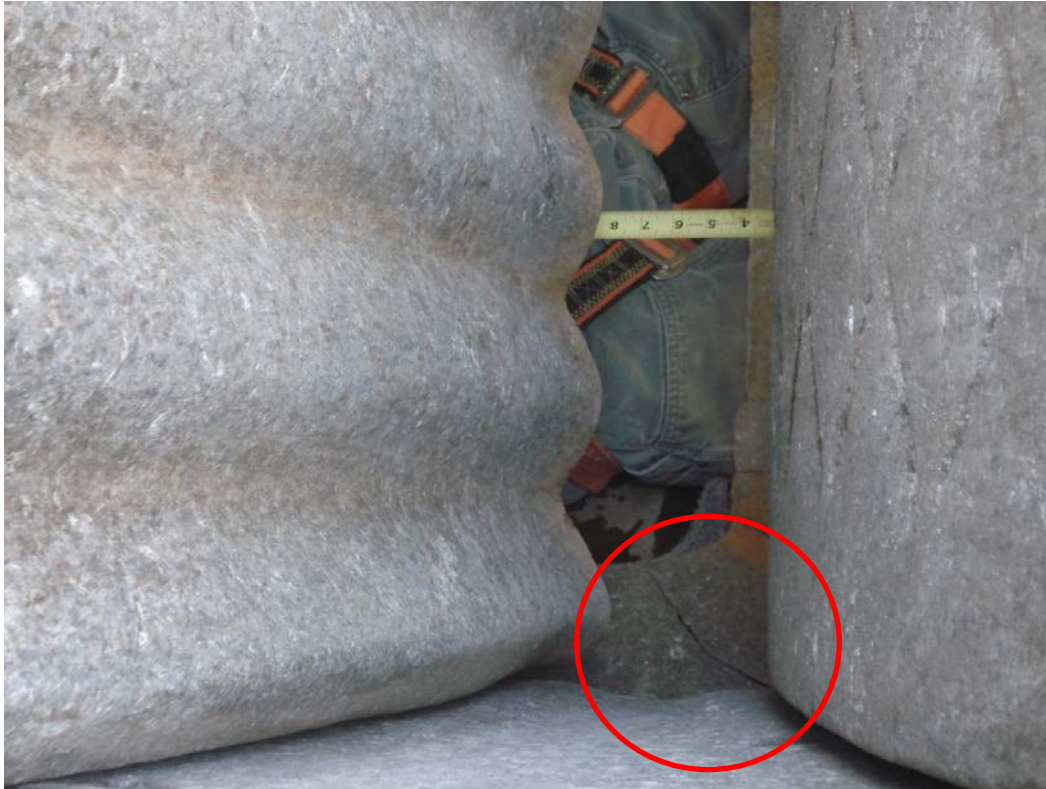
### JAW CRUSHER PHOTO

- The shot rock pile in the quarry contained long, flat pieces of broken limestone.
- The Brown Lenox 4232 jaw crusher had been poorly maintained. All of the main bearing bolts on the crusher were either loose or broken. There was a large crack in the steel frame (see Appendix D). Wear of the jaw plates and failure to maintain the jaw crusher to a specific size range setting allowed large, flat rocks to enter the downstream cone crusher. This caused numerous clogging and bridging of flat materials in the cone crusher that occurred on a daily basis.

**Figure 2** - A very large crack (as shown) in the steel frame of the throat of the jaw crusher. (Note: An accident investigator appears in the photo.)
